# **Restoration Project / Schiller Upright Photographic Journal / Photo Set 2**

**by Chuck Behm**

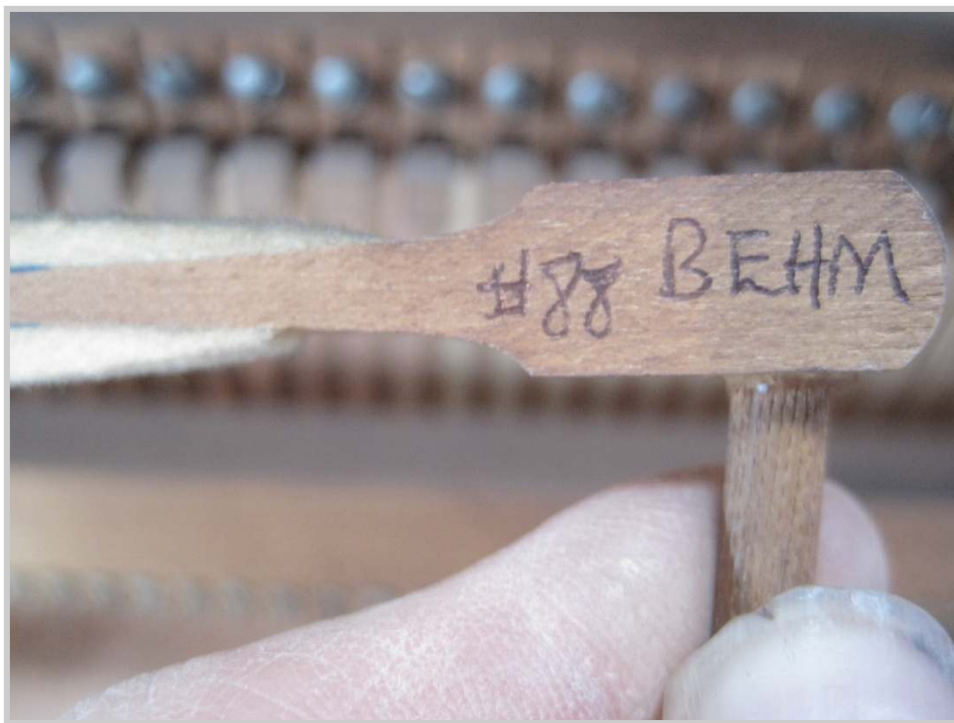
*Photo 28: End hammers of each section have been removed from the action and are numbered to send to Schaff Piano Supply Company for duplication.*

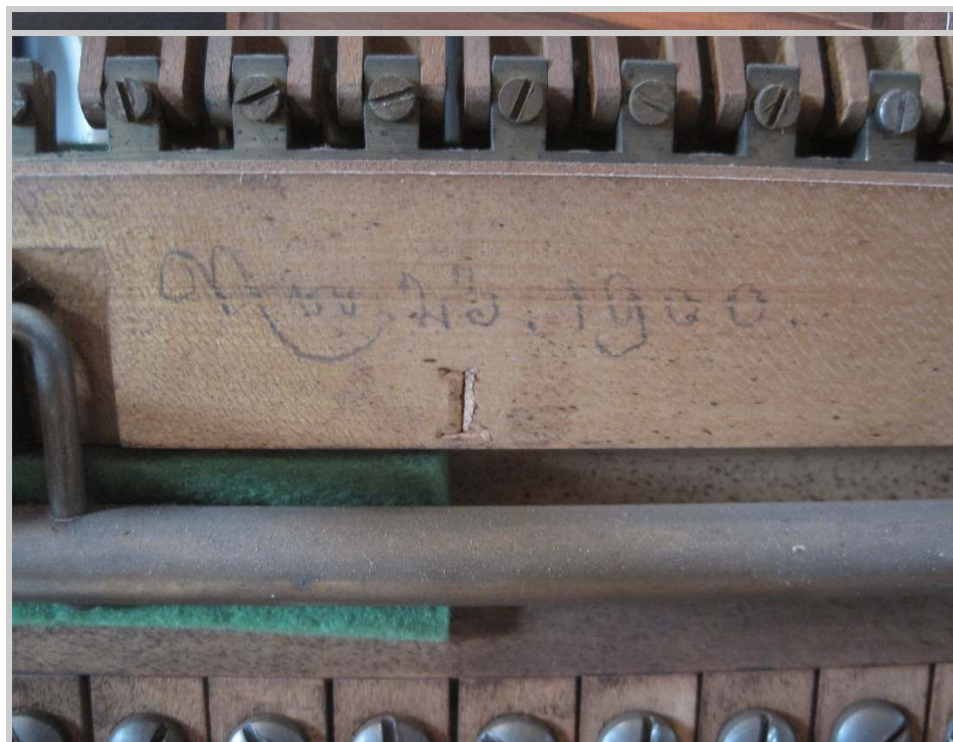
*Photo 29: In an instance of serendipity, I glanced up from taking the shot of my numbering on the hammer in photo 28, to notice for the first time the inscription on the rail written by a factory technician at the very beginning of the last century (the year the piano was built). . .this makes me stop and think—will anything I've accomplished with pianos last 100 years?*

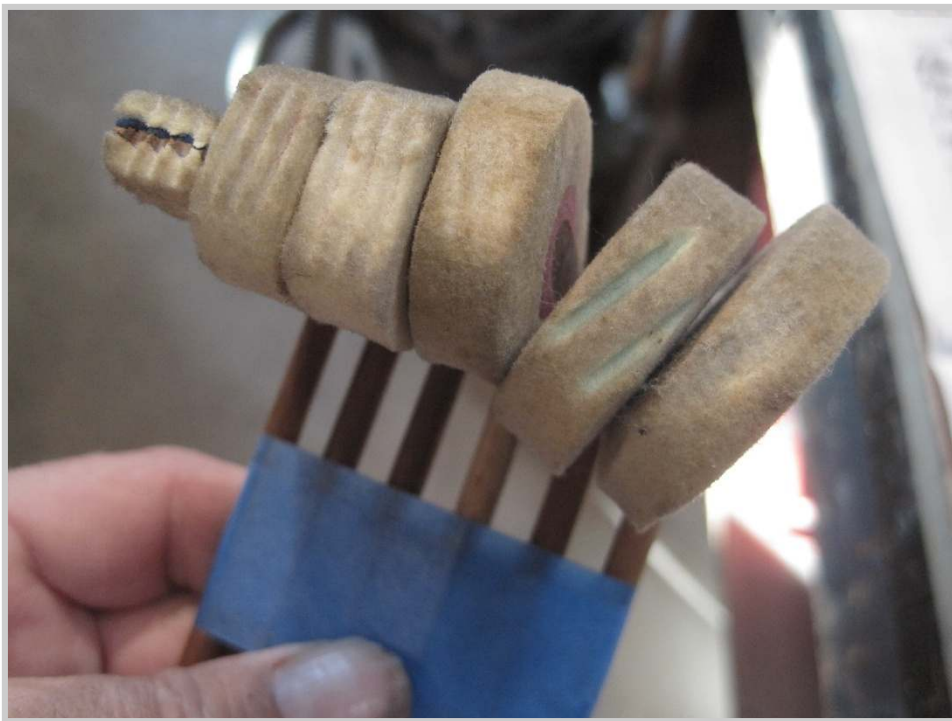
*Photo 30: Wear and tear on the sample hammers being sent in for duplication—a clear need for replacement and not just a simple filing and shaping.*

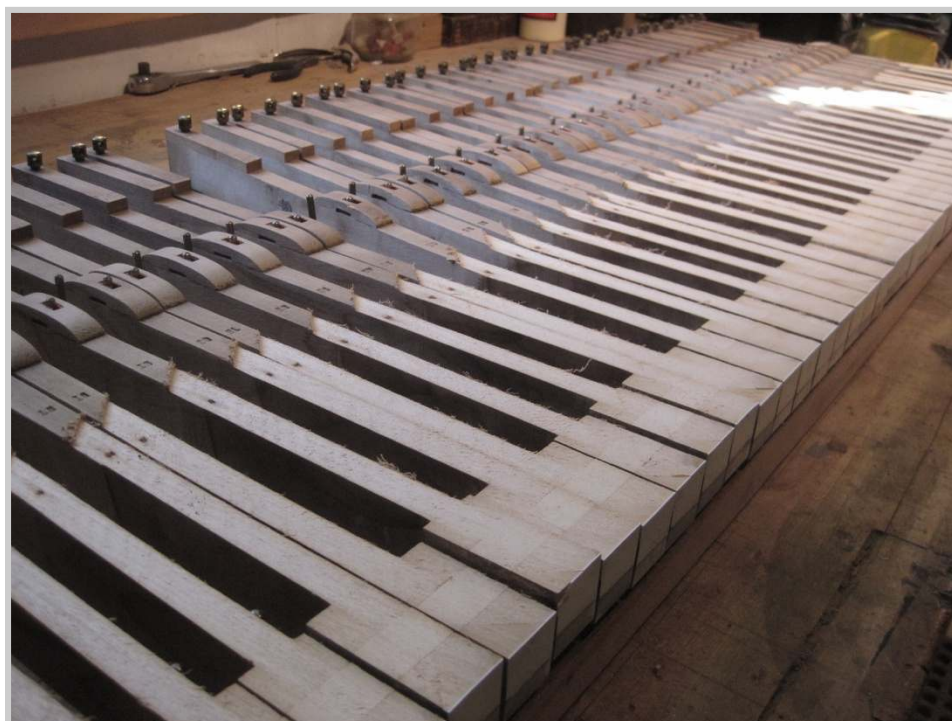
*Photo 31: Turning our attention to the keys, I prep the surface of the natural keys for installation of new keytops. Since the new tops are a bit thicker than the original ivory, the very top of the keysticks are shaved off to compensate for the difference. The old fronts will also be removed prior to the installation of the new tops.*

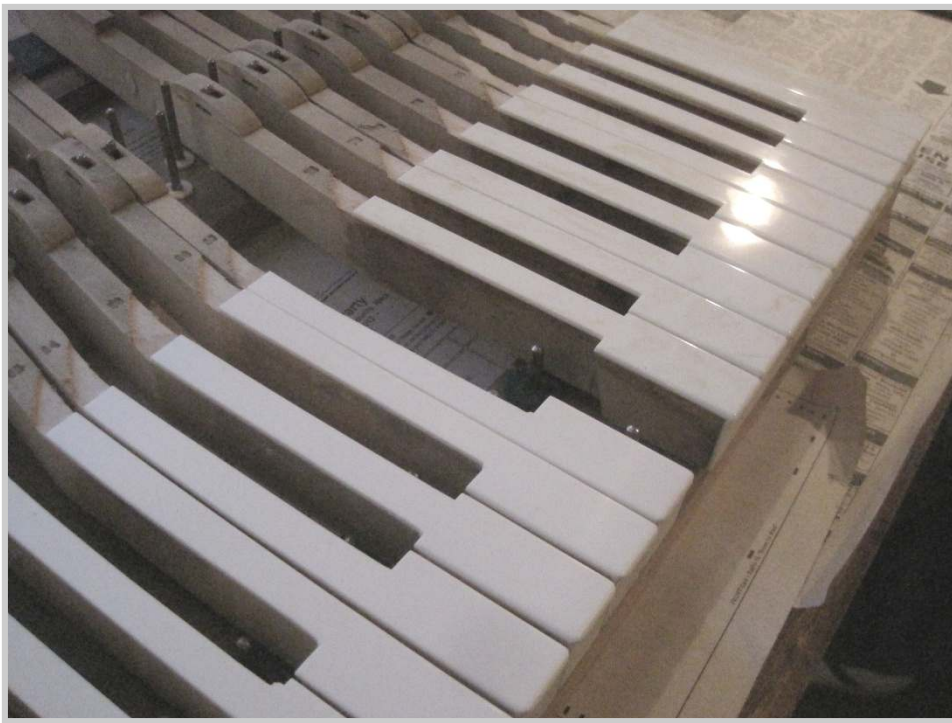
*Photo 32: New keytops are hand filed after being glued on. The satin finish of the keytops to the left in the photo is a result buffing off the sheen with 0000 steel wool.*

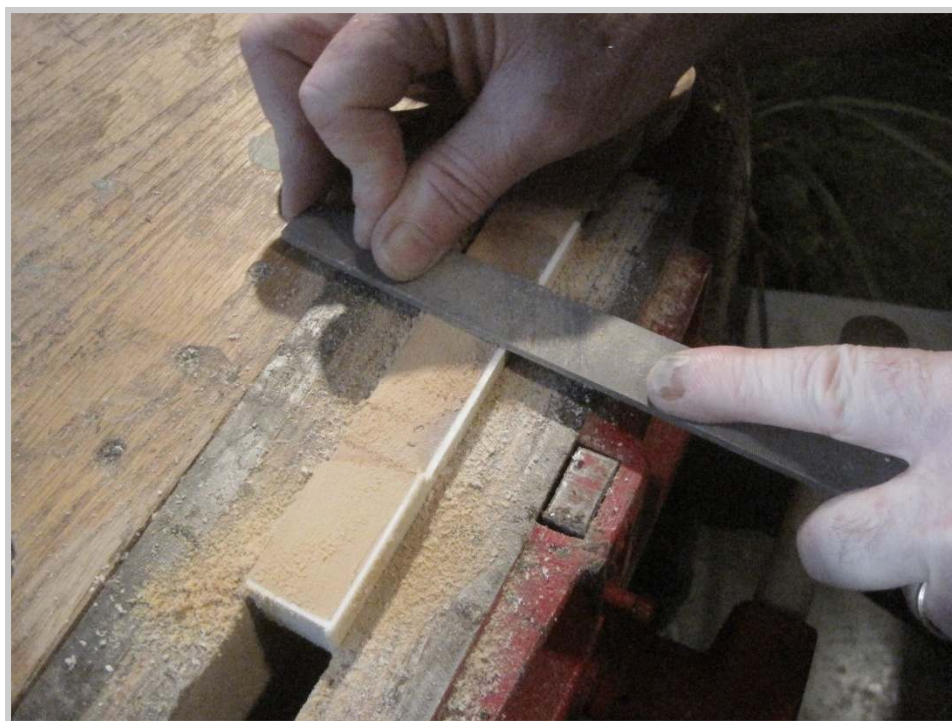
*Photo 33: The sides of the each new keytop is filed flush with the wooden keystick by using a coarse file to knock off any overhang, followed by a fine file for a smooth finish.*

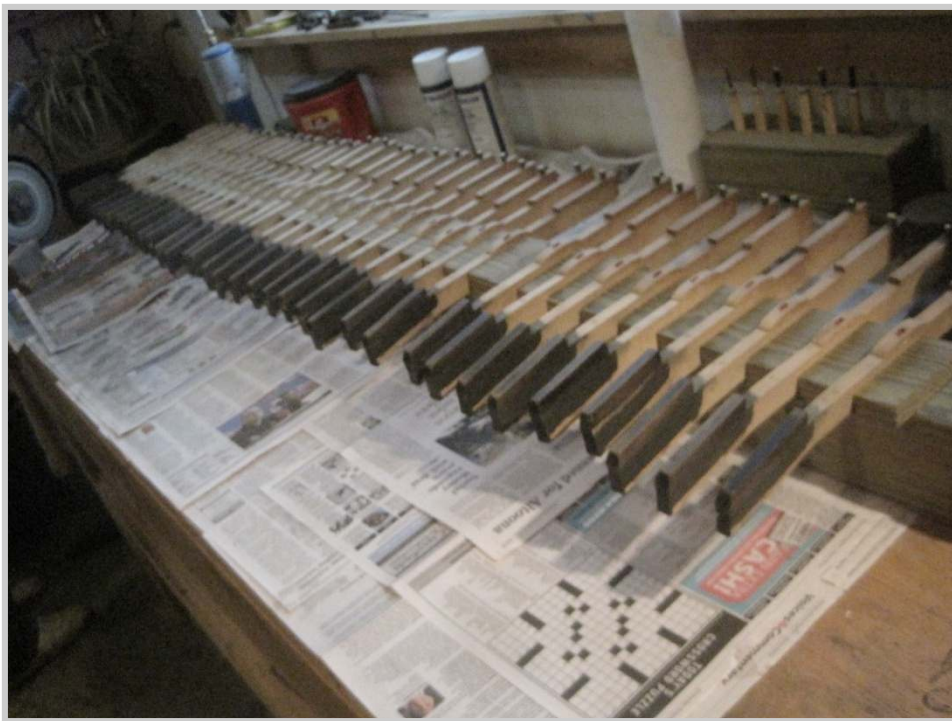
*Photo 34: Sharp keys are placed in racks and the old lacquer finish is stripped off.*

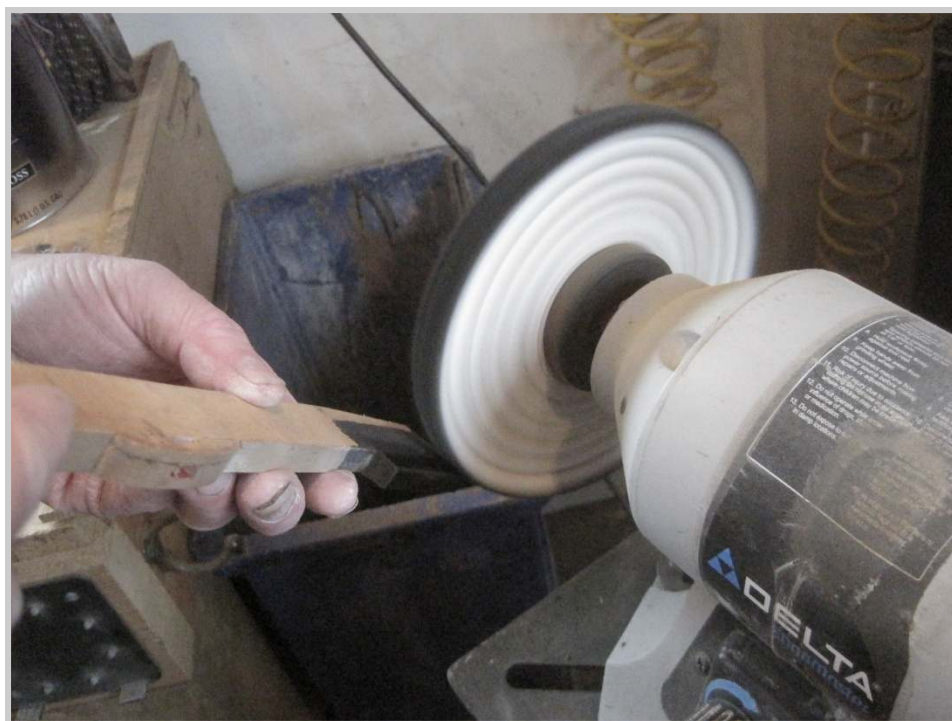
*Photo 35: The ebony sharps are buffed with a special compound to bring out the beauty of the wood. .*

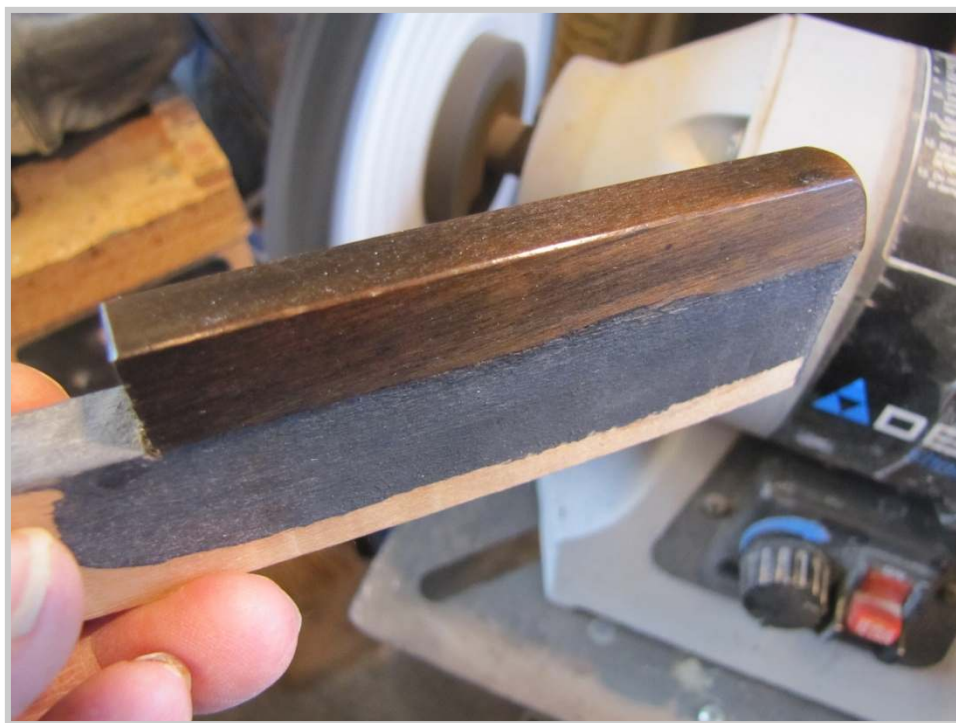
*Photo 36: The beautiful reddish brown finish of the ebony sharps is brought out by polishing.*

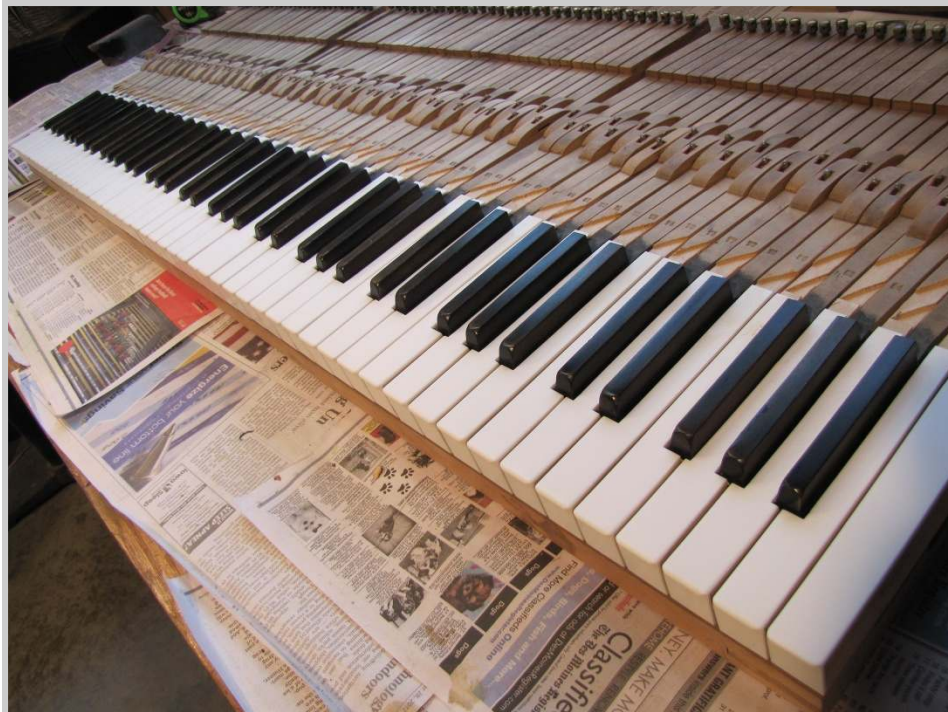
*Photo 37: The finished set of keys ready to be reinstalled when the time comes.*

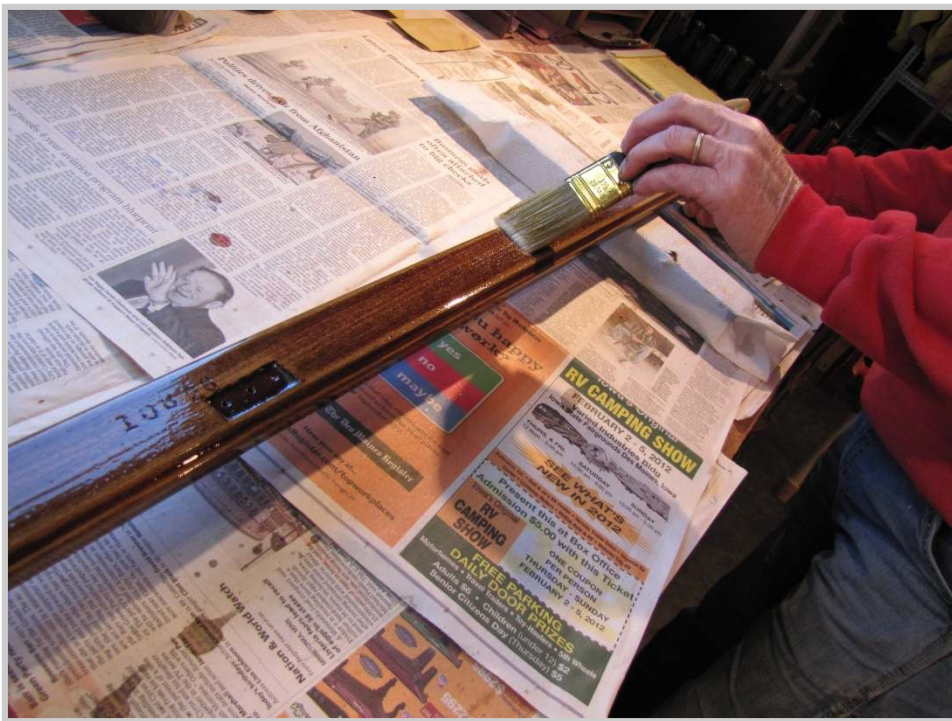
*Photo 38: Turning to the case parts, Dave applies three coats of polyurethane to each case part. Staining was done to match the original finish, which will be preserved on the inside of the lid. The first two coats applied are high gloss for hardness— the final coat is satin for the desired appearance.*

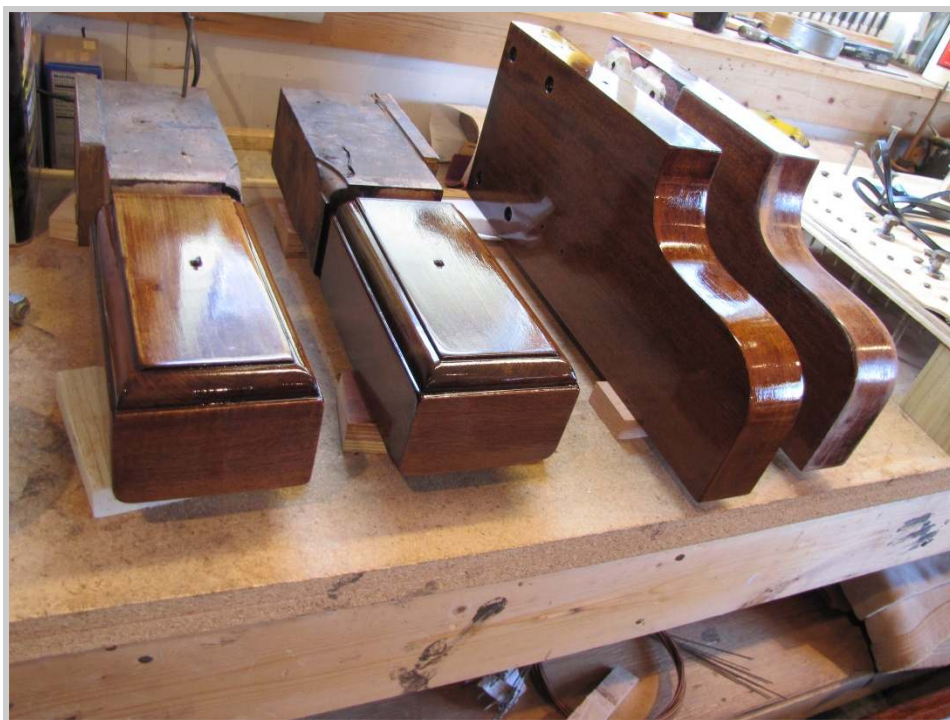
*Photo 39: Parts after second coat has been applied. The arm on the far right is just one coated. Each coat of polyurethane is buffed between coats with 600 grit paper.*

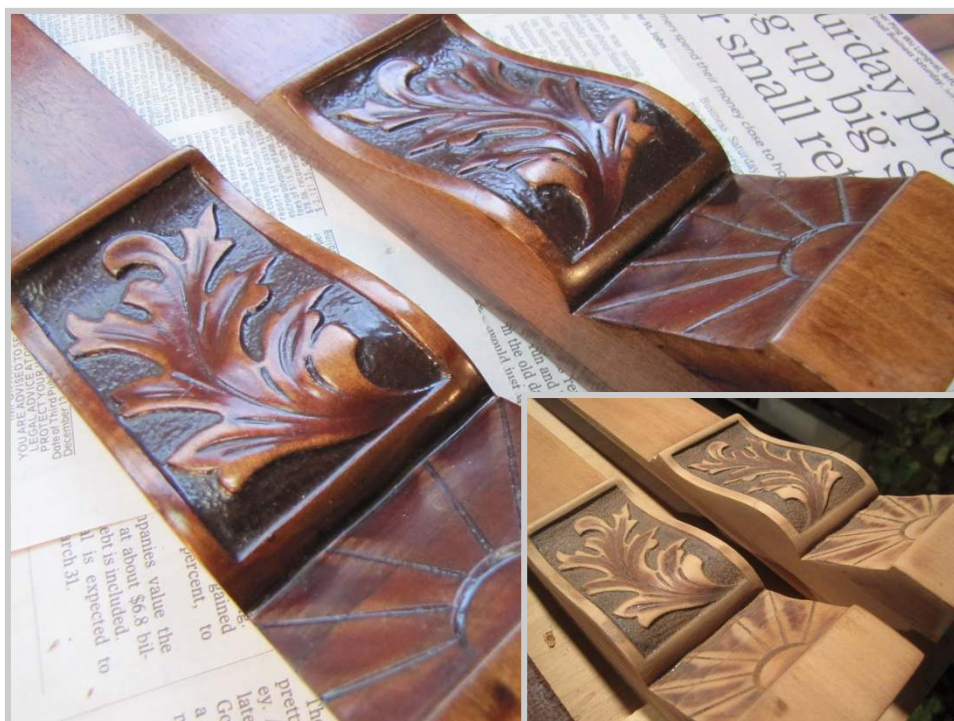
*Photo 40: Decorative case parts before (inset) and after new finish is applied.*

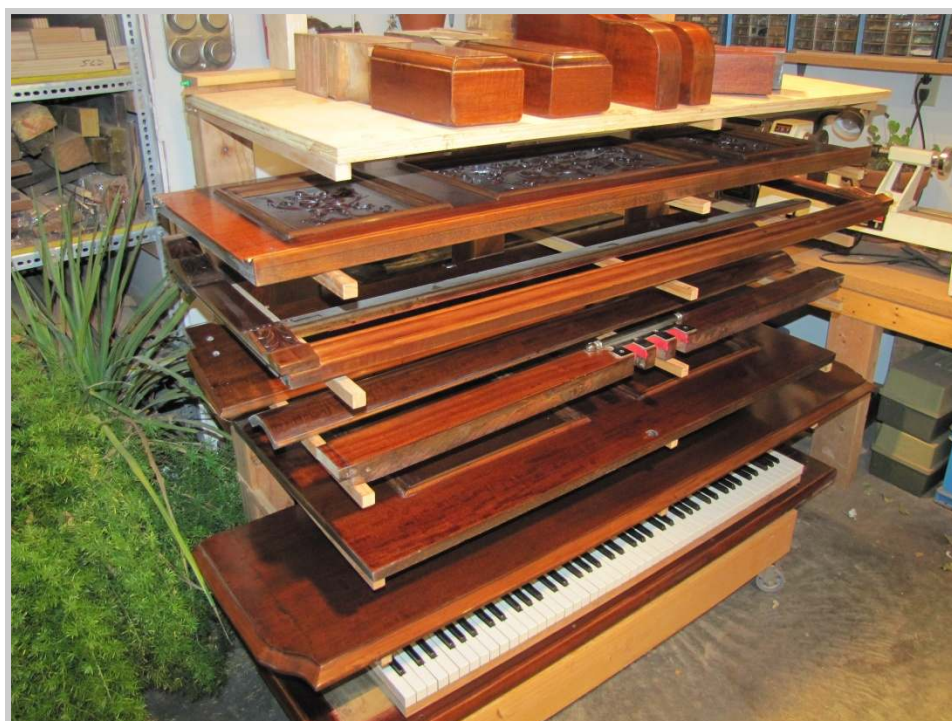
*Photo 41: With all case parts finished and stored on parts trolley for the moment, work can focus on other matters.*

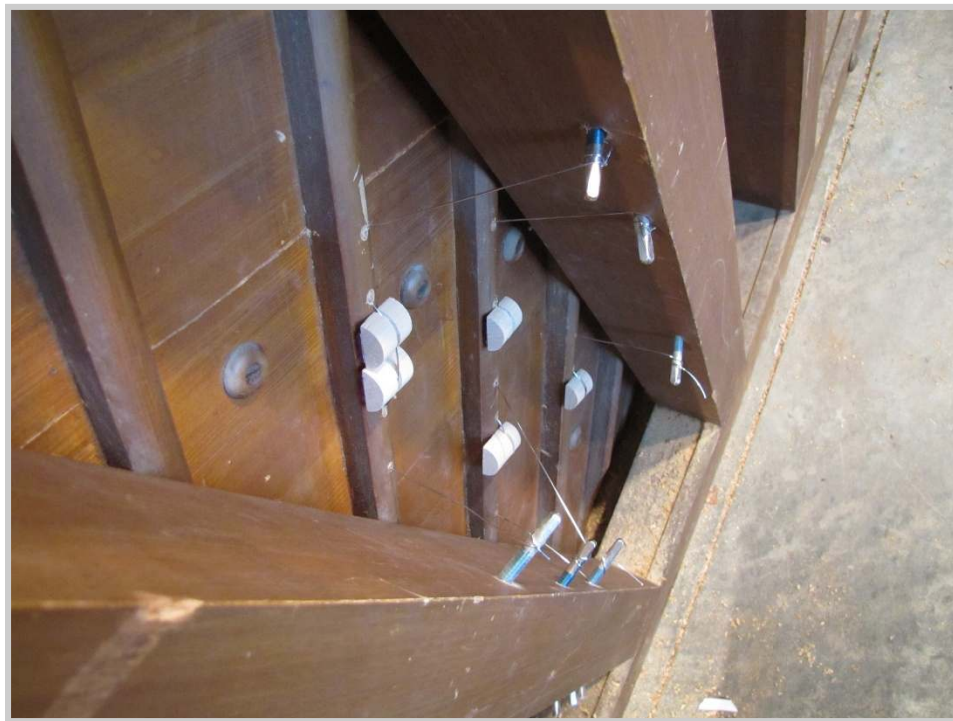
*Photo 42: Loose ribs are effectively reglued by use of piano wire at tension used to draw the ribs and the soundboard firmly together. Tuning pins driven temporarily into the back posts as stakes to pull back on the wire. The holes drilled in the back posts for the pins will be later filled with epoxy, sanded and shellacked.*

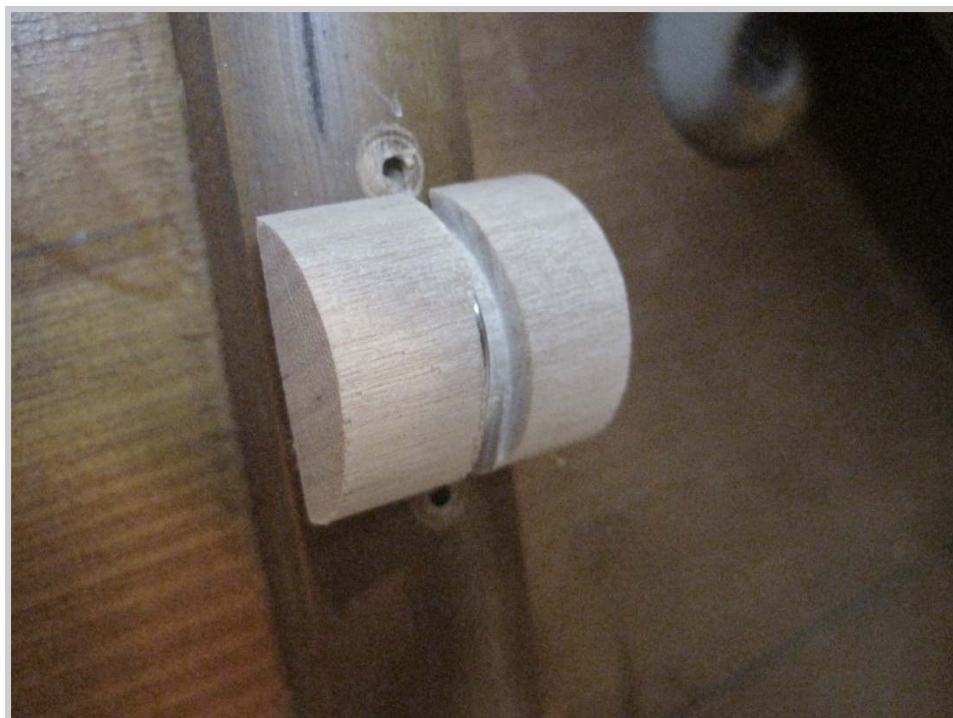
*Photo 43: This is the device that makes this method work. Piano wire is threaded from the front to the back of the soundboard and around half-rounds which are channeled to allow the wire to easily slide as it is tensioned. The only damage to the ribs and the soundboard are the 1/16" holes drilled to allow for passage of the piano wire..*

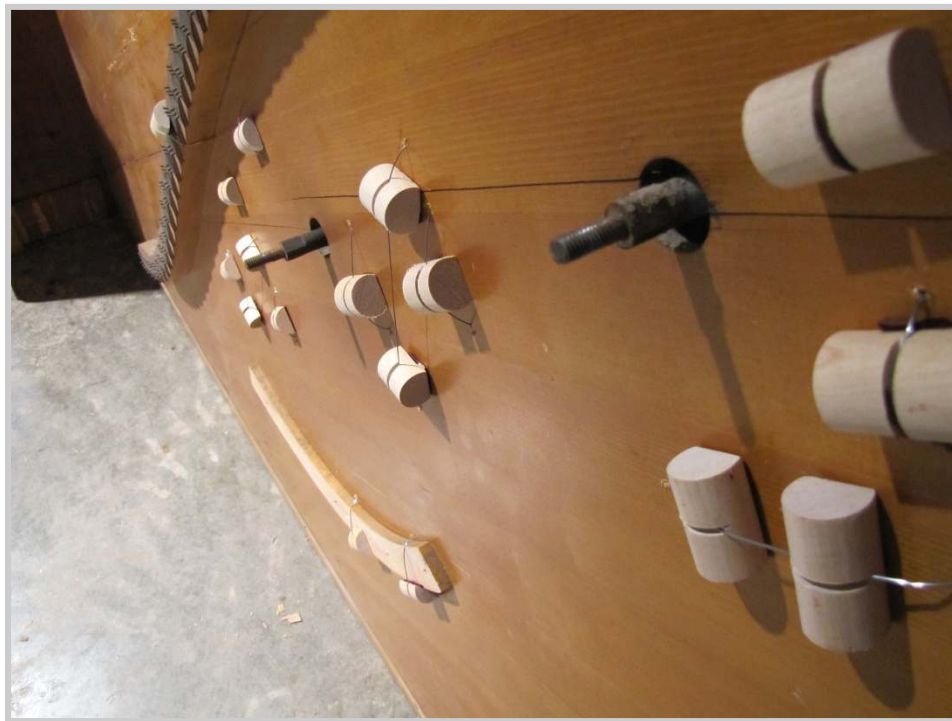
*Photo 44: The wire clamping system as seen from the front of the soundboard.*

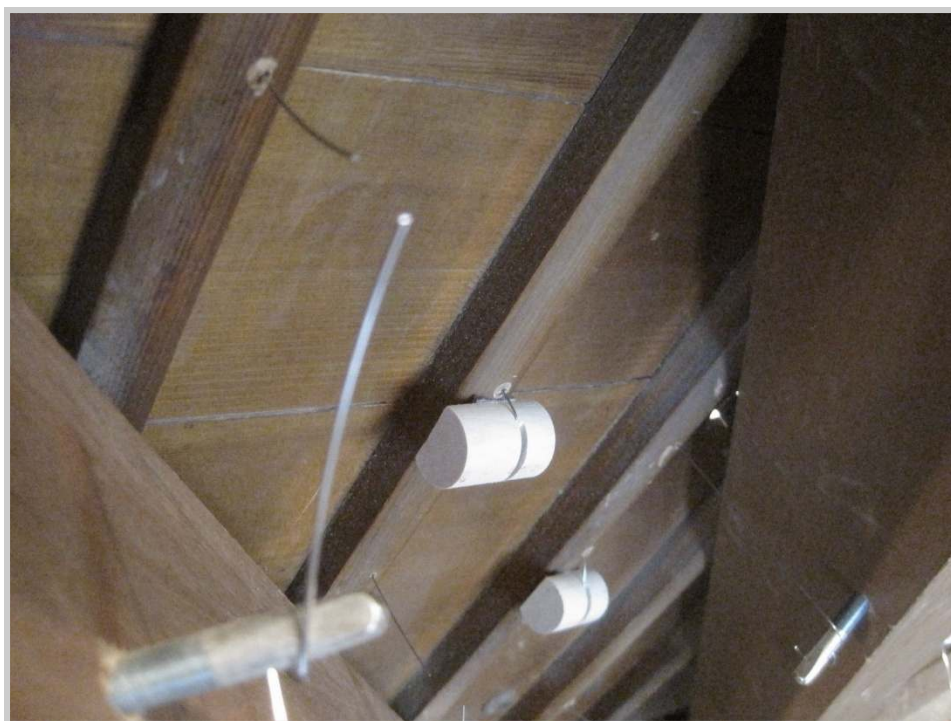
*Photo 45: The morning after the ribs were clamped, the wires were cut. Overnight, the soundboard had gained a noticeable crown, which was announced by a bang with each wire that was cut. The board visibly flexed outward as the tension was released.*

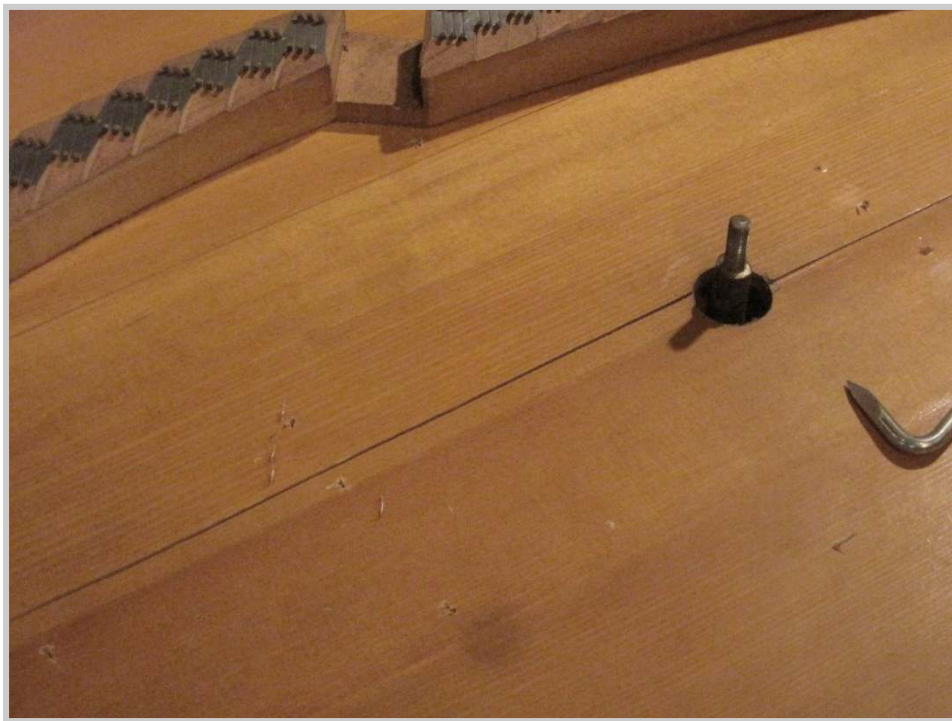
*Photo 46: Laying the piano on its back once again, it is time to tackle the cracks which have opened up in the dry shop air. (The tiny holes which were used for the gluing of the ribs to the soundboard will be filled, and will be nearly invisible when the board is finished.)*

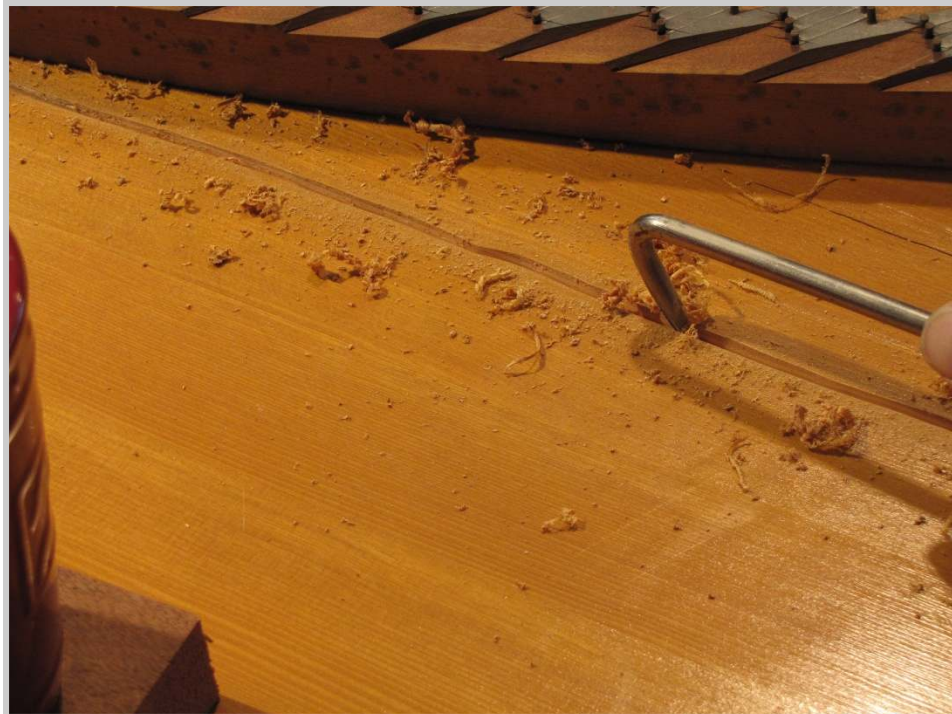
*Photo 47: Each crack is widened with a specialized gouging tool which produces a v-shaped gouge suitable for shimming. Multiple passes with the gouging tool with a moderate amount of downward pressure produce the cleanest cut.*

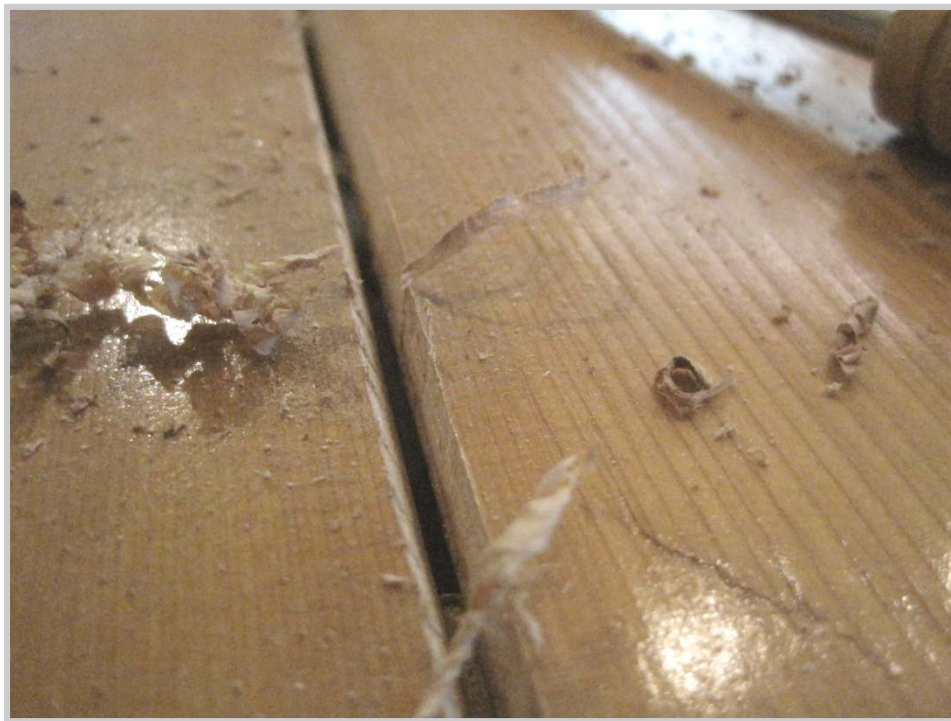
*Photo 48: A perfectly gouged channel for a shim.*

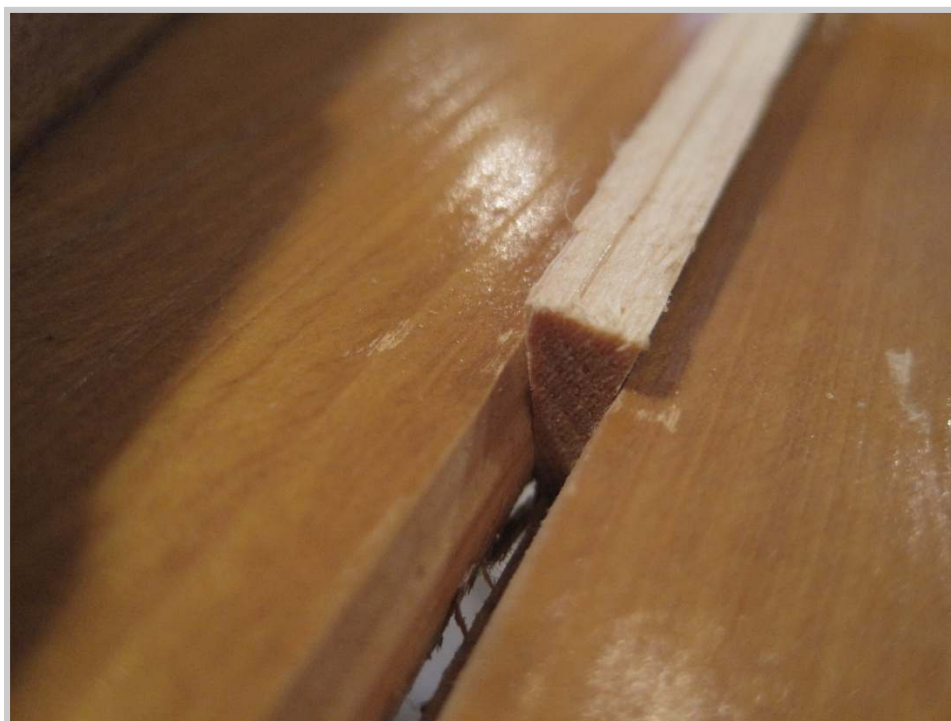
*Photo 49: A sample piece of shimming material is used to test the width of the groove. The point of the shim should protrude below the gouge, while not sinking below the level of the soundboard on the topside.*

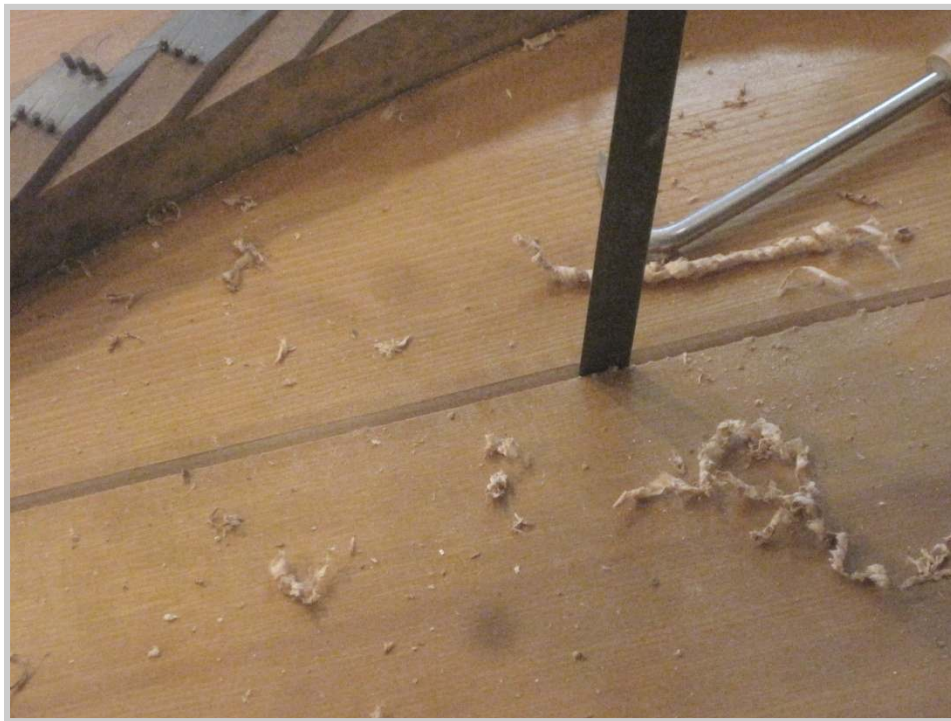
*Photo 50: A piece of thin steel is used to easily find the ribs. Moving the steel from side to side, it will knock up against the solid ribs while cutting through any remaining material at the bottom of the v-shaped gouge. The start and stop point for each rib is marked with a scratch line on the soundboard.*

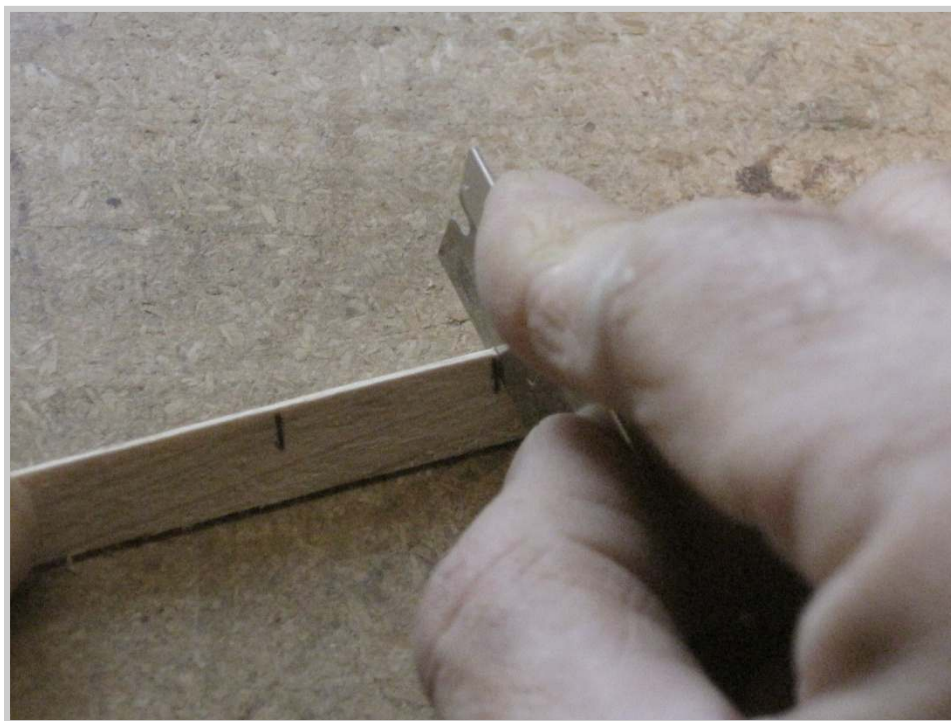
*Photo 51: The sides of the shim to be used are marked for notching to match the scratch lines on the soundboard. The edges of the notches are first scored with a sharp razor by rocking it back and forth.*

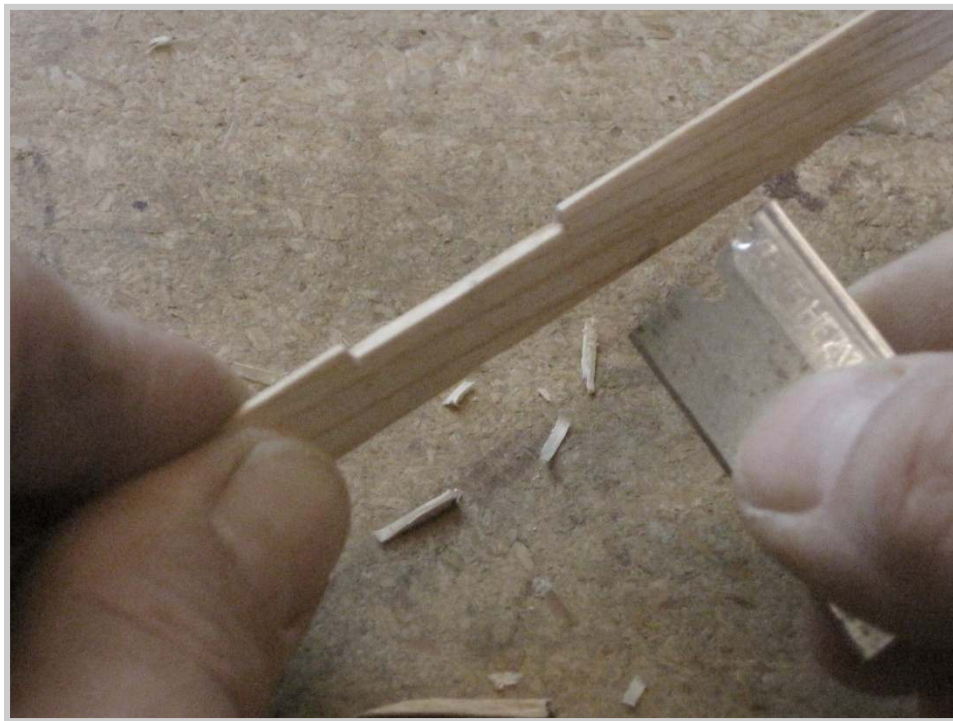
*Photo 52: Each notch is cut out with a razor blade.*

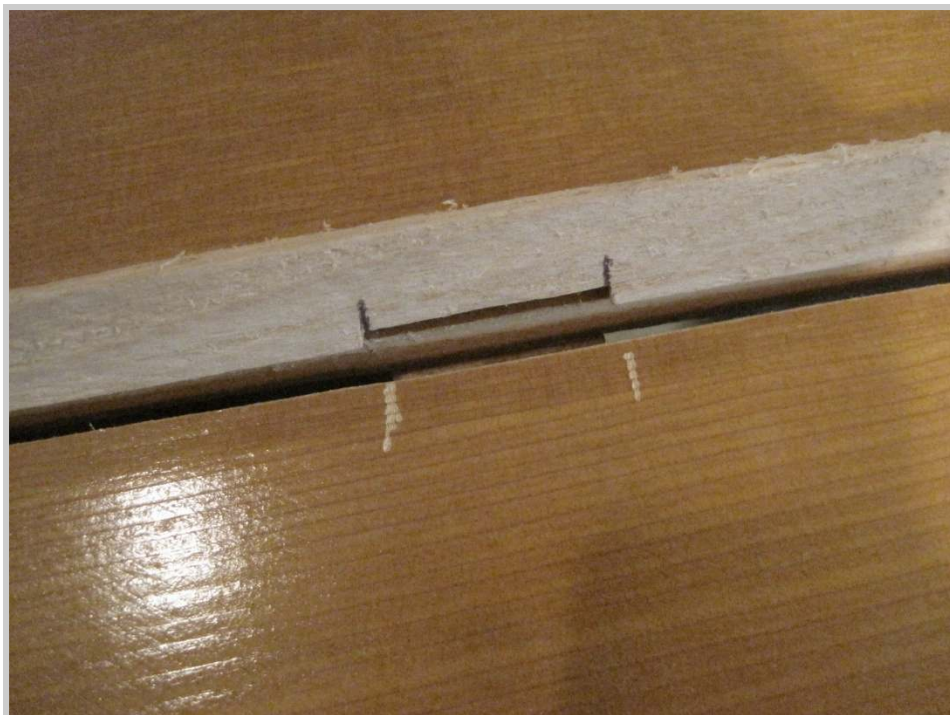
*Photo 53: Each visible rib will have the corresponding notch in the intended shim.*

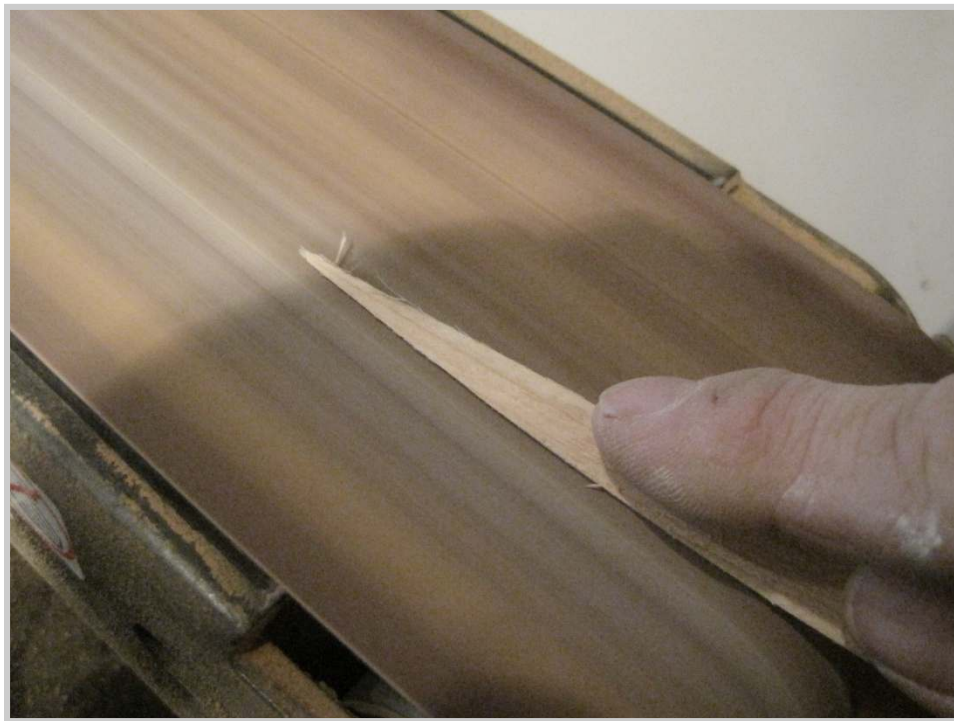
*Photo 54: The end of a shim is tapered using a belt sander.*

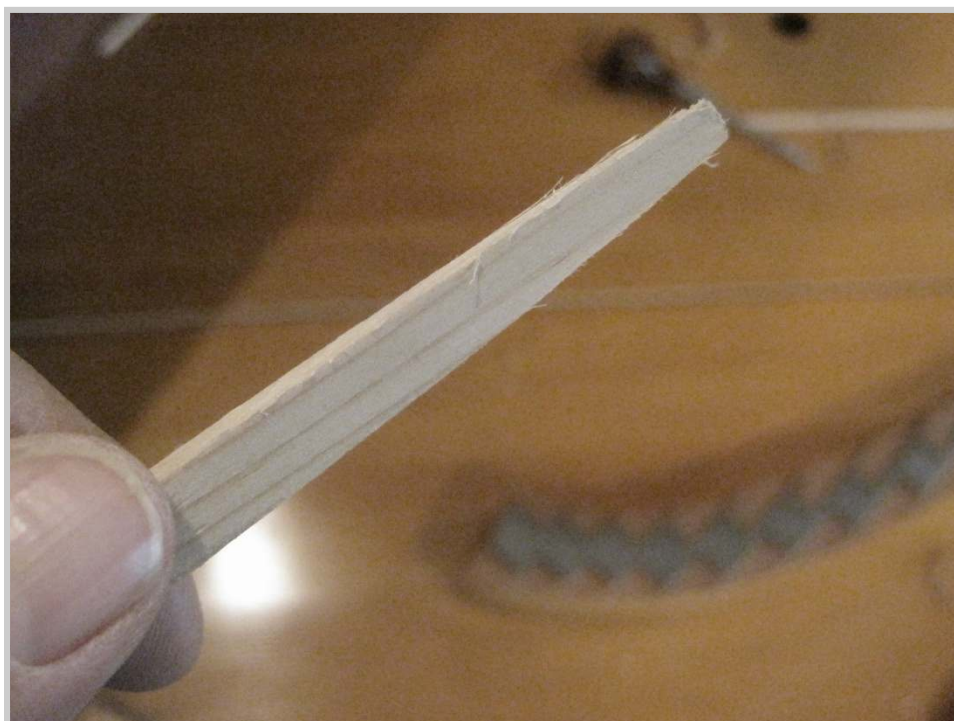
*Photo 55: For a gouge ending in an open area, a shape like the bow of a boat works the best.*

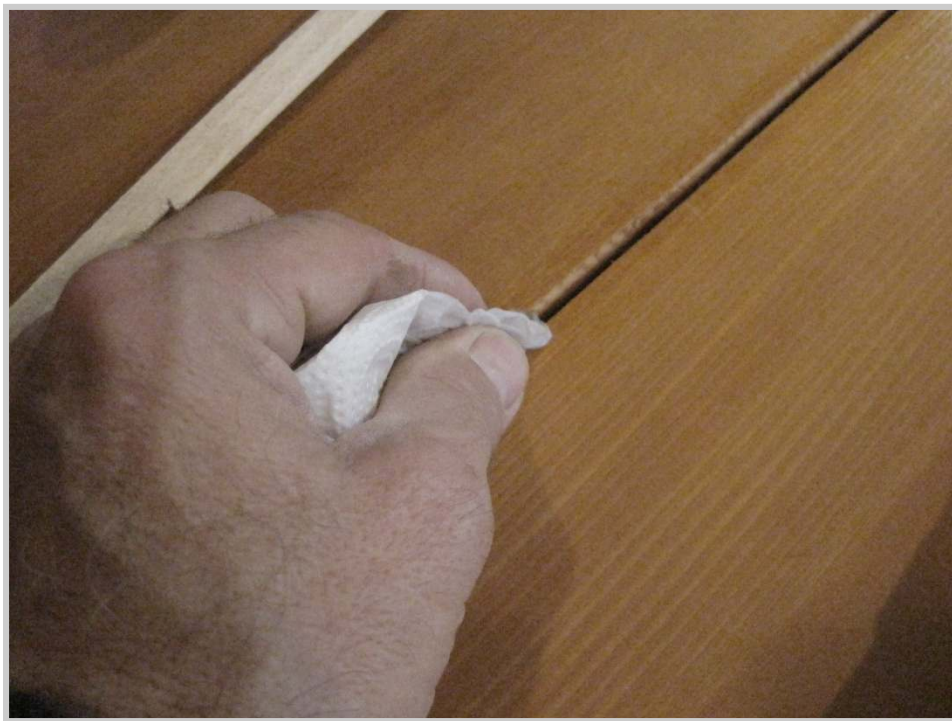
*Photo 56: If Gorilla glue <sup>®</sup> is to be used (my preference) the v-shape gouge is moistened as per gluing instructions.*

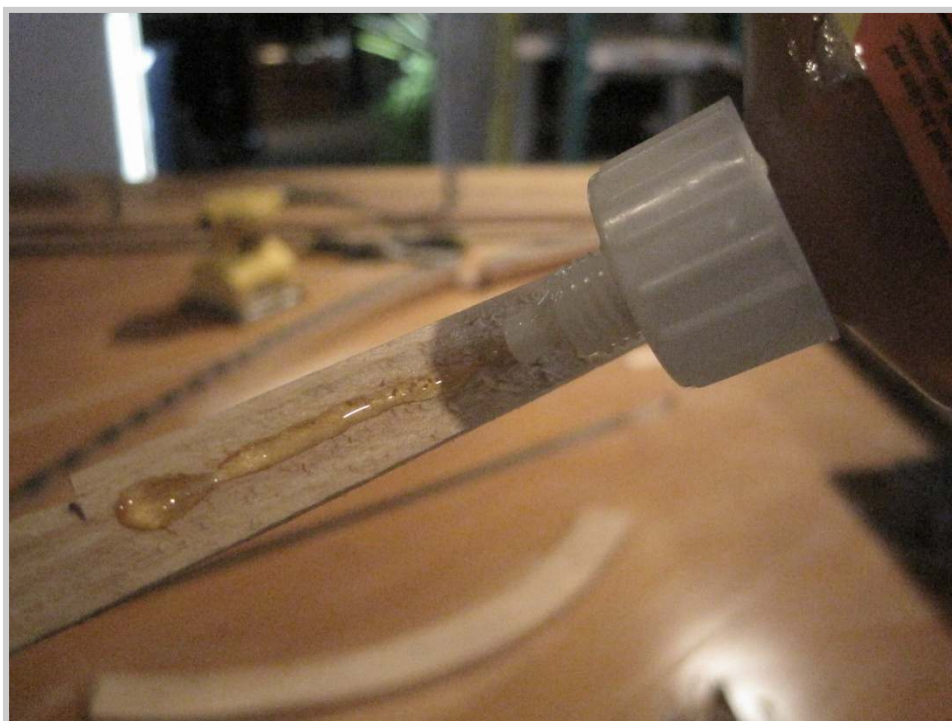
*Photo 57: A generous layer of glue is applied to both sides of the shim, and then evenly spread over the surface. When using Gorilla Glue one always needs to wear gloves, by the way.. Although the stuff has the consistency and look of honey, the job of trying to scrub it off of bare skin is anything but sweet!*

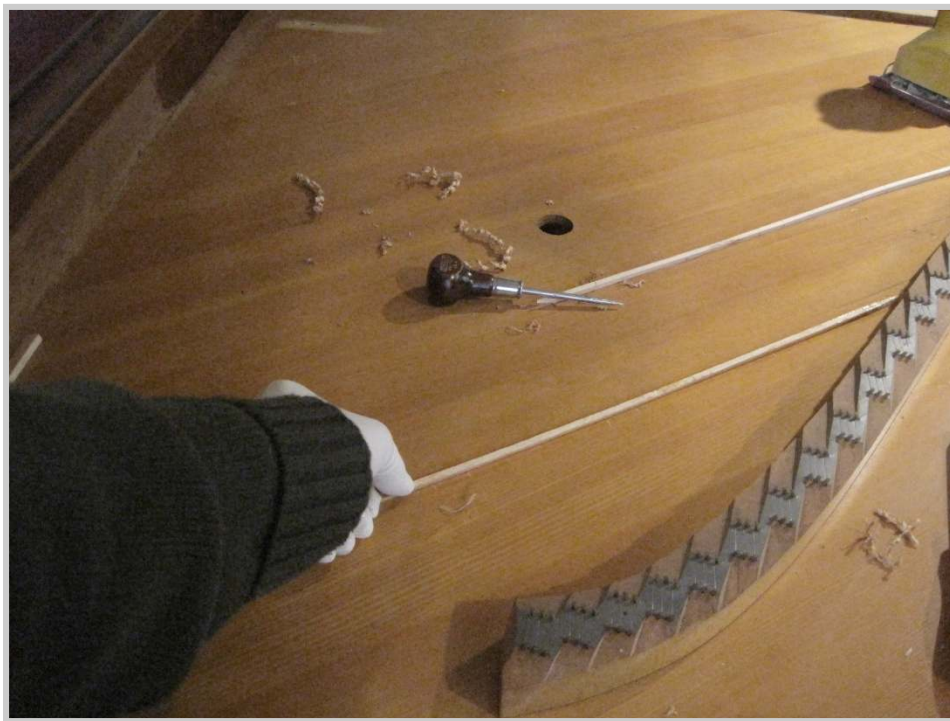
*Photo 58: The shim is pressed into place. What is desired is a good fit from side to side in which the shim doesn't want to pop out of the gouge on one end or the other*
