# **Restoration Project / Schiller Upright Photographic Journal / Photo Set 2**

**by Chuck Behm**

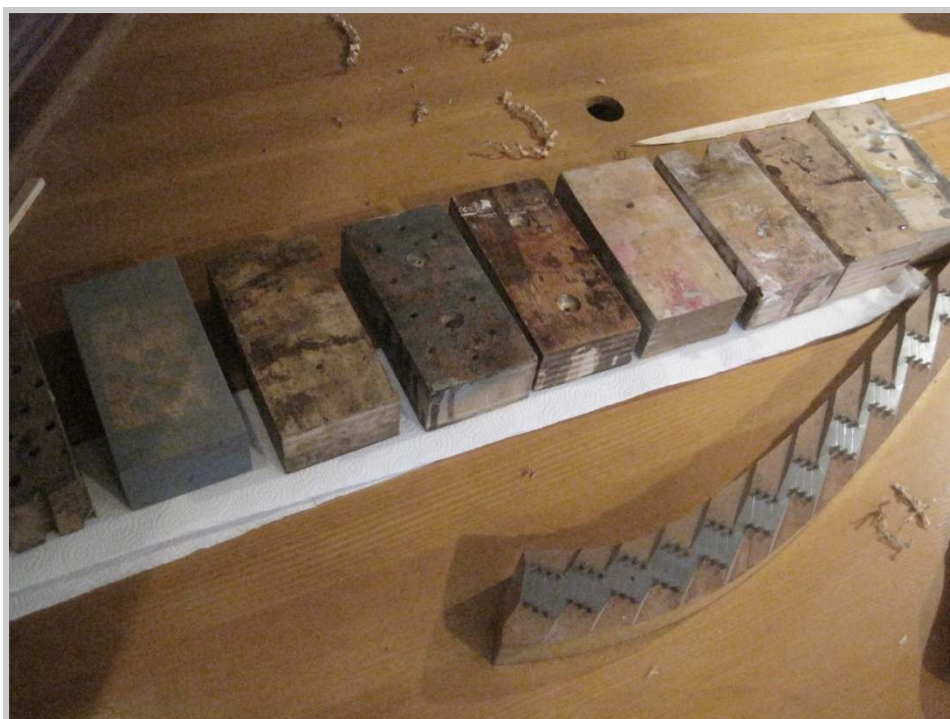
*Photo 59: A row of wooden blocks are placed over the shim, with a layer of folded paper towels in between the shim and the blocks to prevent adhesion of the two wood surfaces. The paper towels will stick to the shims, but are easily scraped off once the glue has dried.*

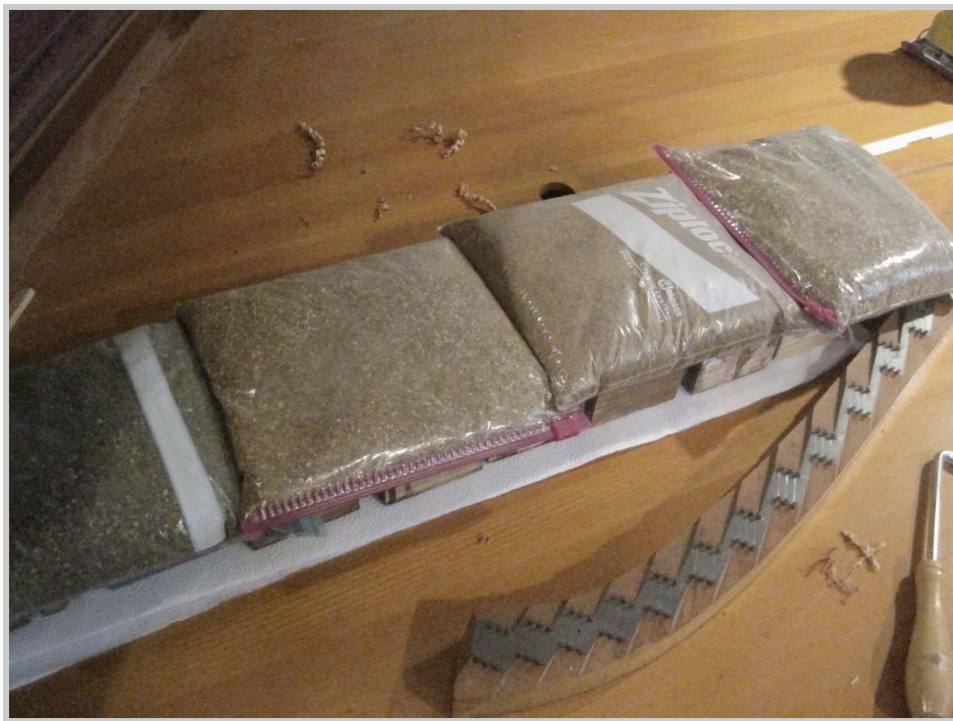
*Photo 60: For tight fitting shims, bags of sand provide enough weight to hold the shim in place while the fast-acting glue sets. Gorilla glue expands a bit, filling any tiny discrepancy between the sides of the groove and the shim.*

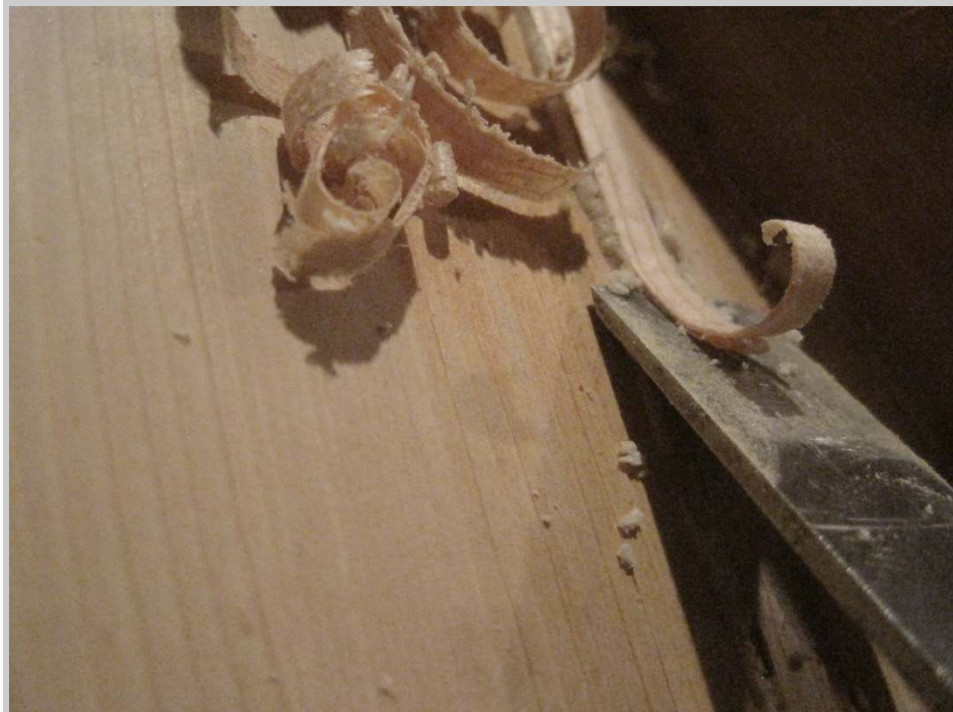
*Photo 61: After curing overnight, the excess shimming material is removed, first with a sharp chisel, then by sanding with a palm sander.*

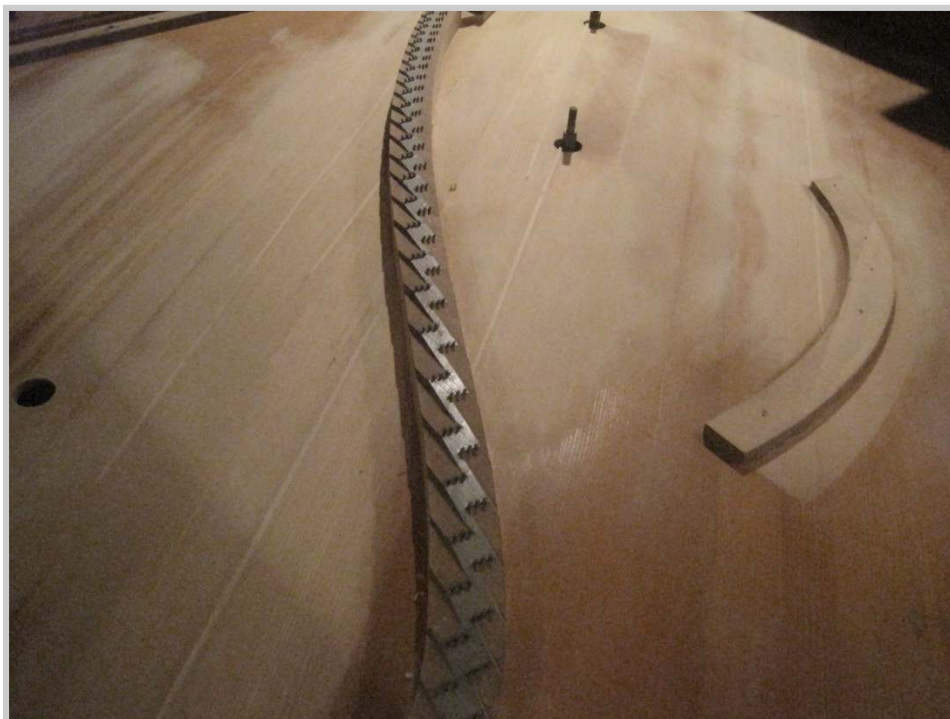
*Photo 62: The soundboard after all shims are glued in place, then trimmed and rough sanded. The bass bridge is being repaired and will be reattached in the near future.*

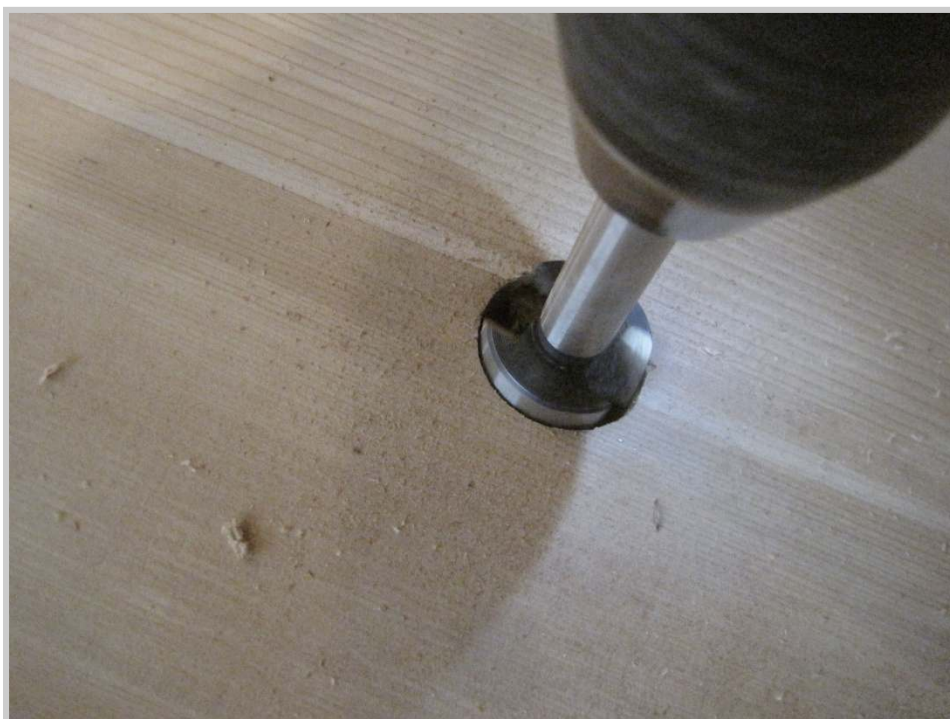
*Photo 63: Where shims run across bolt holes, they are easily trimmed after gluing with a Forstner bit.*

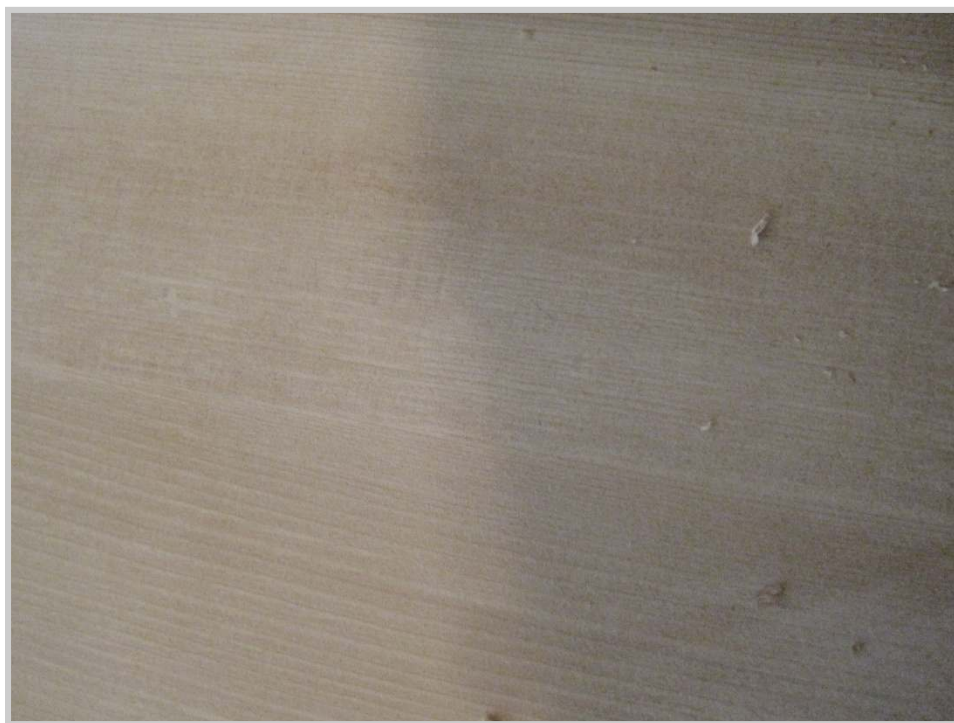
*Photo 64: Well-fitted shims will blend in to the point of invisibility when the soundboard is sanded down. The only evidence of shims will be a difference in coloration with the shim material usually being a lighter shade.*

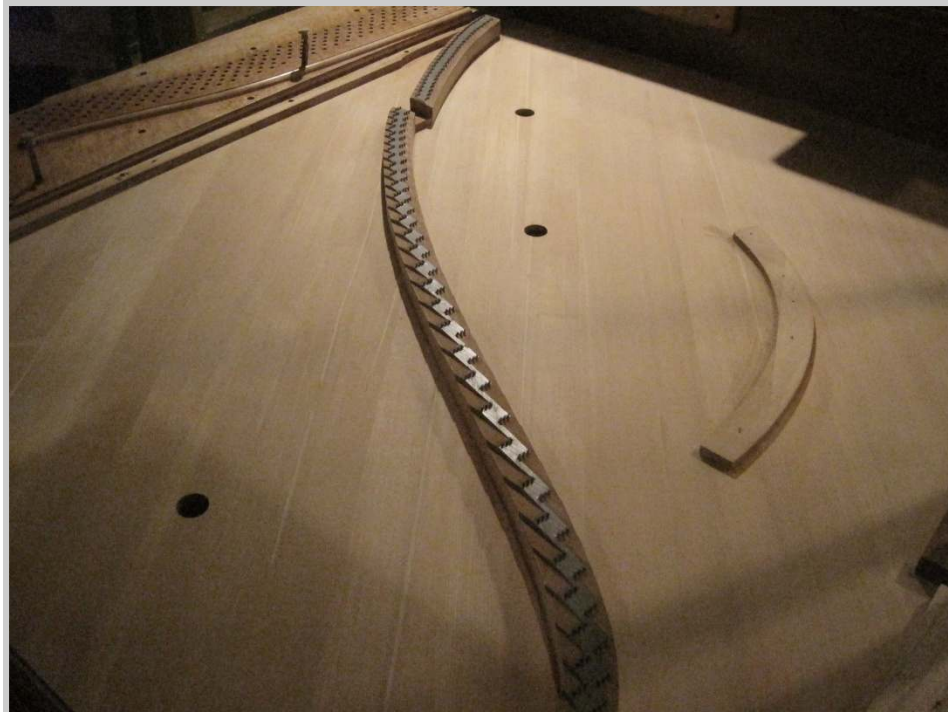
*Photo 65: The soundboard after overall sanding down to 220 grit has been accomplished. When thumped, the soundboard now has a very mellow and long-lasting vibration—unlike before the repairs when it was dead.*

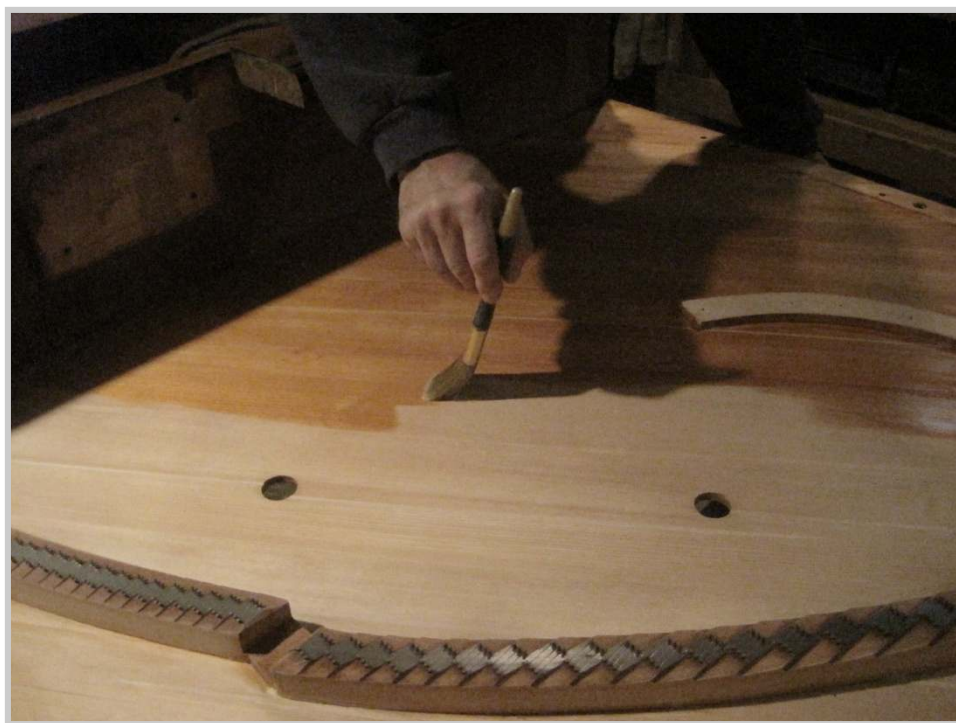
*Photo 66: A first coat of shellac is applied.*

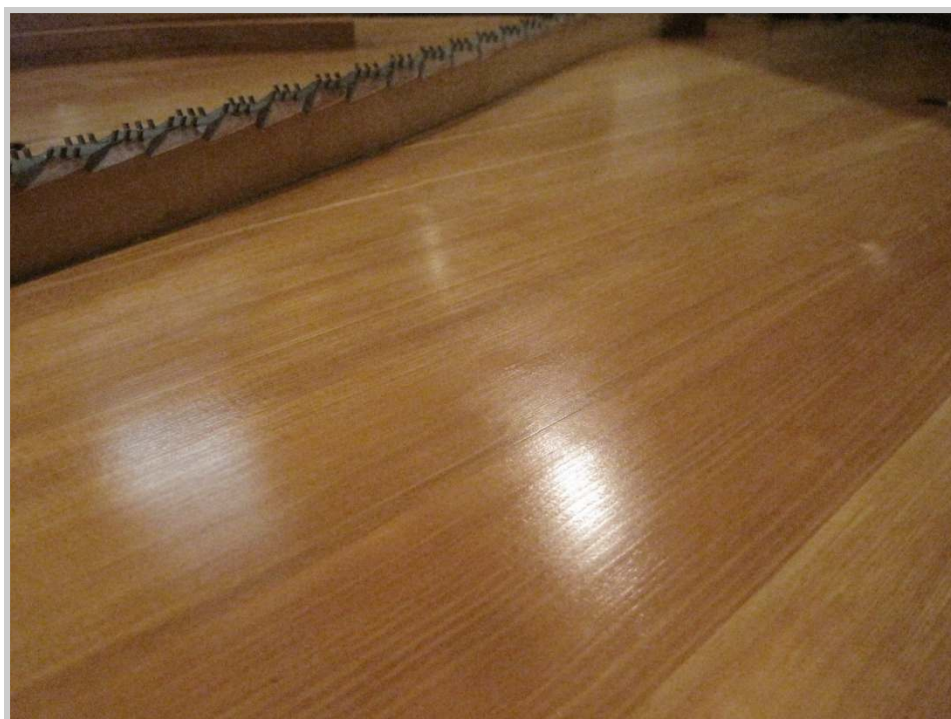
*Photo 67: The board after the third coat of shellac.*

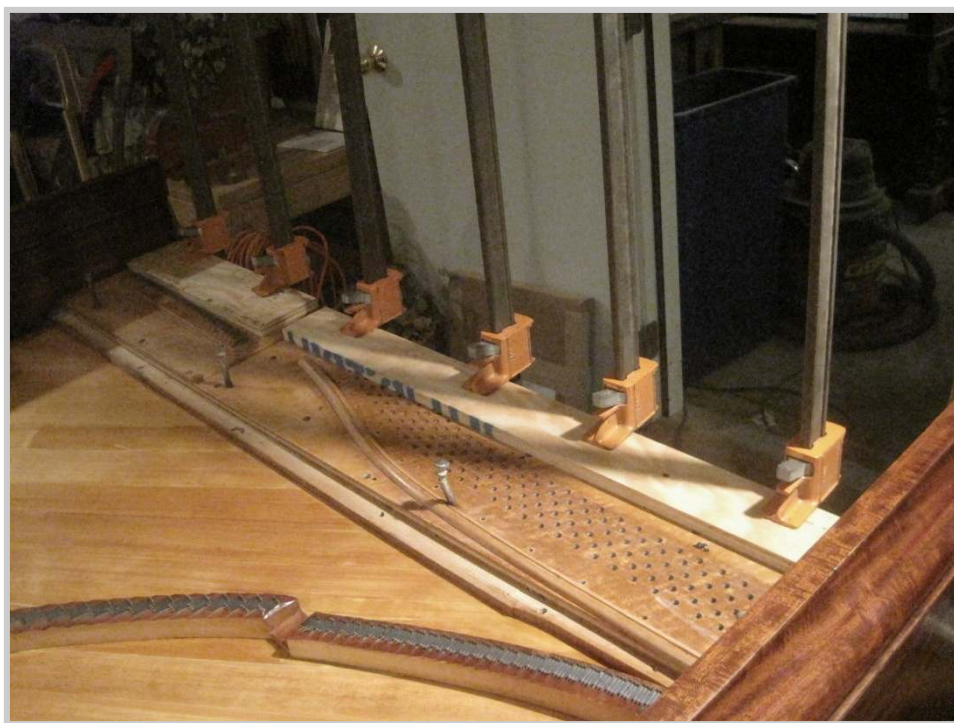
*Photo 68: Before the plate is reinstalled, one other repair must be made—that of the loose joint between the pin-block and the back. Titebond glue is worked into the joint, then clamps are applied overnight.*

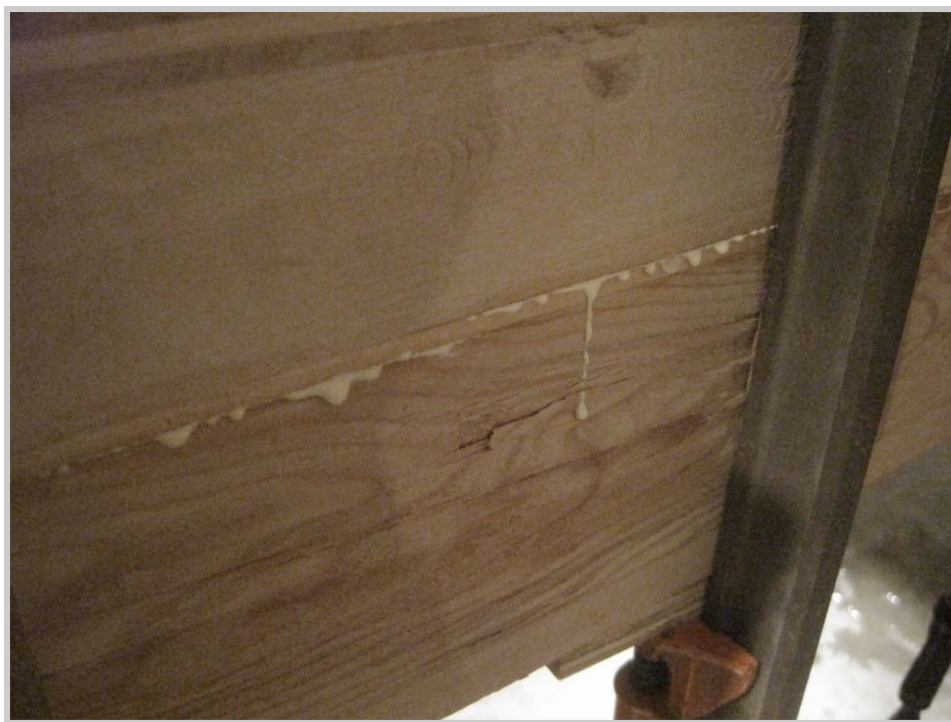
*Photo 69: A bit of squeeze-out indicates a tight fit.*

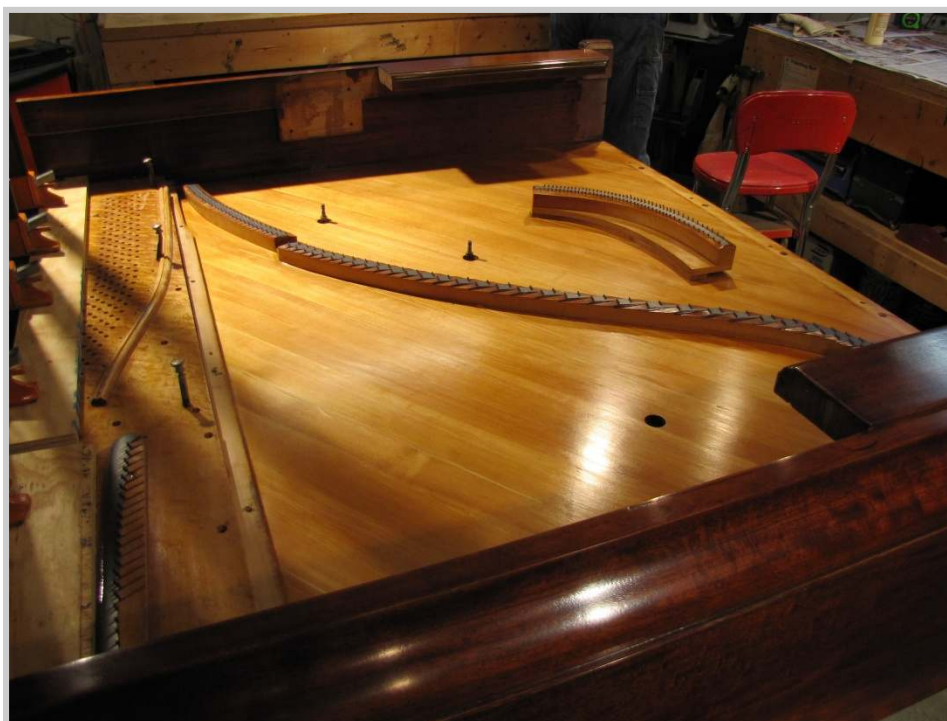
*Photo 70: The completed soundboard, with bass bridge reinstalled. The bridges have also been shellacked, with the upper surfaces painted with DAG <sup>®</sup>, a specialized lubricant. All is ready for the reinstallation of the cast iron plate, which has been cleaned and is ready to go.*

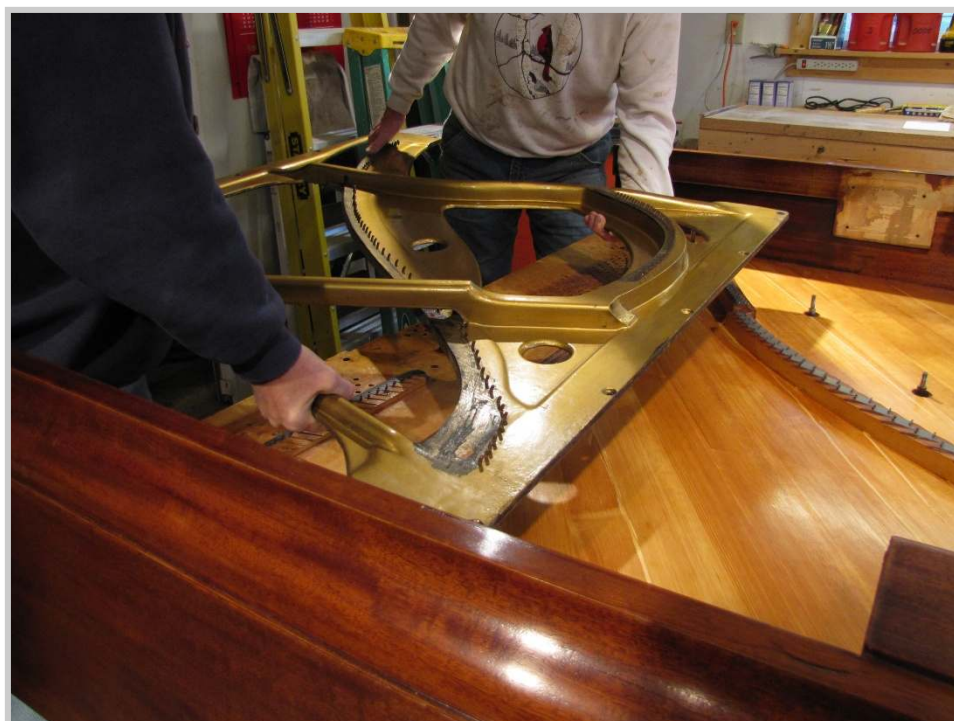
*Photo 71: The plate must be slid in from the top to miss protruding case parts—otherwise a hoist would make the operation simpler.*

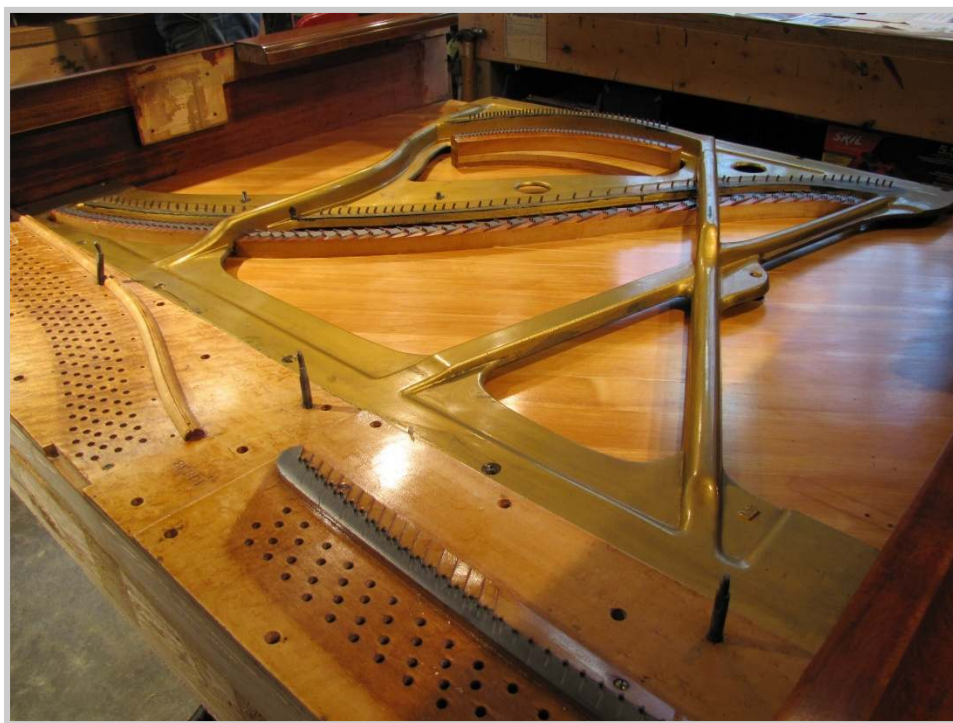
*Photo 72: A perfect fit. Always a good feeling to have the plate safely in place once again.*

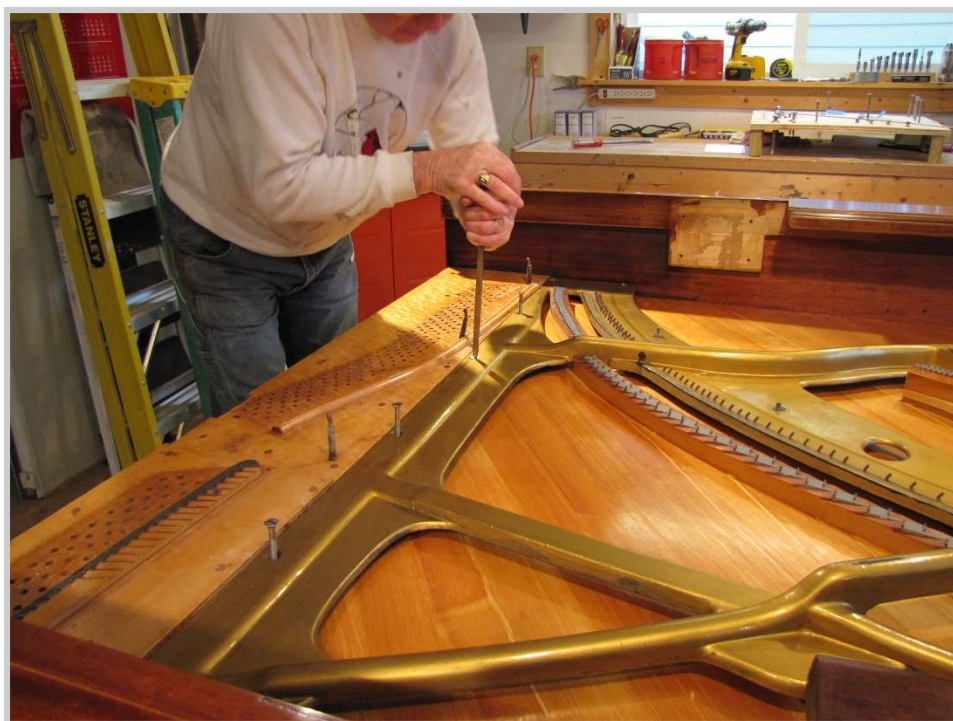
*Photo 73: Dave tightens down plate screws.*

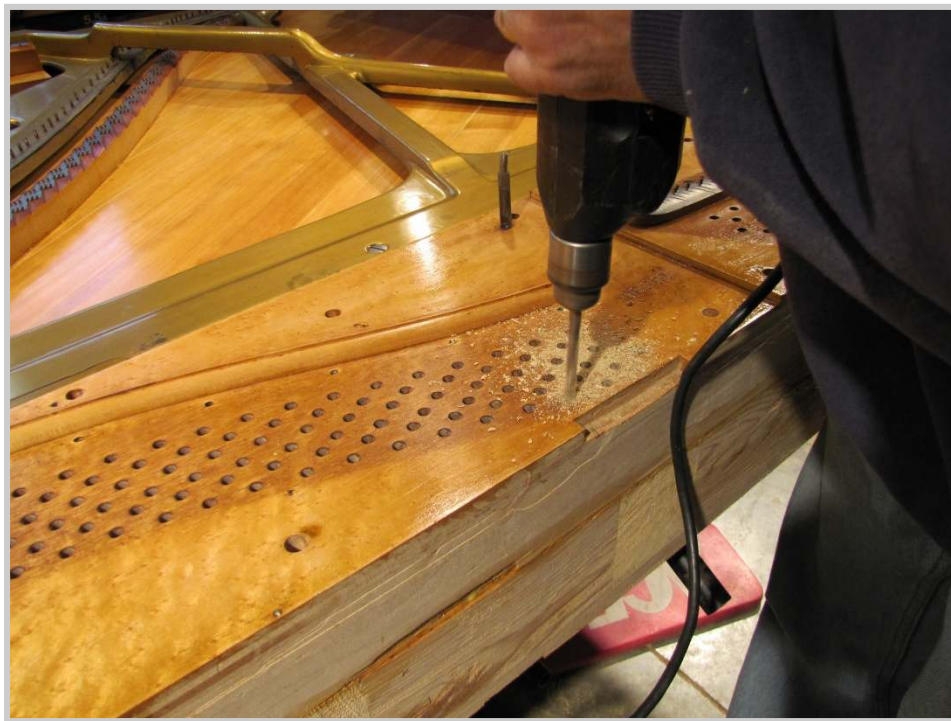
*Photo 74: While Dave is on screw-tightening detail, I ream the pin holes with a size 3 (.276") drill (not a reamer) for a fresh cut of wood. This is a quick in and out procedure with very little wood being removed— just enough to take any glazing off the sides of the century old holes.*

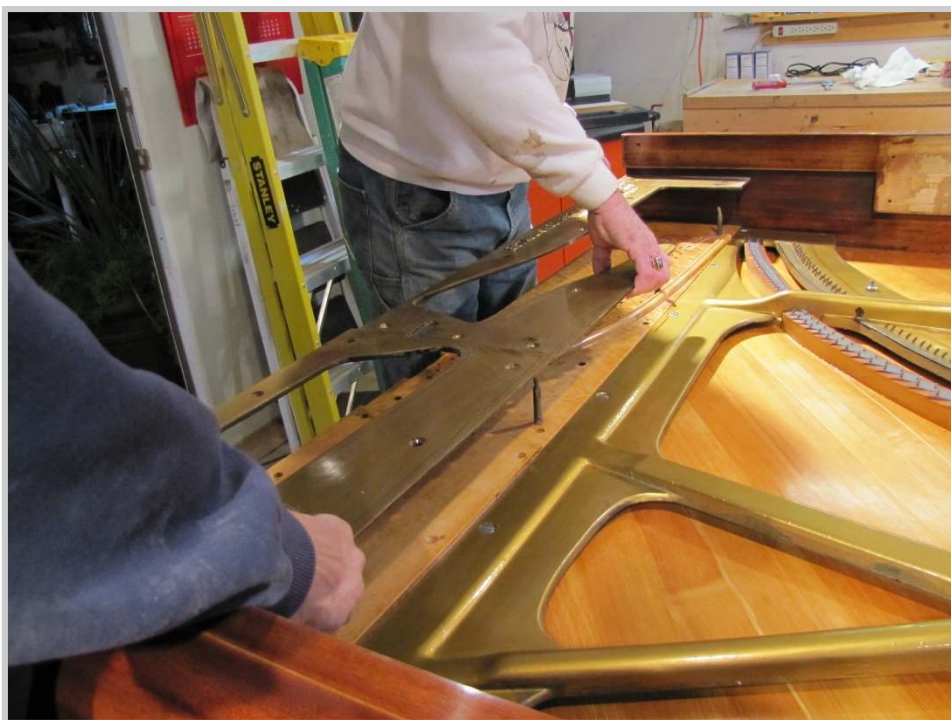
*Photo 75: The upper part of the two-part plate is now put into position.*

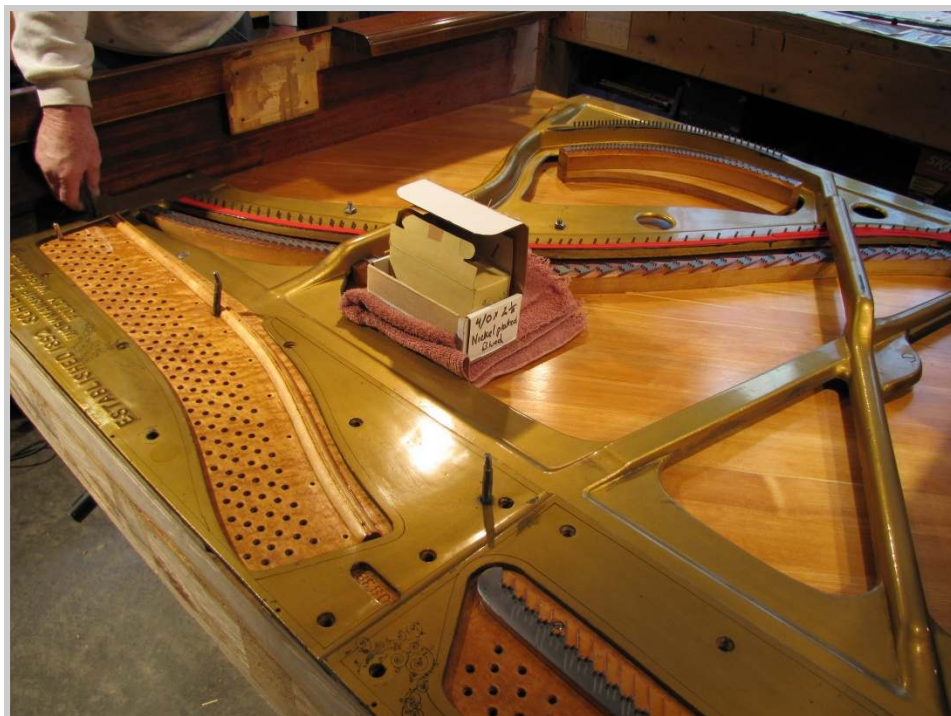
Photo 76: Test pins (both size 3 and size 4) are driven. The size 3's max out at 60 inch pounds, not enough.

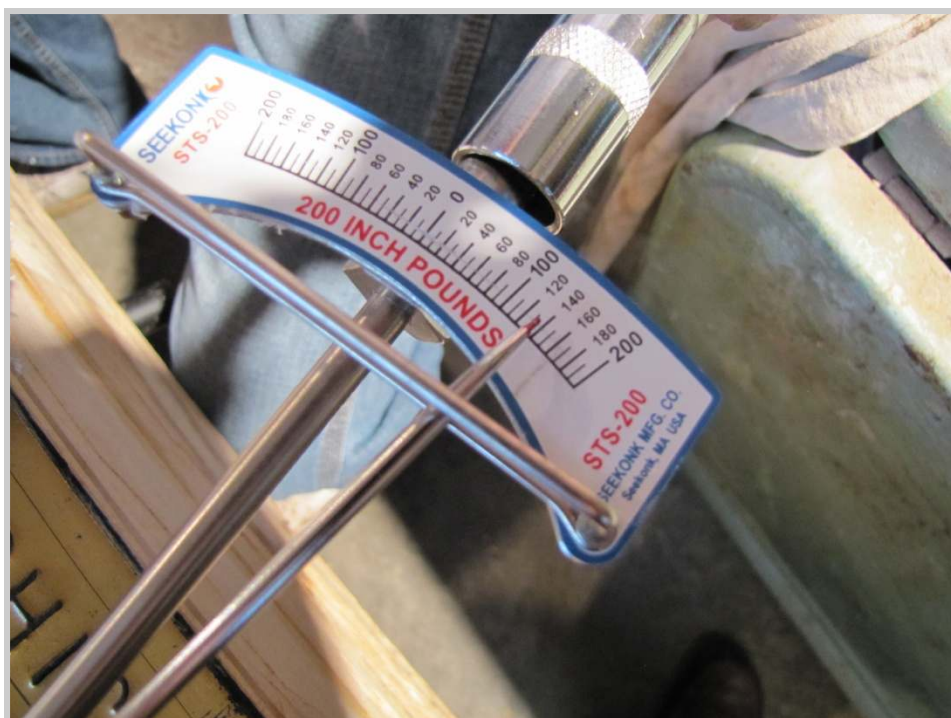
Photo 77: Size 4 pins test out at over 120 inch pounds—much more suitable. Smooth, tight turning, no ratcheting whatsoever. Blue, size 4 Denro <sup>®</sup> pins will be used.

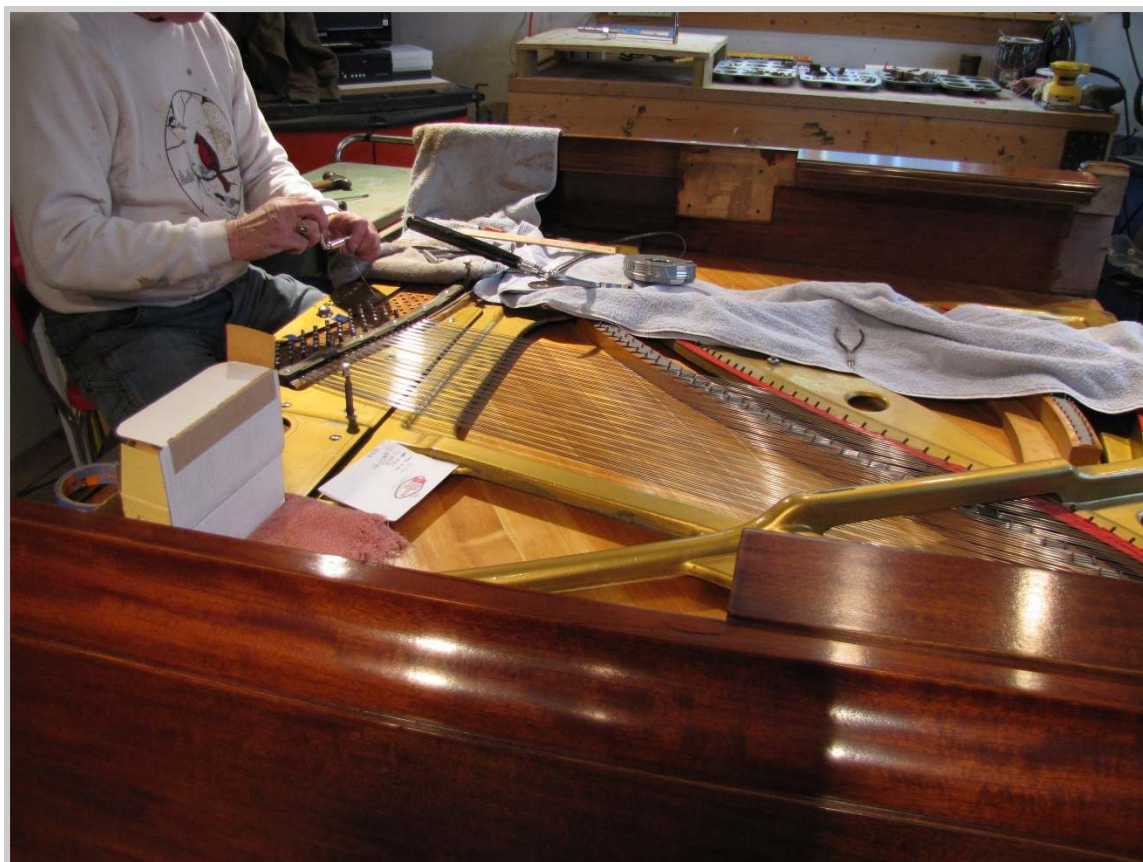
*Photo 78: Dave gets to work on the treble strings. The bass strings have returned and are ready to go..*
