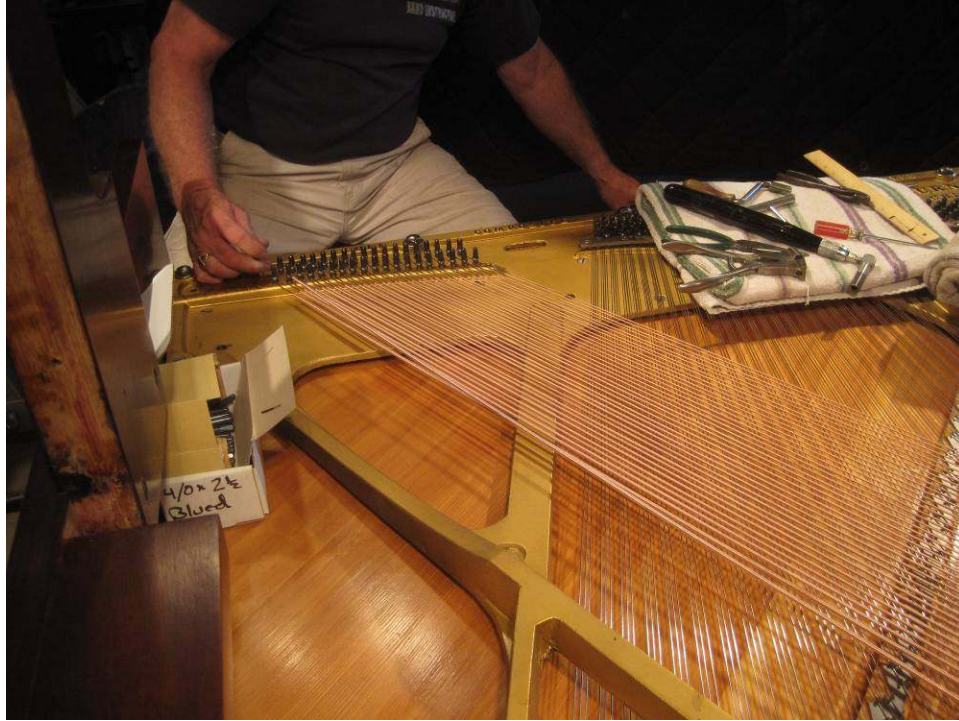
*Photo 93: With the plate bolted back into place, Dave works on restringing and repinning the piano.*

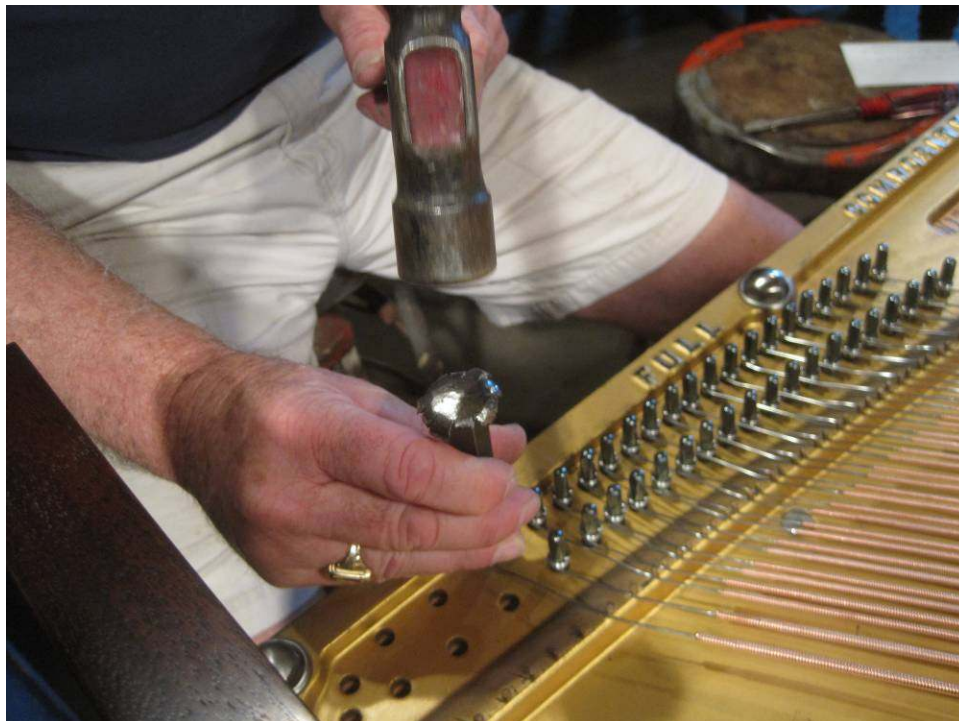
*Photo 94: Each string is attached to a 2 1/2" long tuning pin which is pounded into the pinblock using a special pin punch. The string is then drawn up to an approximation of the correct tension.*

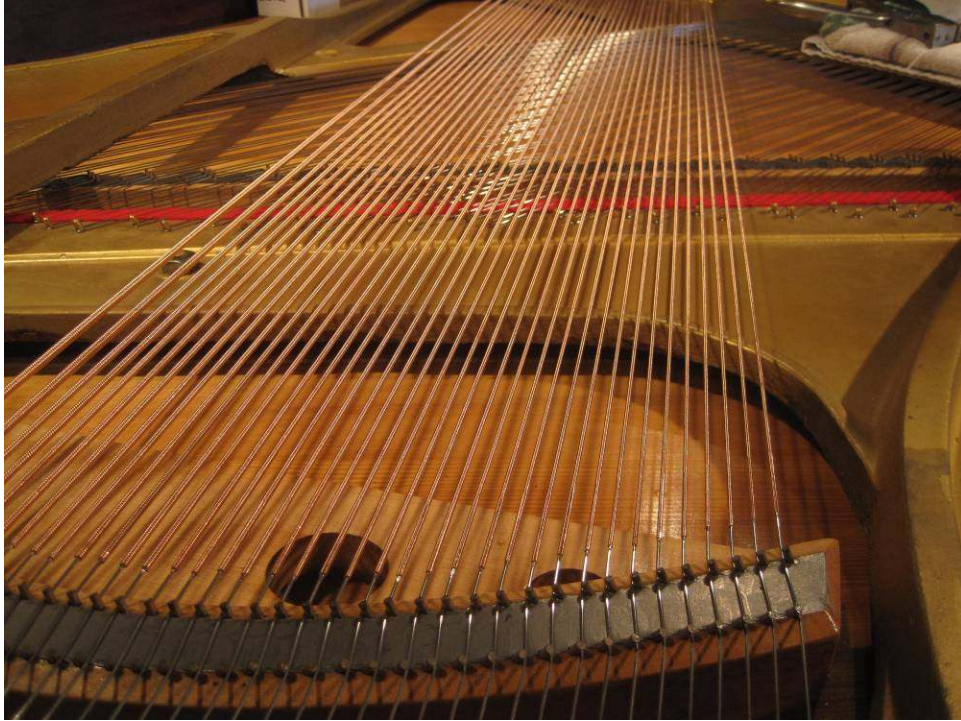
*Photo 95: The new strings as seen from the bottom of the piano looking up.*

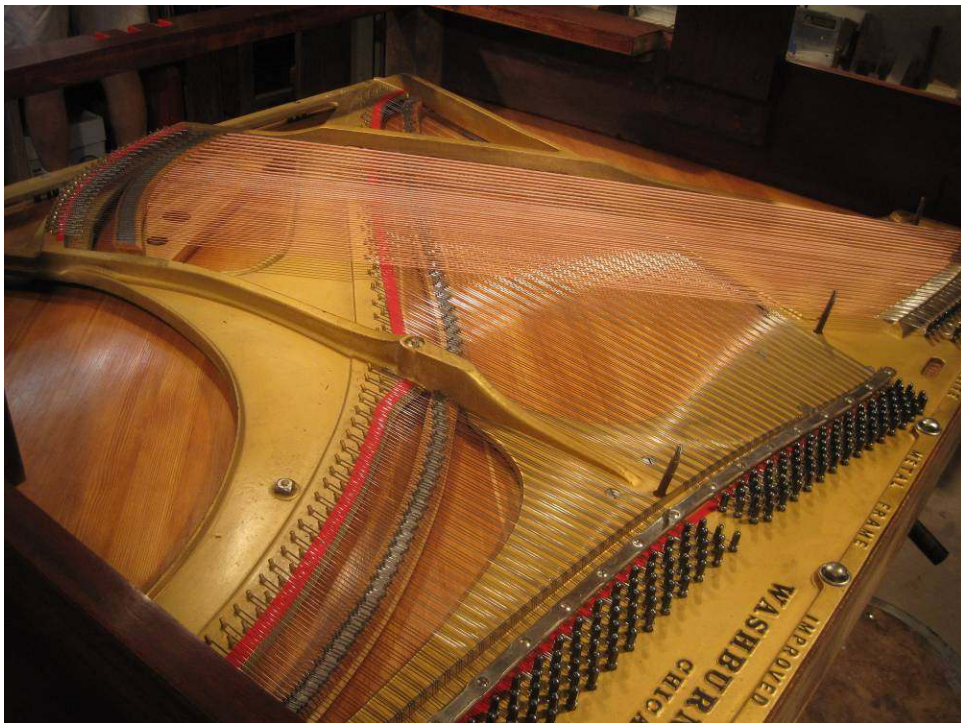
*Photo 96: Newly strung piano seen from the top with 18 tons of tension now back on the plate.*

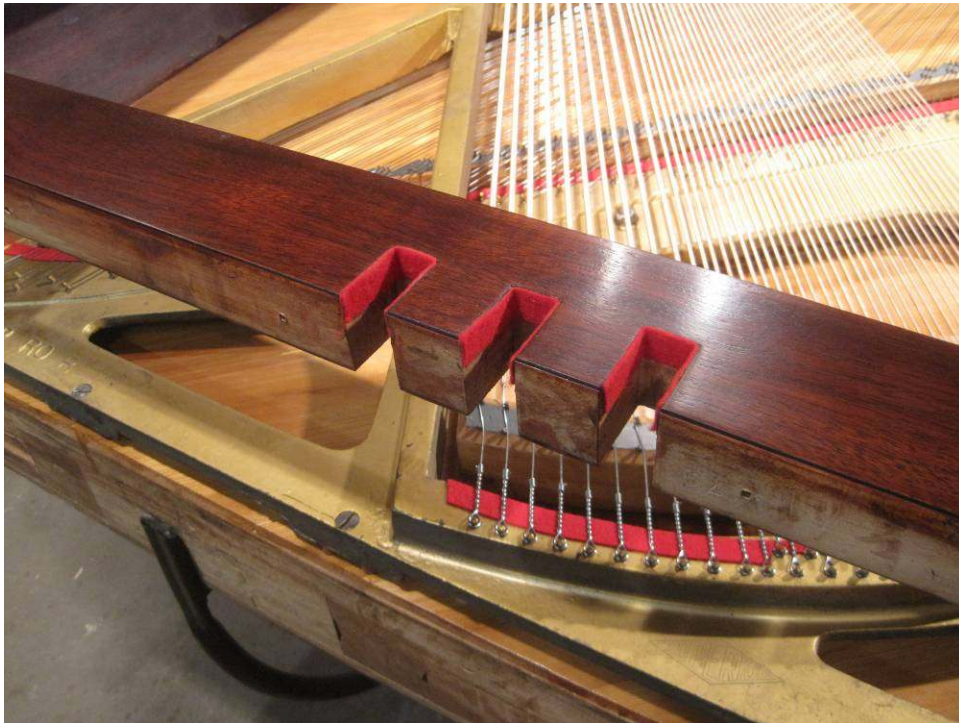
*Photo 97: With the stringing done, the case may be reassembled. The first case part to go back into place is the toe rail, with newly refelted slots for the pedals.*

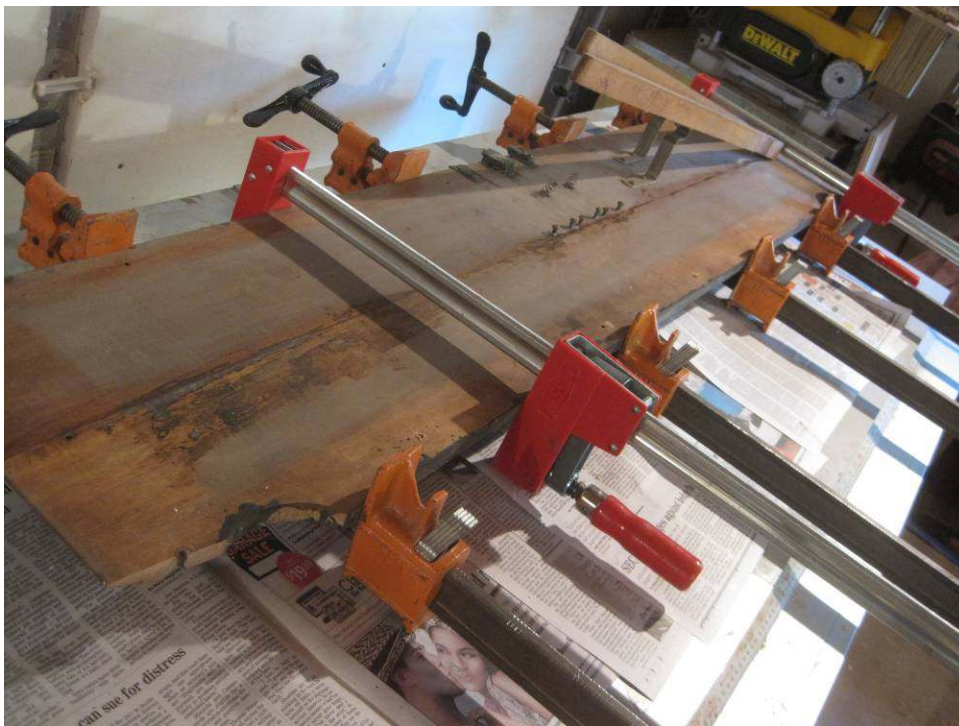
*Photo 98: The floor of the piano needed repair before returning to the piano. The two boards of the floor had split apart and needed to be reglued.*

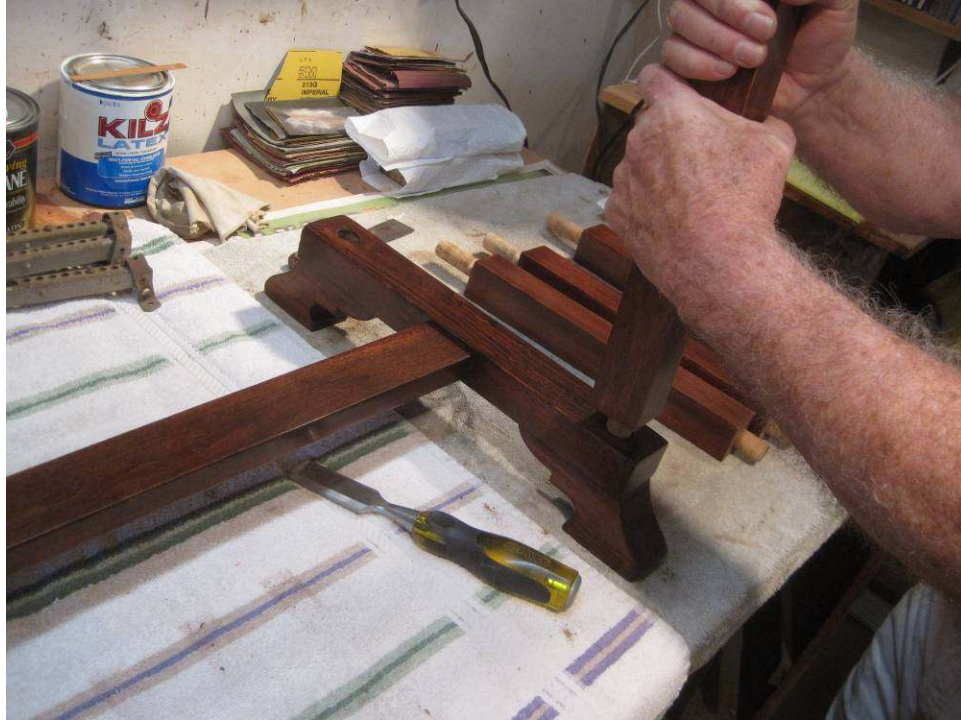
*Photo 99: With the glue curing on the floor repair, Dave turns his attention to the bench. The bench had been disassembled before refinishing. Here the legs are glued in place into the base.*

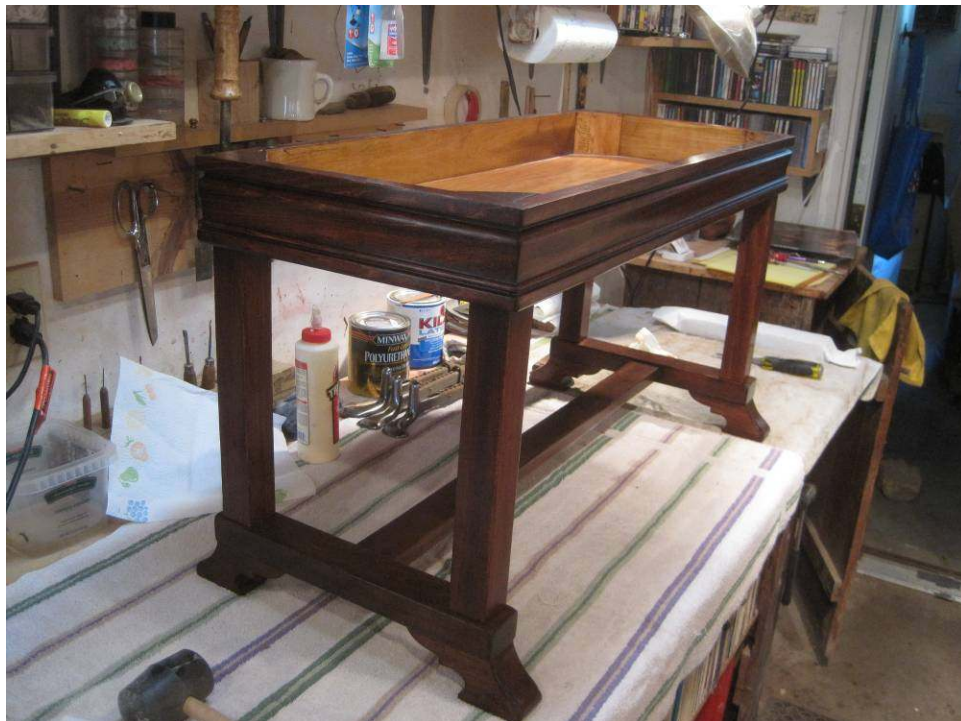
*Photo 100: The reassemble bench.*

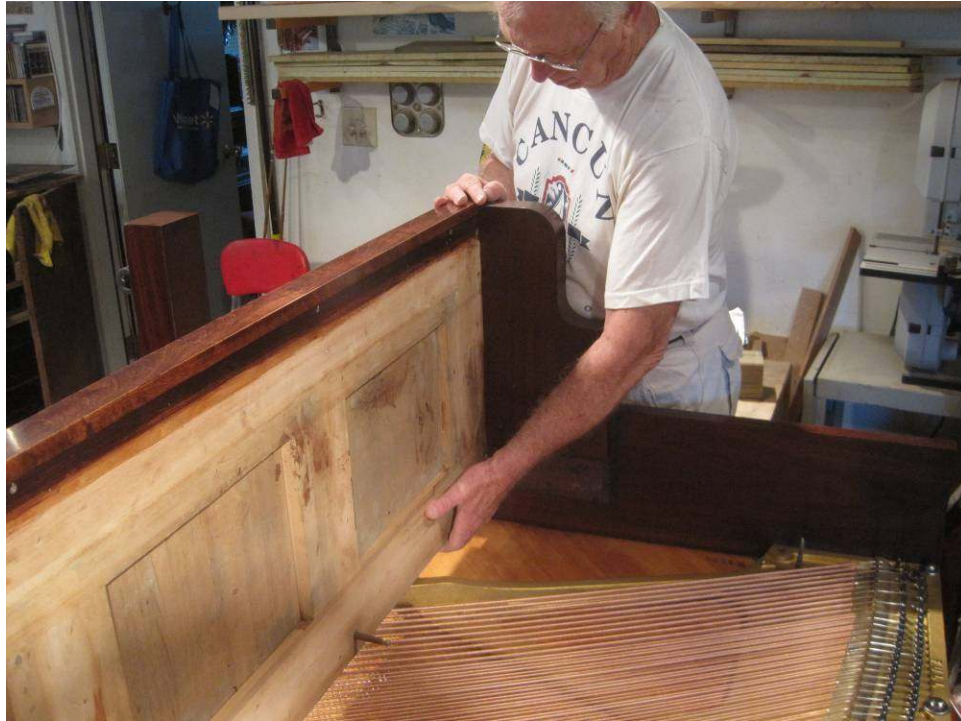
*Photo 101: The keybed is returned to the piano.*

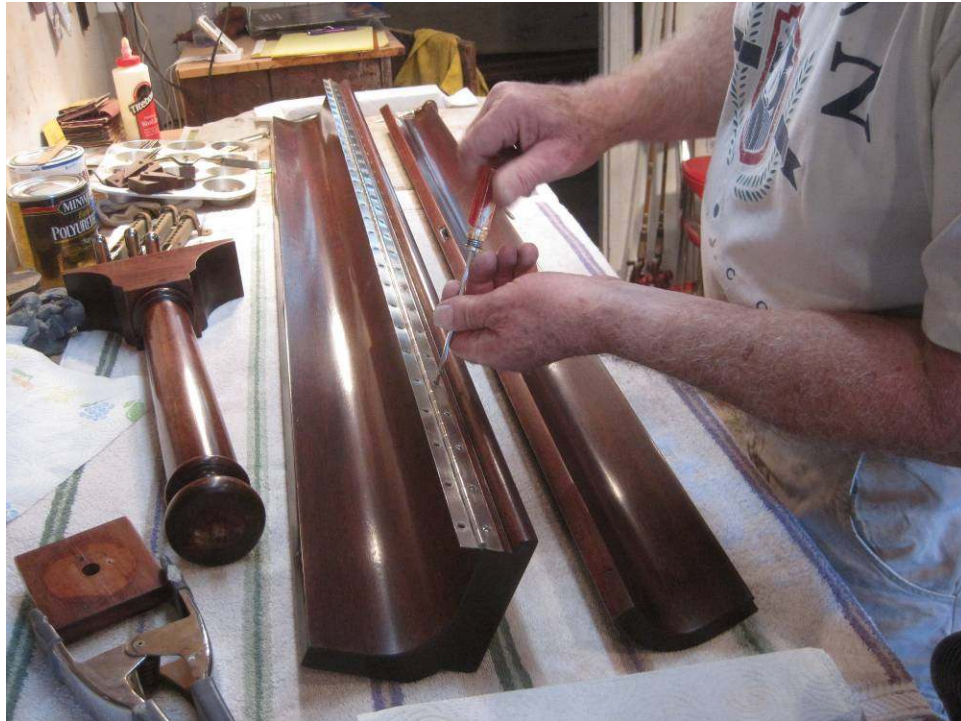
*Photo 103: Other case parts are readied for reinstallation.*

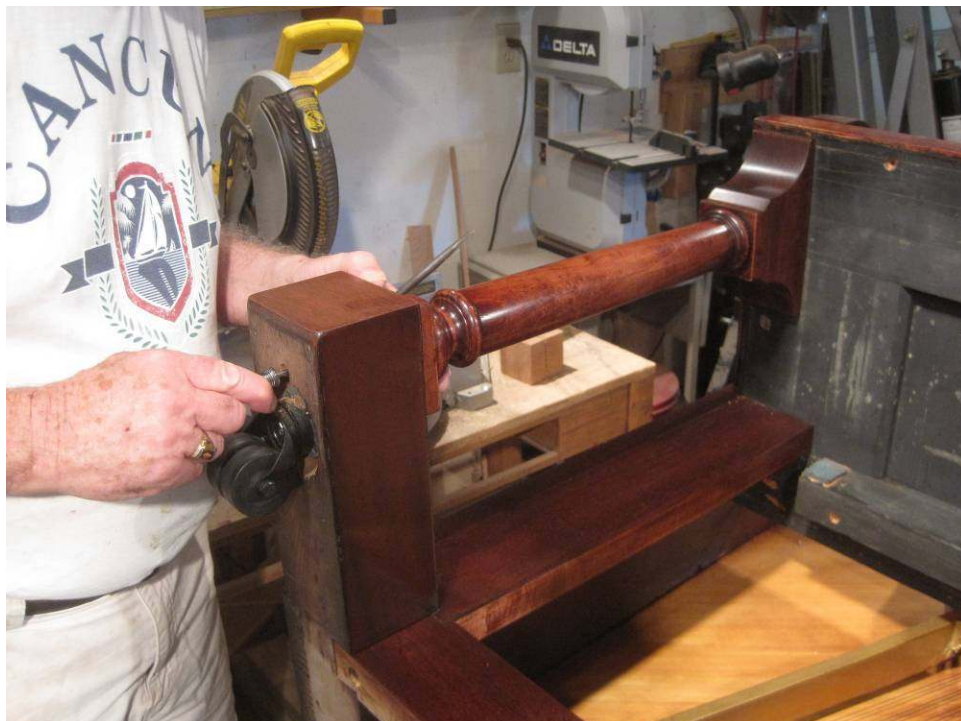
*Photo 104: The pillar legs are screwed into place*

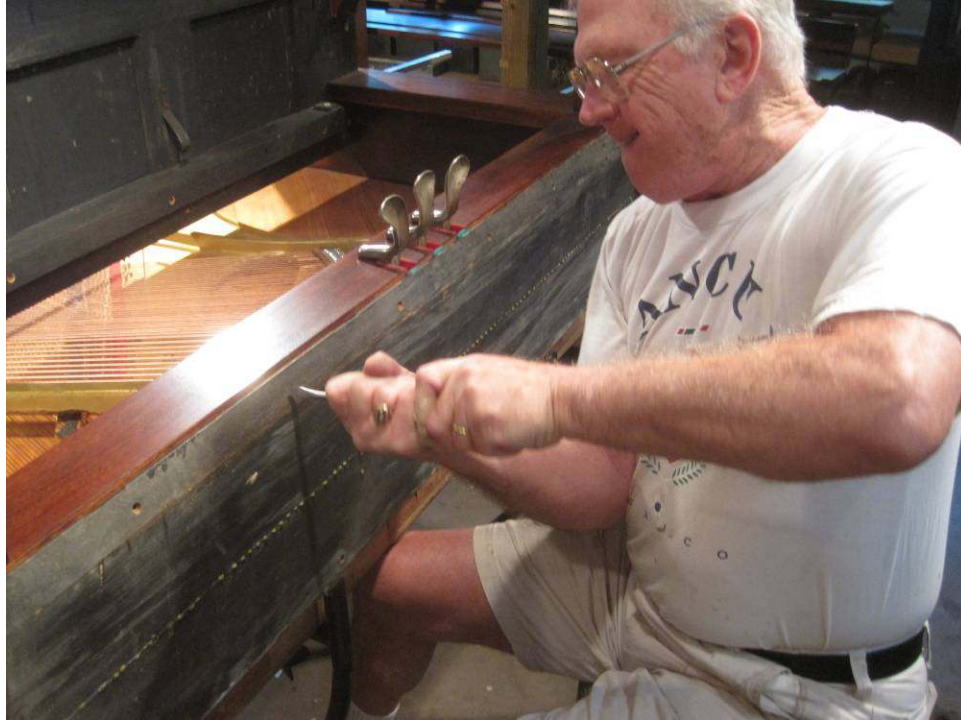
*Photo 105: Dave screws the floor of the piano with pedals attached back onto the piano. The line of dried glue drops along the repaired seam will be chiseled off.*

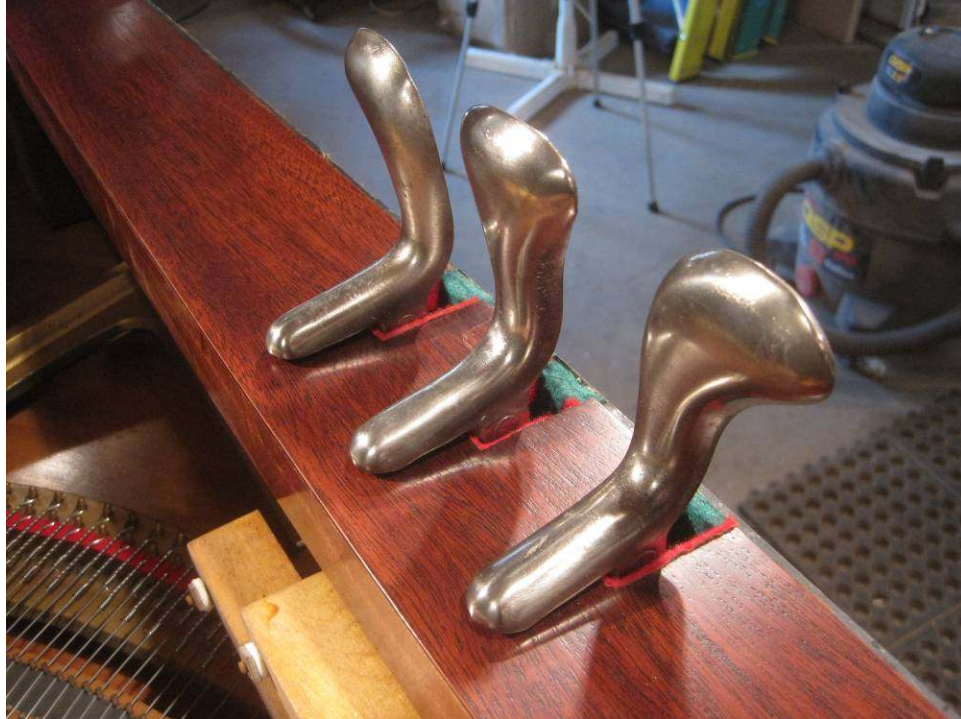
*Photo 106: Polished nickel-plated pedals.*

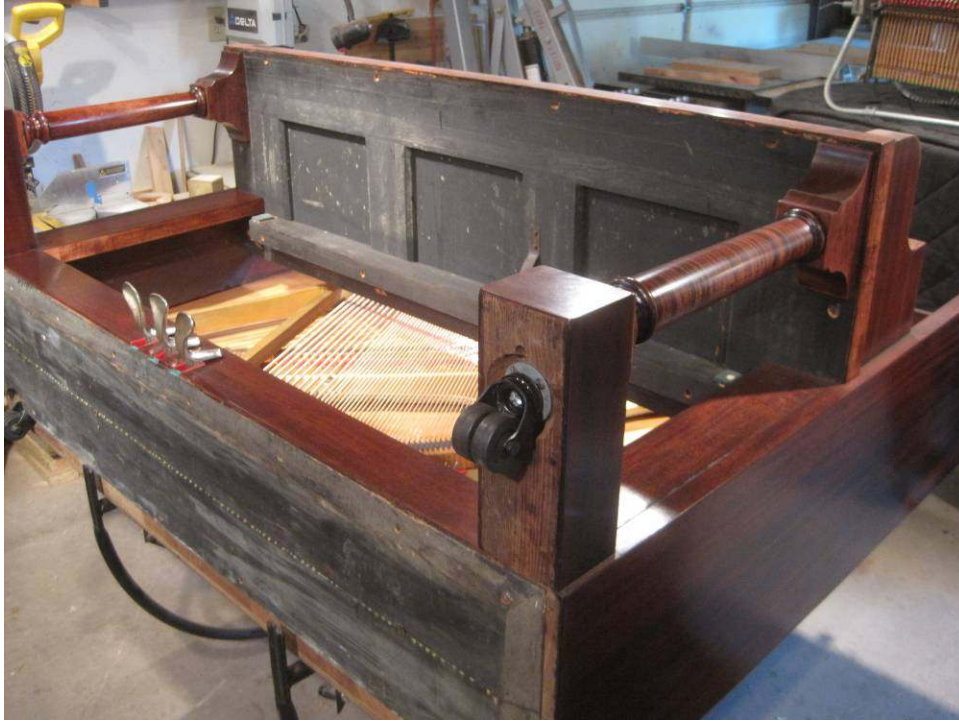
*Photo 107: The bottom half of the case, now reassembled.*

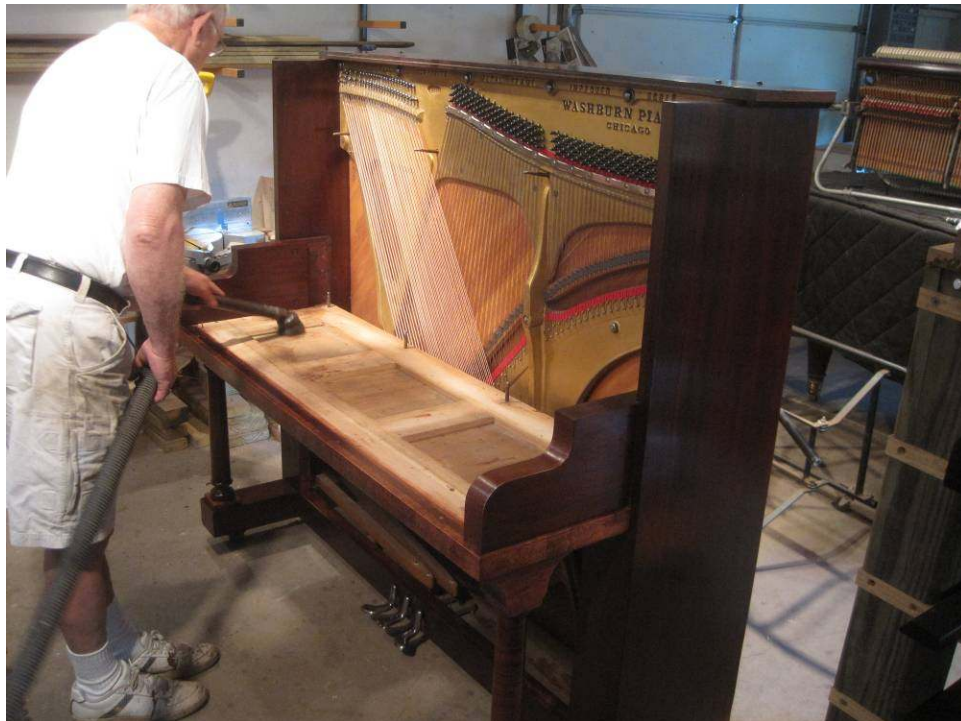
*Photo 110: Dave vacuums up the keybed, in preparation for reinstallation of the keys.*

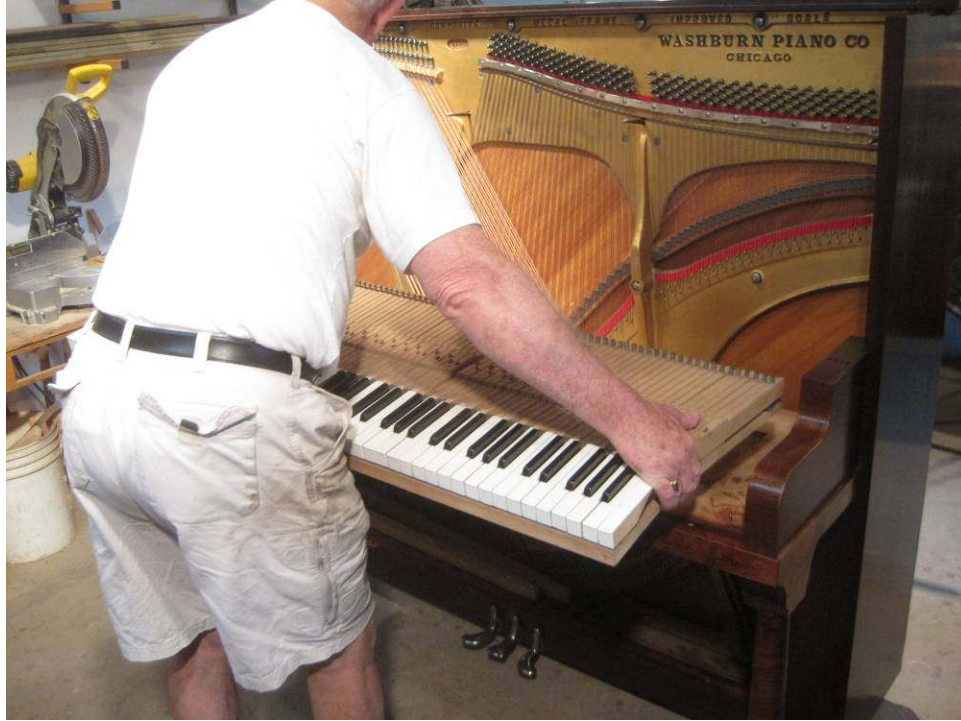
*Photo 111: The keyframe with keys attached is reinstalled.*

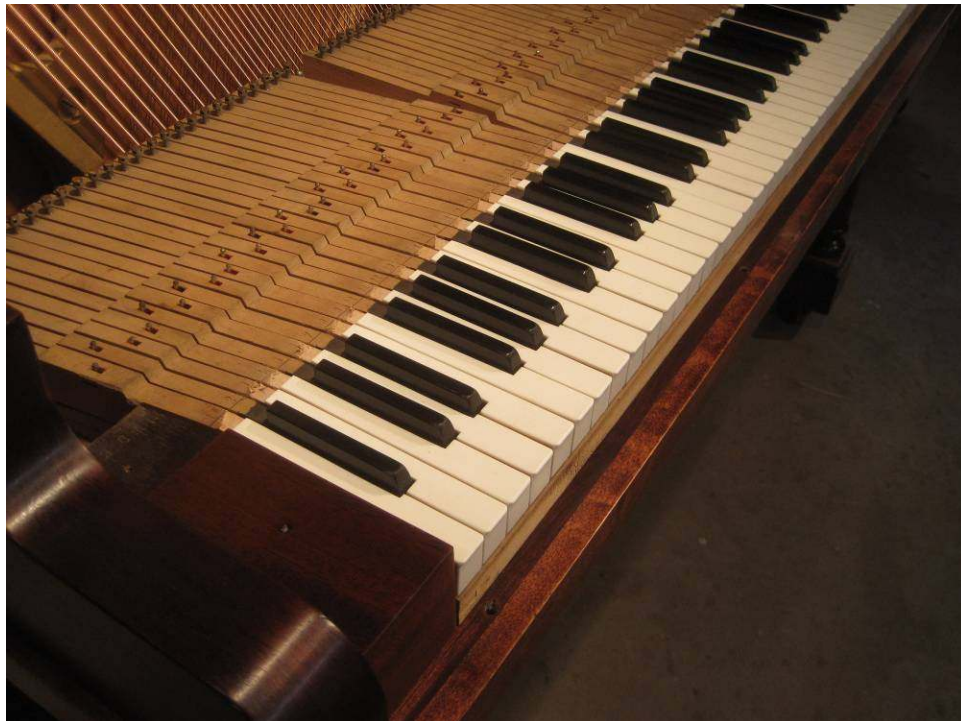
*Photo 112: New keys in place.*

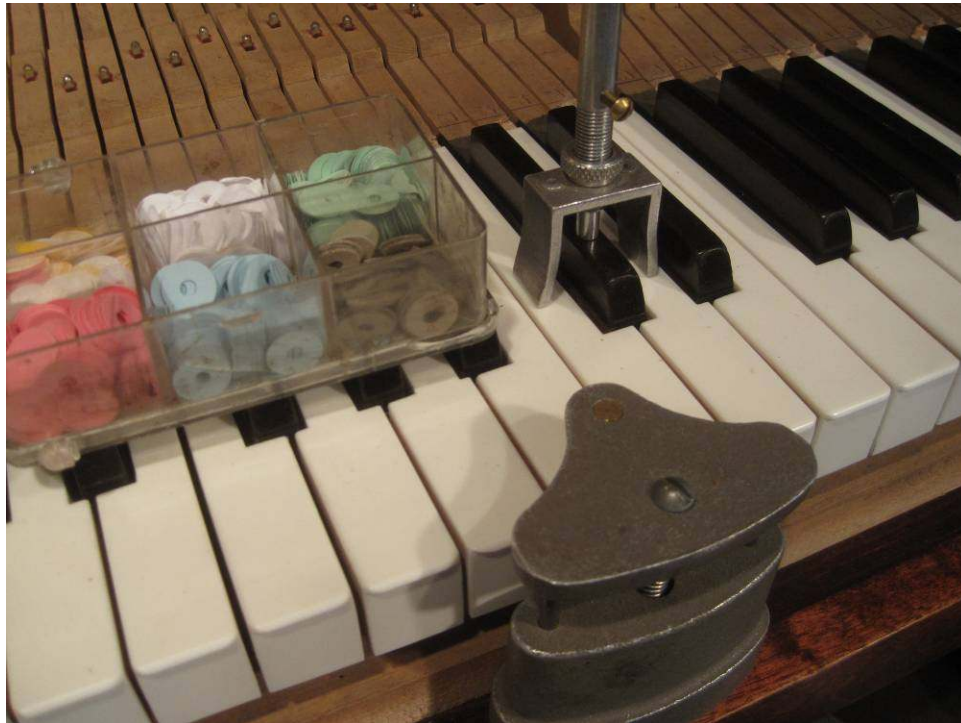
*Photo 115: The keys, both naturals and sharps, are leveled.*

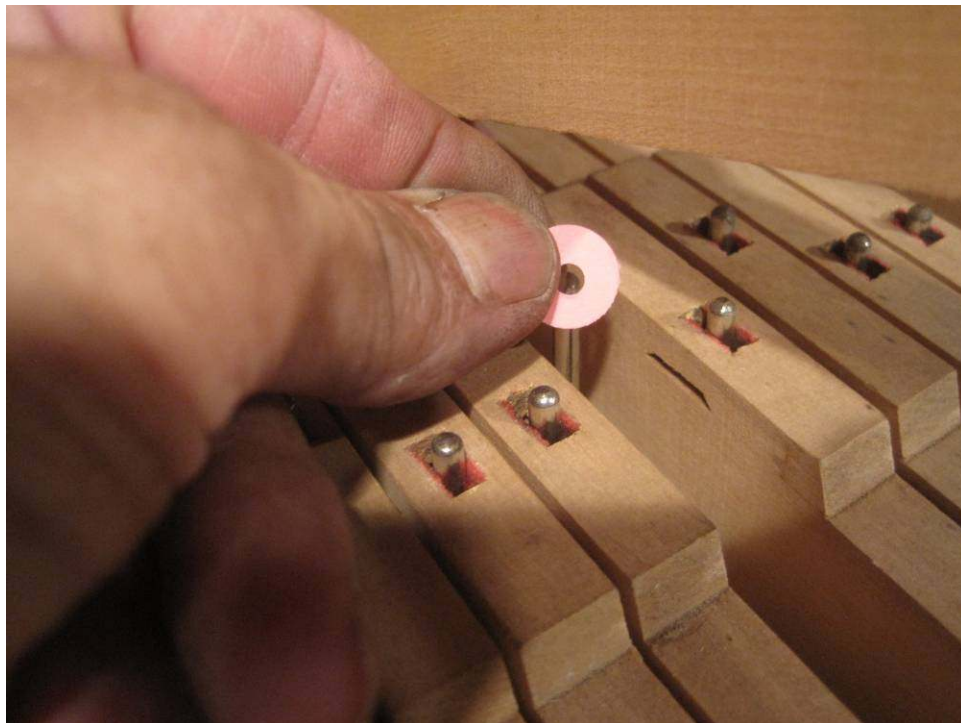
*Photo 116: Leveling papers as thin as .001" are inserted to bring the keys up to level.*

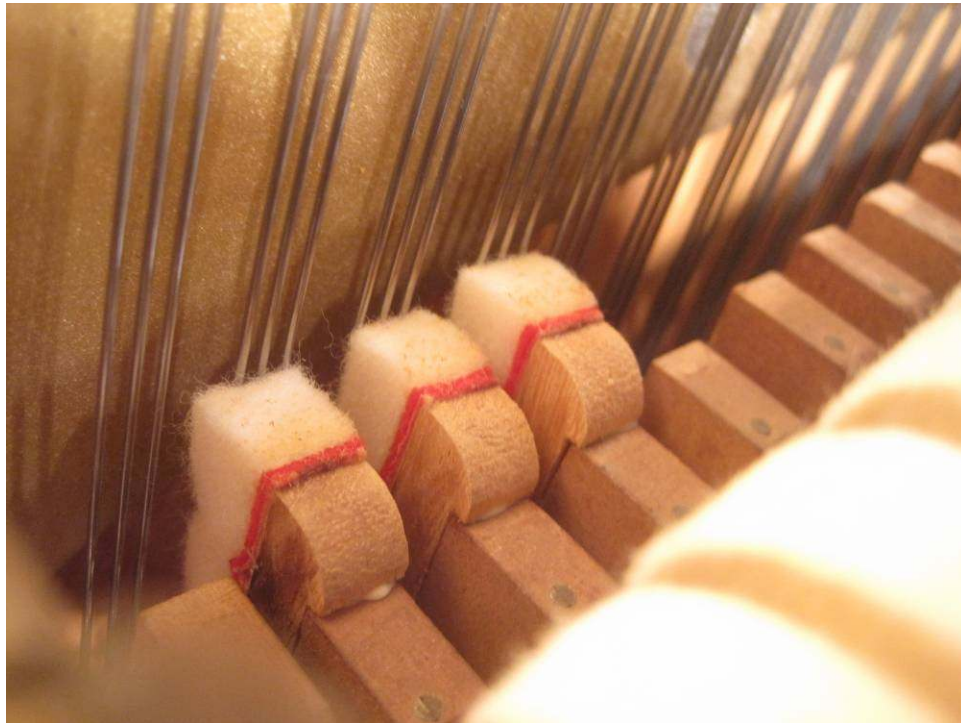
*Photo 117: New treble dampers are installed using the strings to clamp them in place. Minor adjustments in positioning will be done after the glue has cured.*

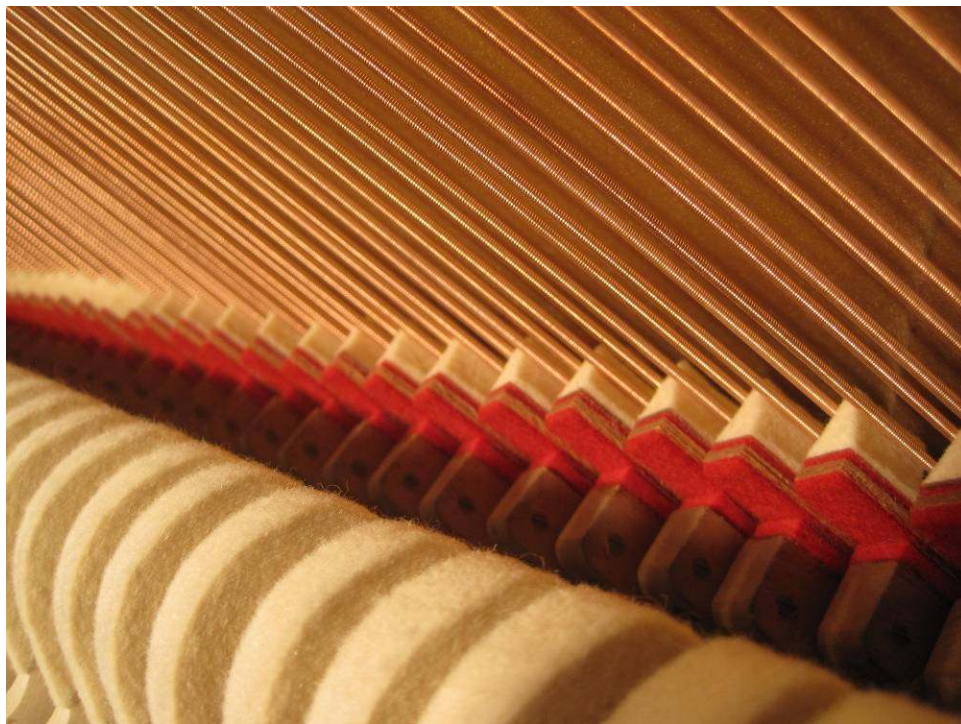
*Photo 118: New bass dampers, installed and adjusted.*

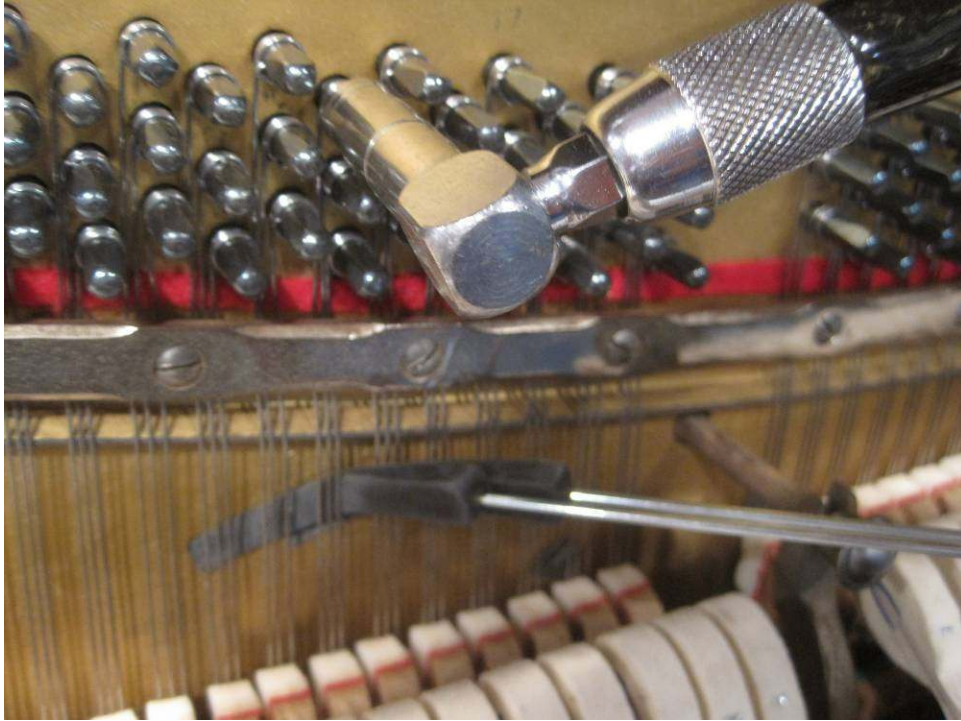
*Photo 119: The first tuning is done with at least three more to follow.*

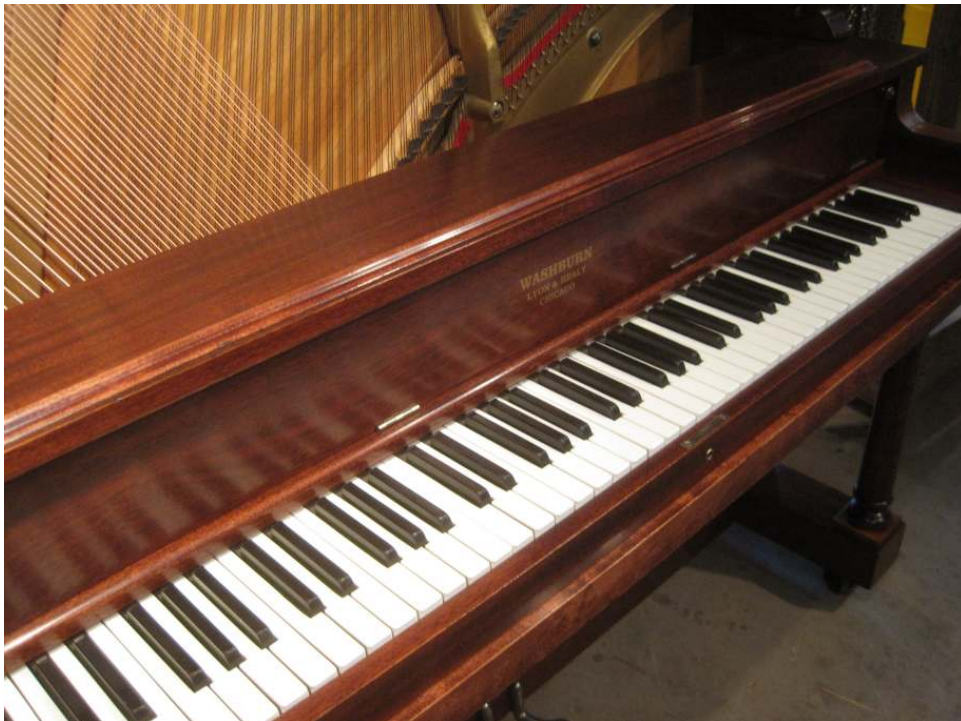
*Photo 120: The fallboard and music desk are returned to the piano.*

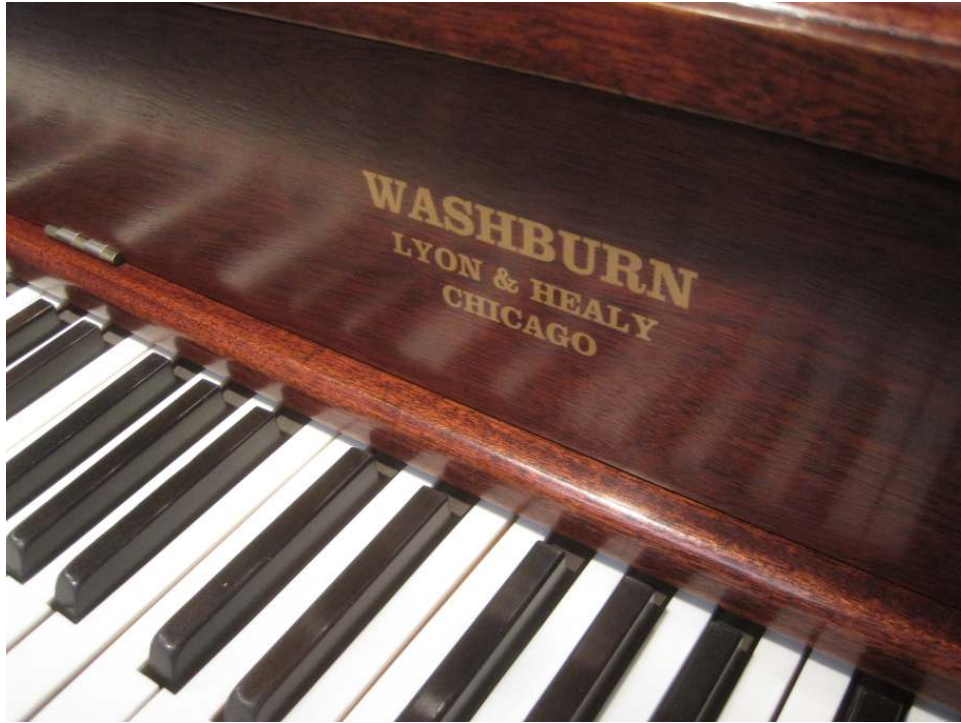
*Photo 121: A close-up of the new fallboard decal.*

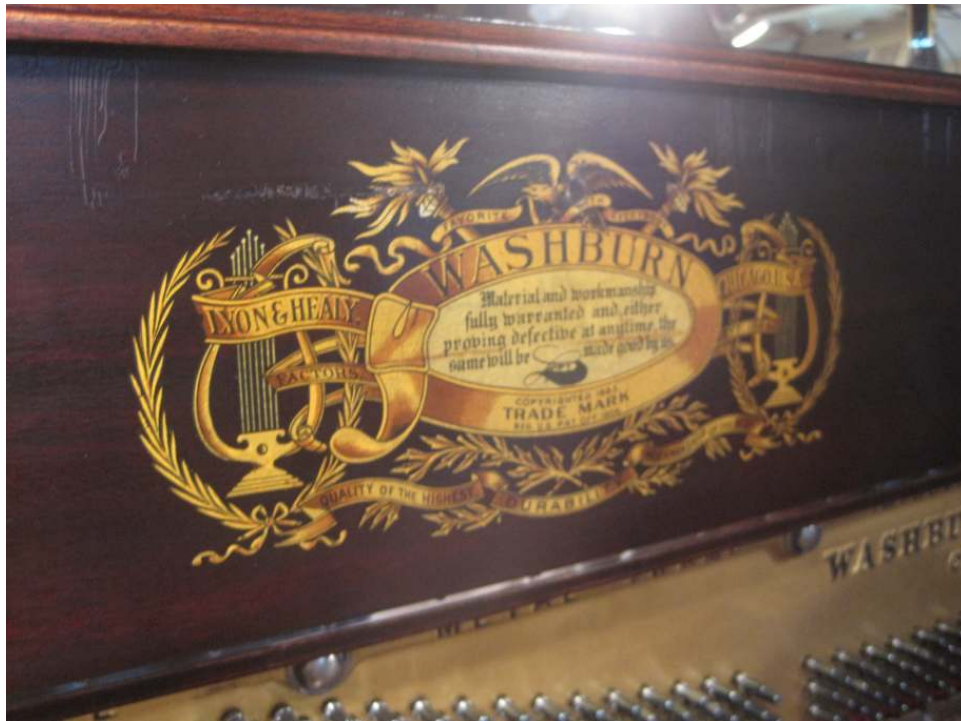
*Photo 122: The ornate decal inside the lid, preserved with a new coat of finish.*
