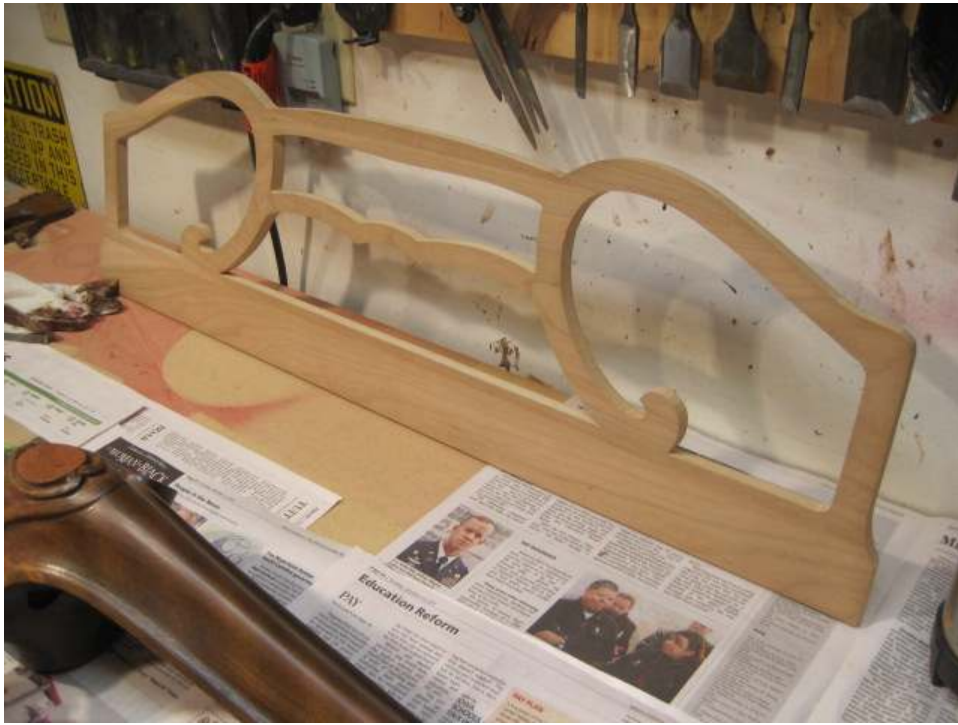
*Photo 20: The 2nd project was the music rack. Although the replacement rack from Schaff looked promising, it turned out to have a core made of MDF, which I found unacceptable – it soaks up stain like a sponge, and keep turning back to its light color after the stain was absorbed.*

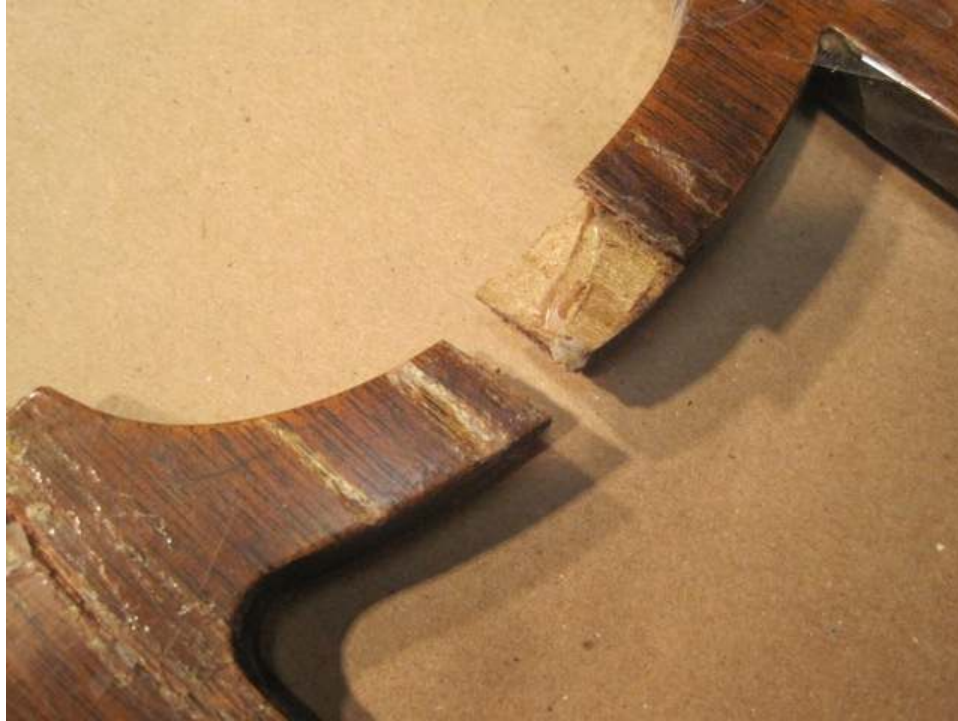
*Photo 21: I decided it would be better to see what could be done with the old rack. The damage was compounded by the fact that repairs had apparently been attempted before. Old glue made a perfect fit impossible. Here's the condition of the left support.*

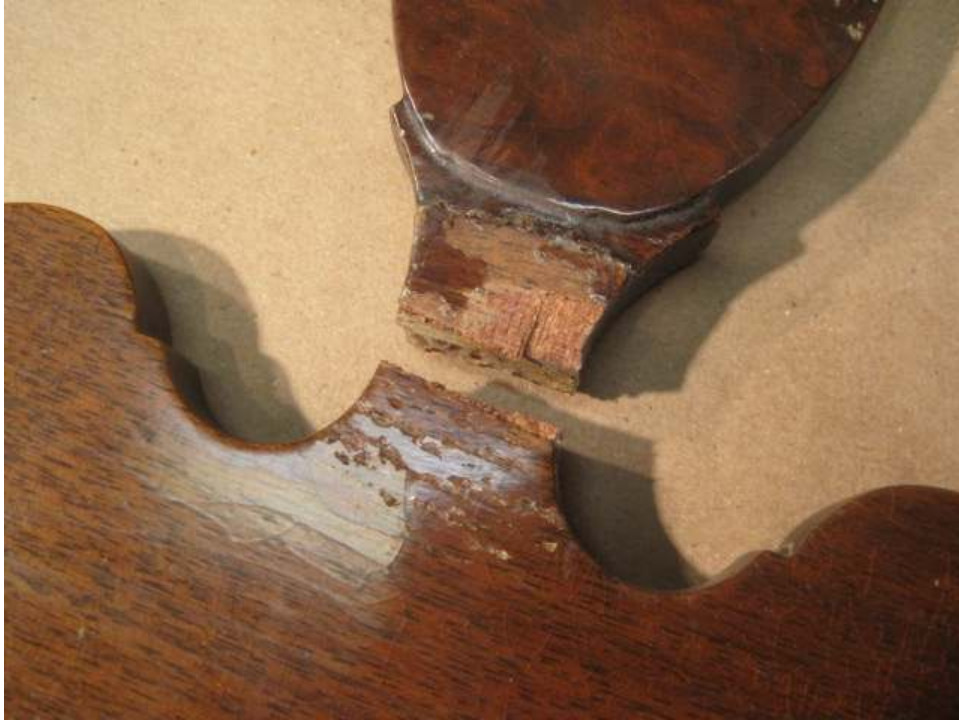
*Photo 22: The middle support, with missing veneer.*

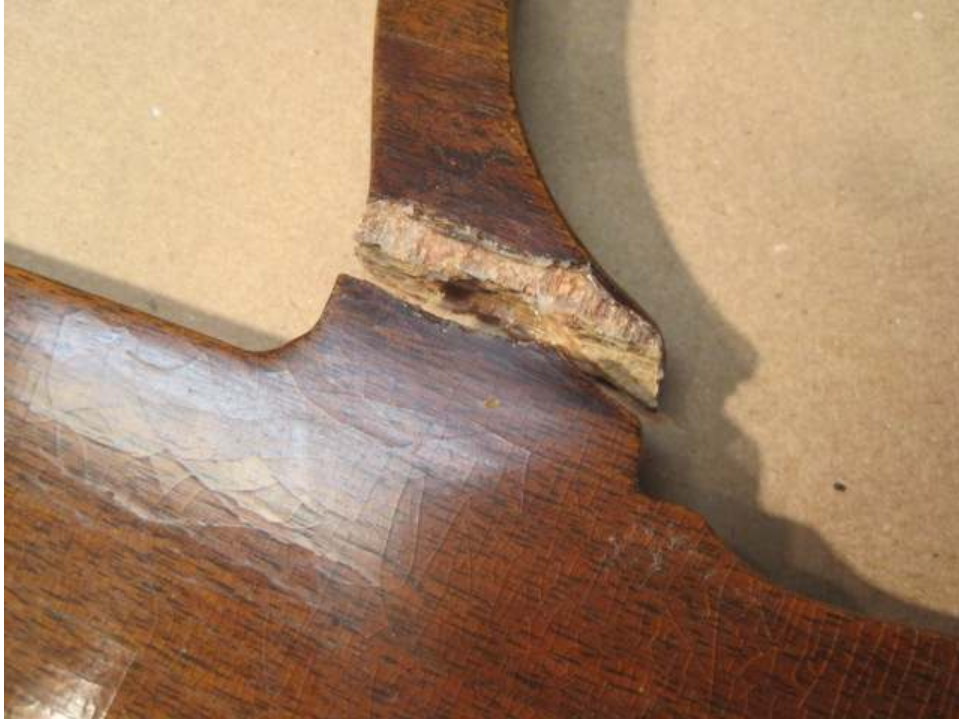
*Photo23: The right hand support. It was obvious that this would be a more complicated repair than the broken leg.*

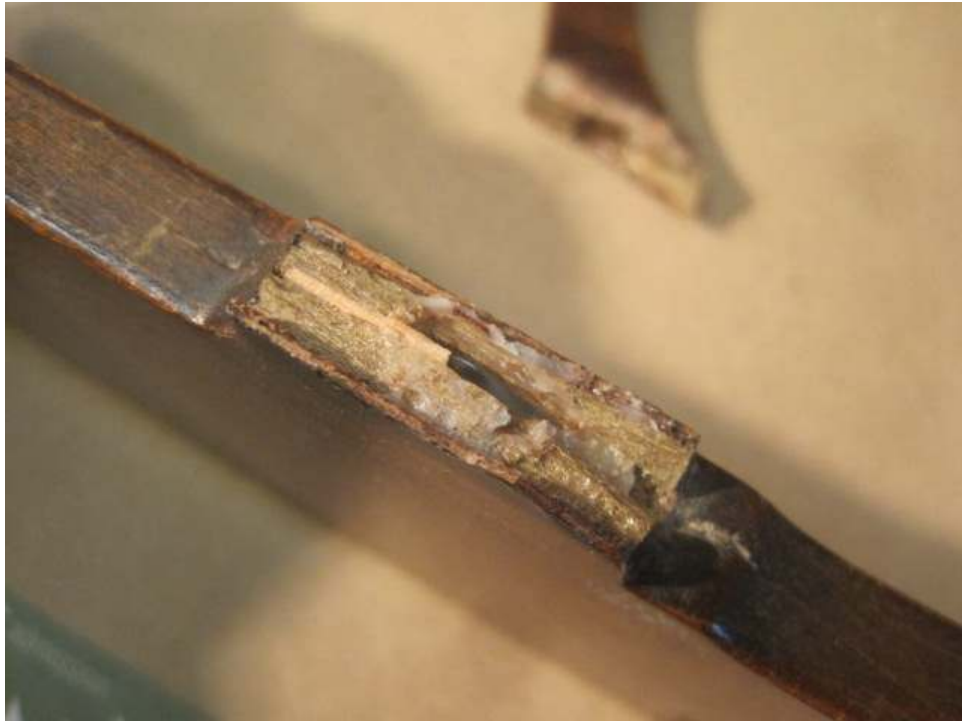
*Photo 24: The problem with old glue is that it gets down in the crevasses of the damaged area and is impossible to cleanly remove. The only cure for this is to cut off the damage, and start with a clean slate.*
