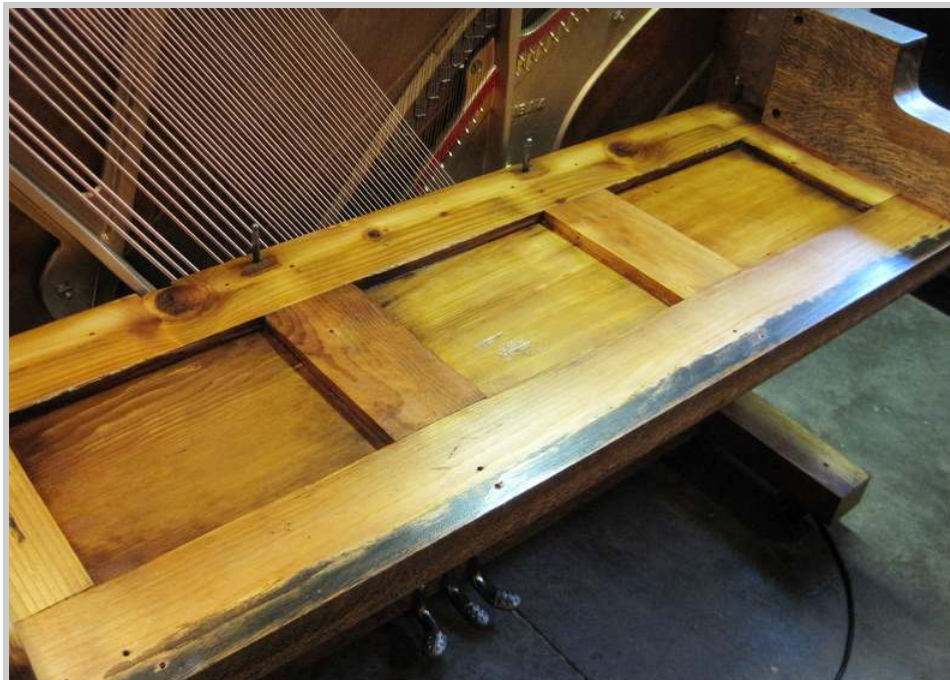
*Photo 321: With the keybed sealed with two coats of shellac, and a top coat of polyurethane, it is now sweet-smelling and ready for the keyframe to be reinstalled.*

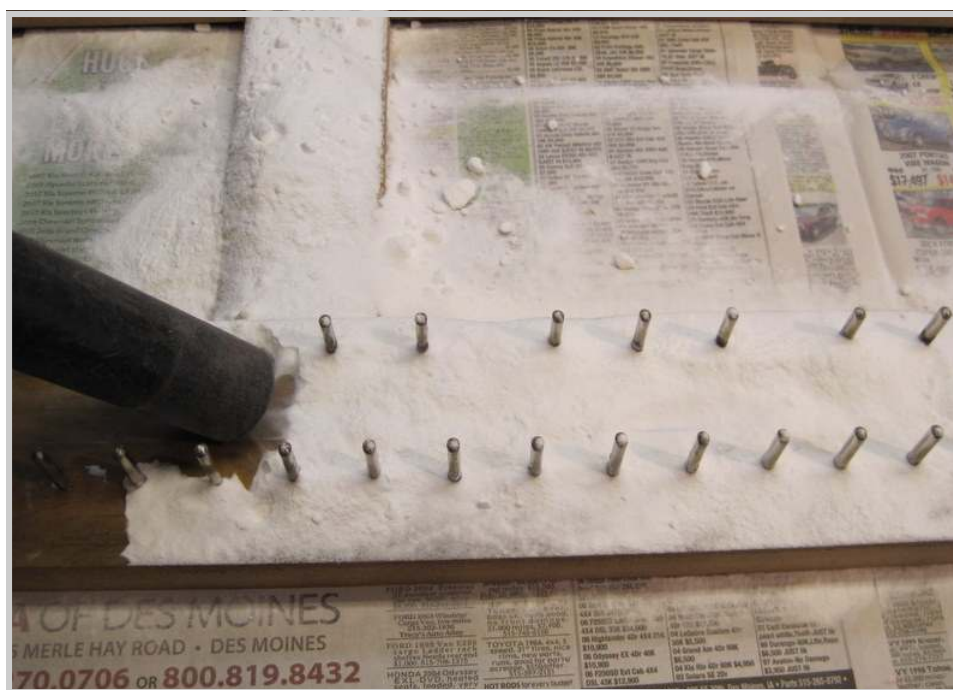
*Photo 322: The six pounds of baking soda that have covered the keyframe for more than a month are vacuumed off, taking the mouse odor with it. All I can say is thank goodness for baking soda. It works wonders in this type of situation.*

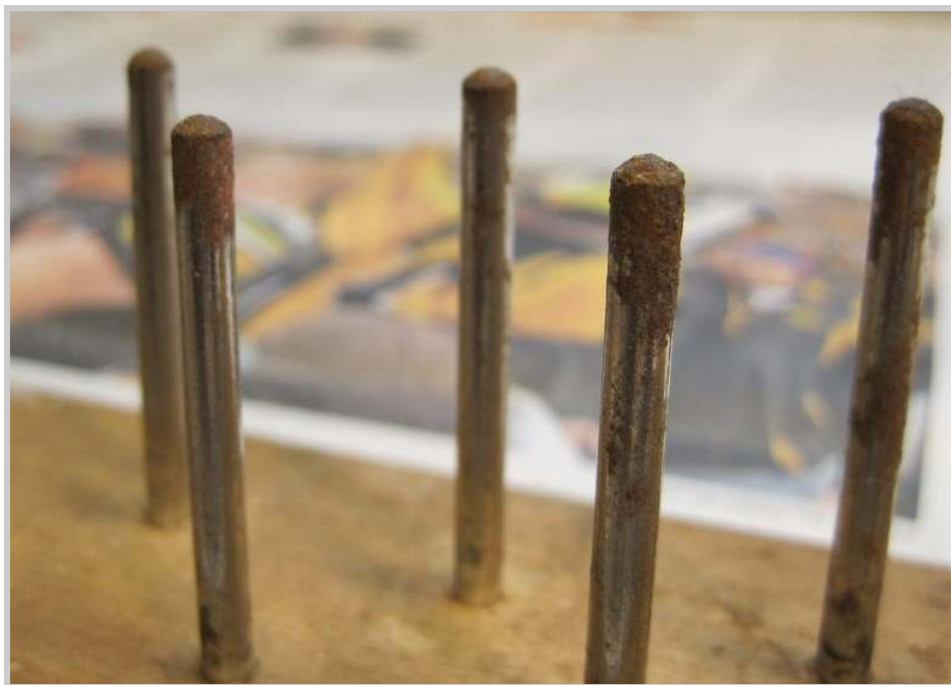
*Photo 323: Examination of the balance rail pins reveals corrosion too deep to simply polish out. Removal of the old pins and replacement with new is necessary.*

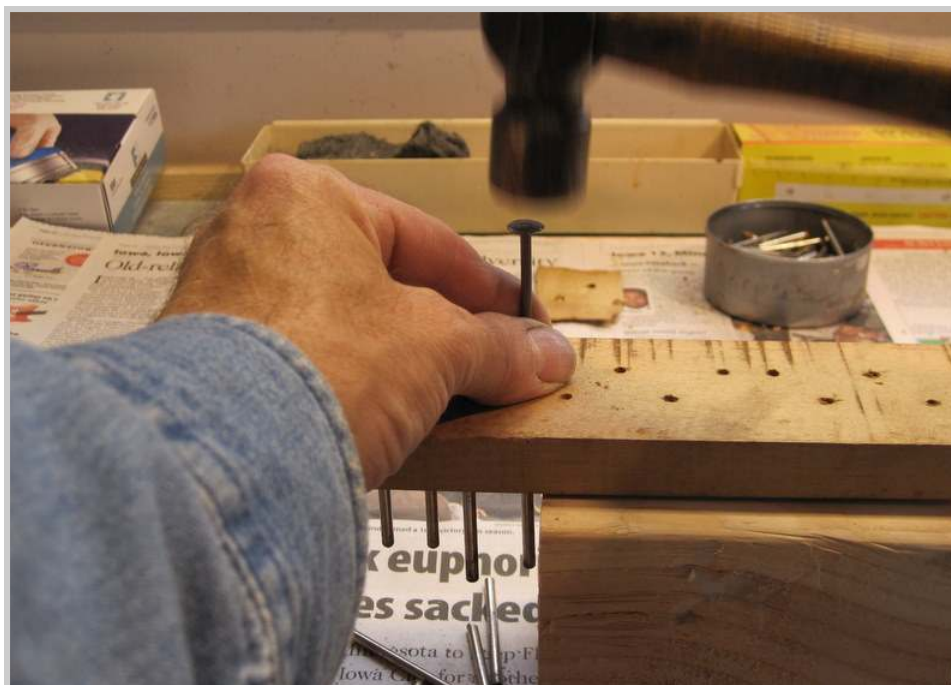
*Photo 324: With the balance rail removed from the key frame, the corroded pins are punched out using a roofing nail with the point clipped off.*

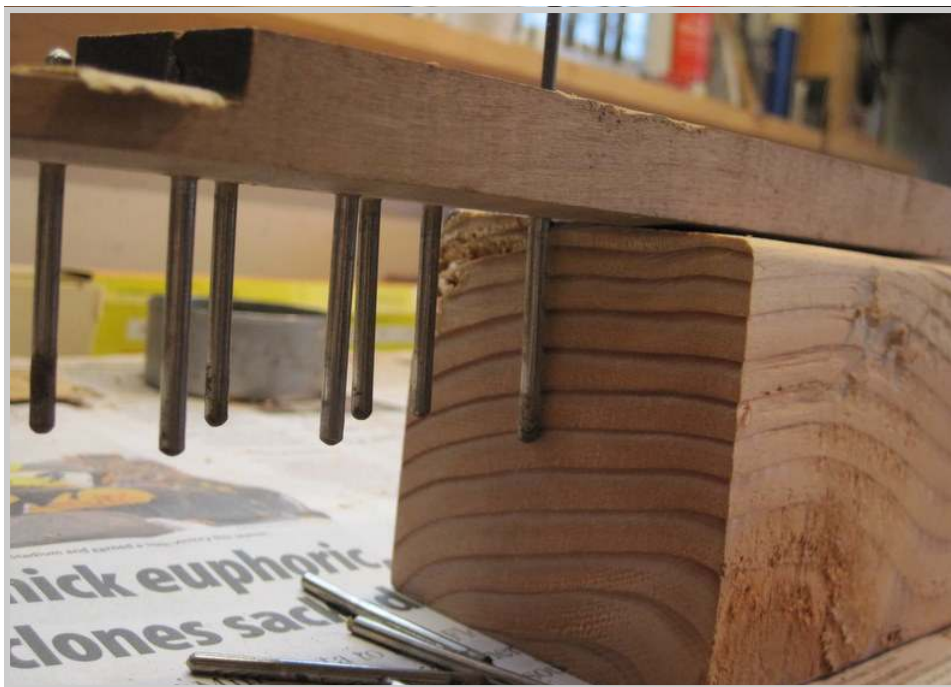
*Photo 325: The 4 X 4 block holds the balance rail far enough off of the surface of the bench that the pins are free to drop out below once they are punched through.*

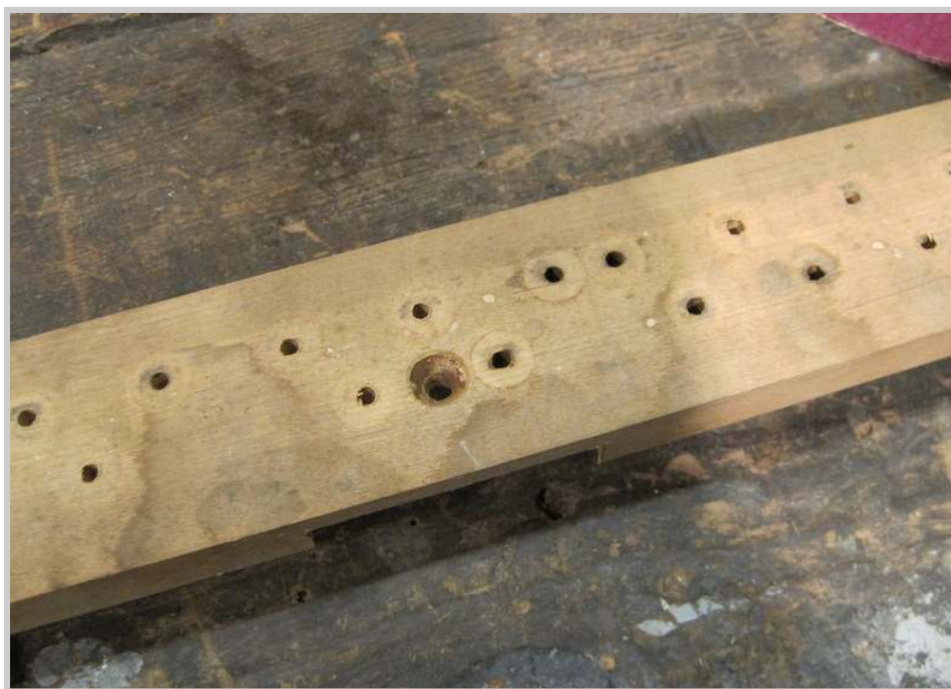
*Photo 326: With all the pins removed, the balance rail itself needs attention to remove stains and odors.*

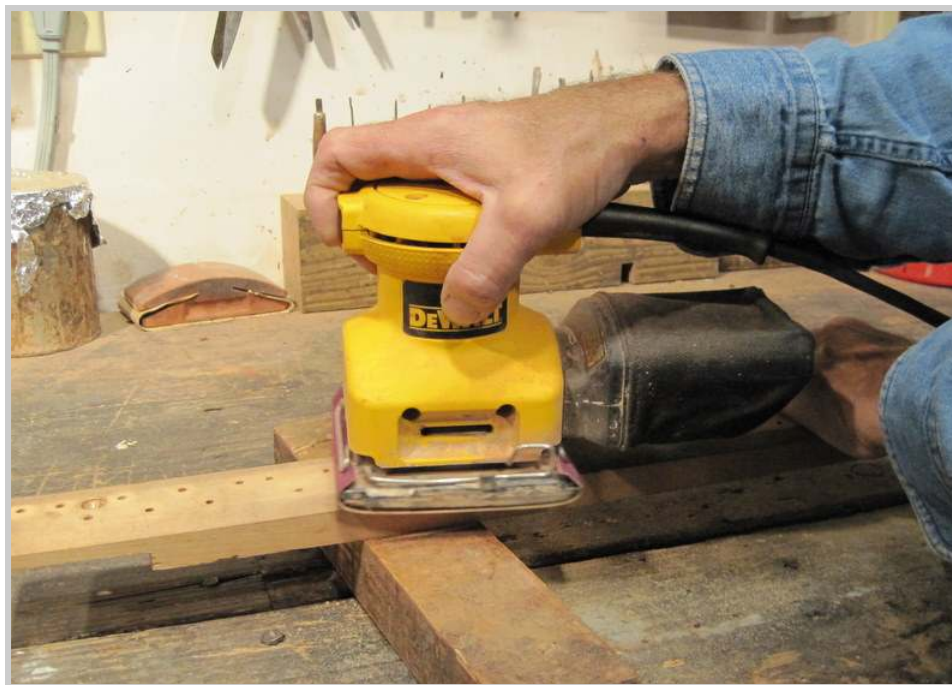
*Photo 327: The sanding out process involves a once over with 100 grit paper, followed with 150 and 220. Being a harder wood (maple) than the keybed itself, the staining had not soaked far into the fibers of the wood, and was much easier to remove.*

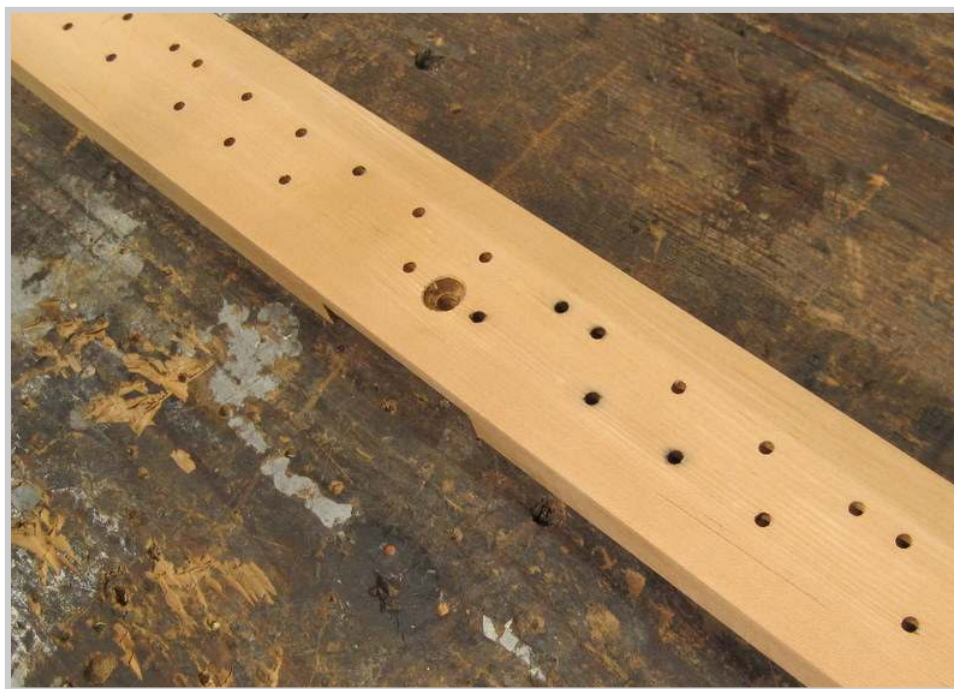
*Photo 328: The balance rail, looking much better than before.*

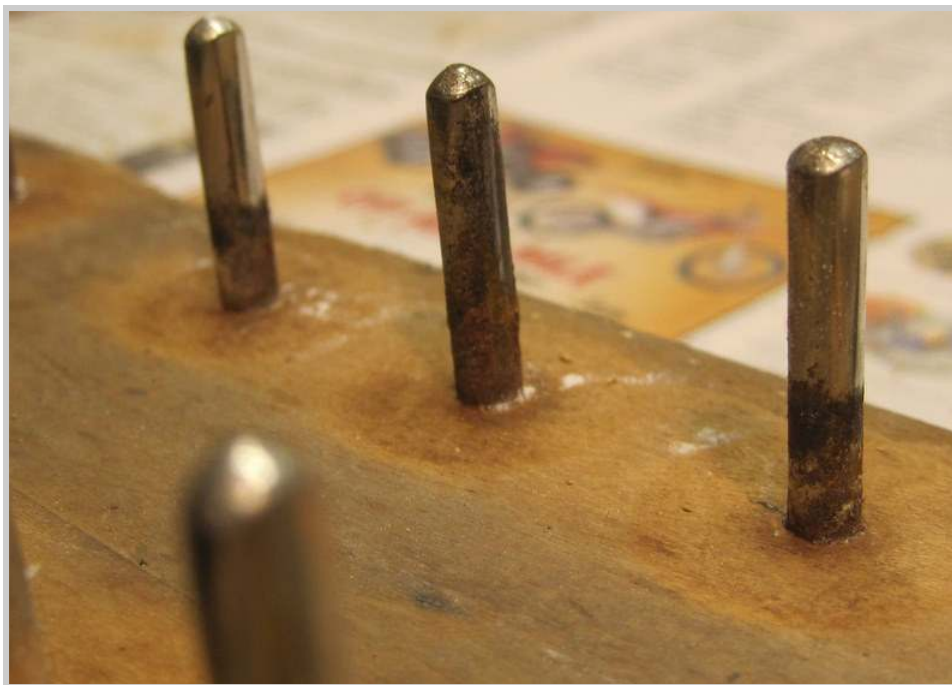
*Photo 329: The front rail pins are unfortunately in no better condition than the balance rail pins, and must be replaced as well.*

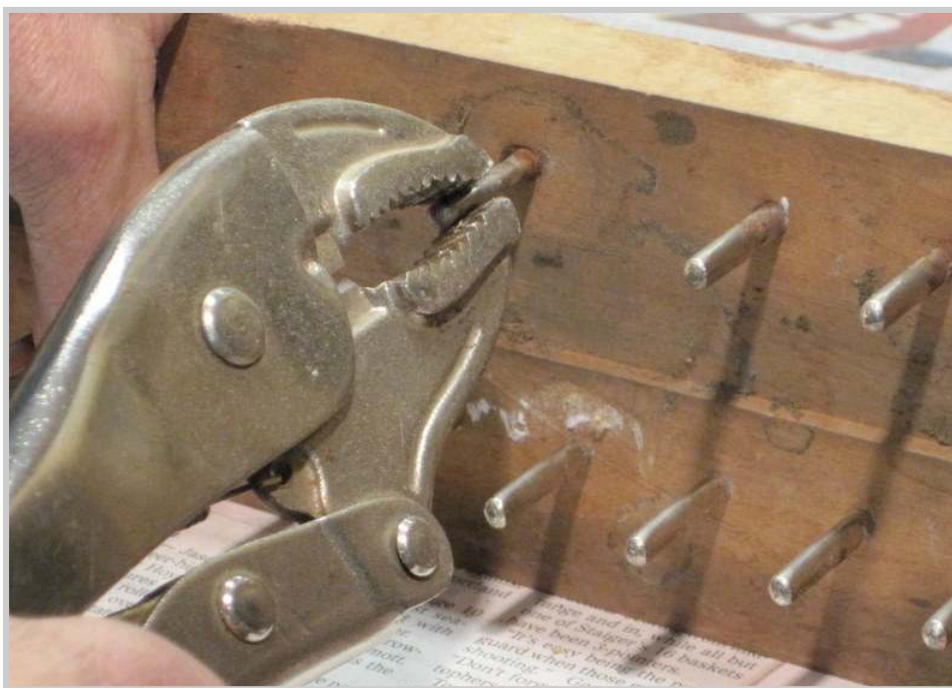
*Photo 330: Removal of the front rail pins involves grasping the pin tightly with a pair of vise grip pliers, and pivoting clockwise and counter-clockwise while pulling out. Care is taken not to exert any side-to-side pressure which could distort the shape of the hole.*

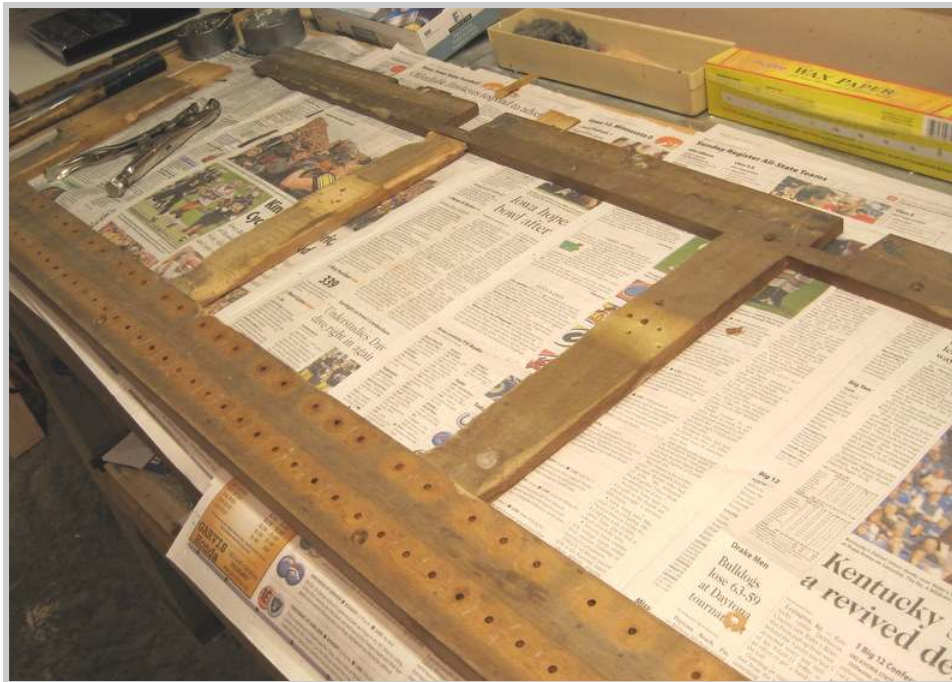
*Photo 331: The rest of the keyframe, with pins removed from the front rail.*

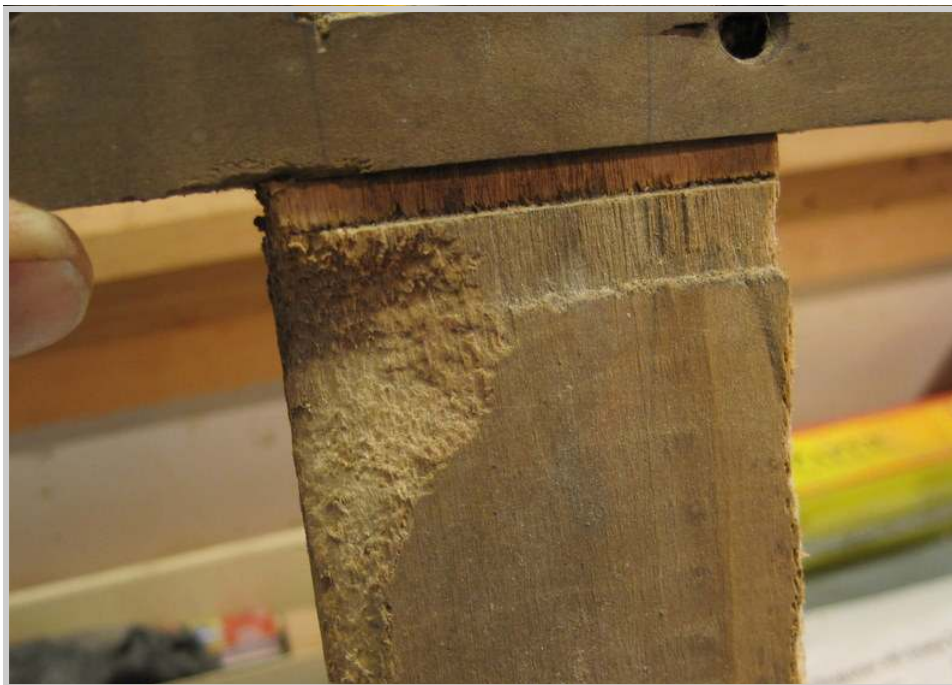
*Photo 332: The front to back members of the keyframe, as well as the back rail, have severe damage courtesy of the factory mice. These parts, being of a softer wood than the front and balance rails, suffered from much more abuse. Replacement of these parts of the keyframe, at this stage of the project, seems desirable. If there's one thing I hate, is to finish a job and wish I had done this or done that. "Do it right the first time," was my dad's motto. I've tried to make it mine as well.*

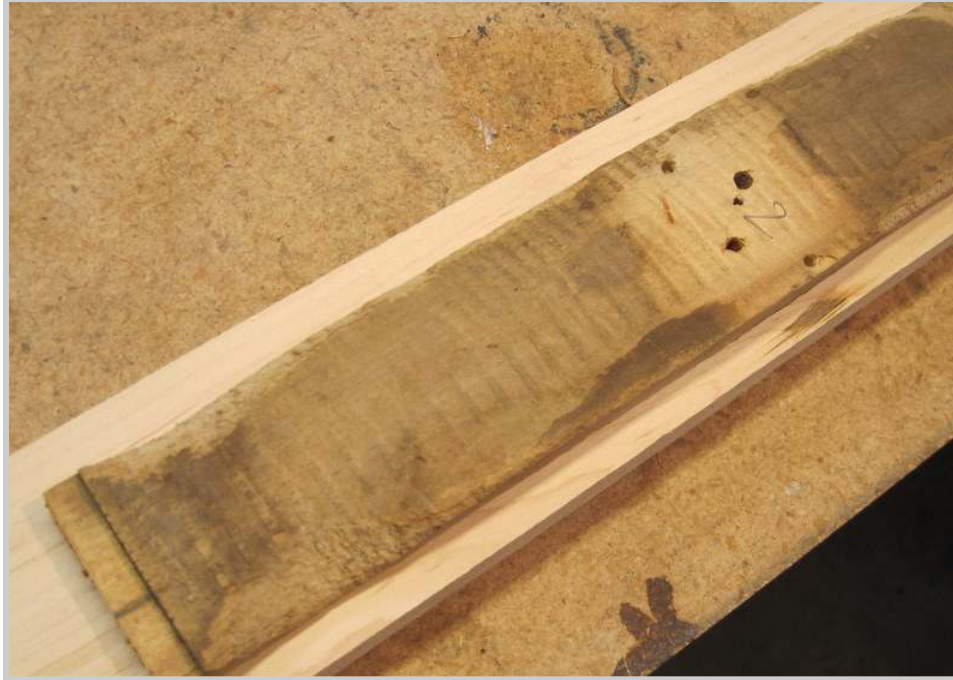
*Photo 333: From the lumber rack, a piece of maple is chosen to make new frame parts.*

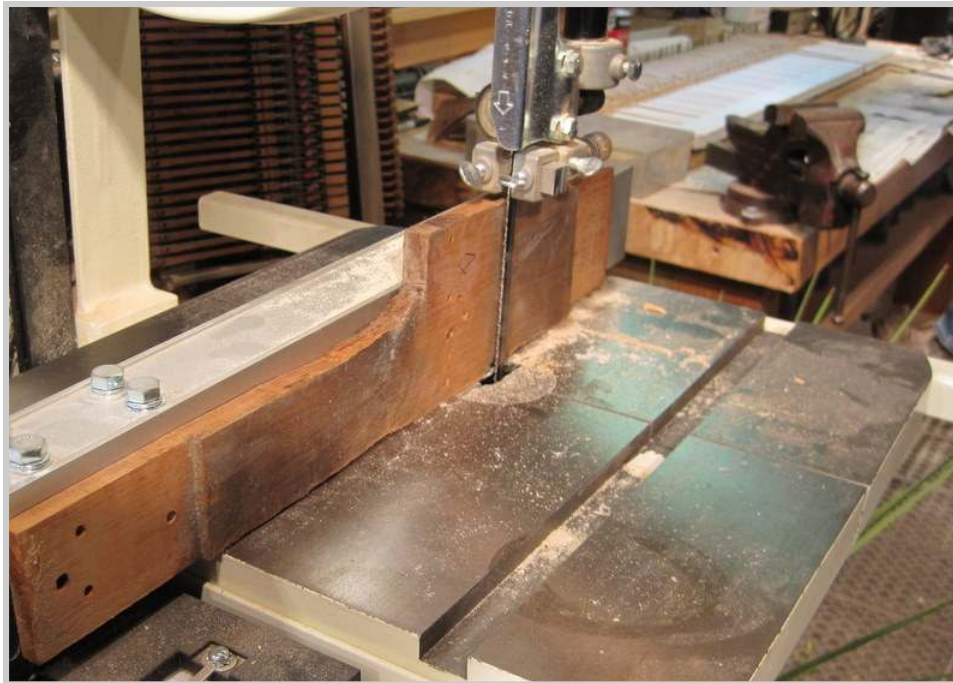
*Photo 334: The band saw is set for the thickness of the old stock.*

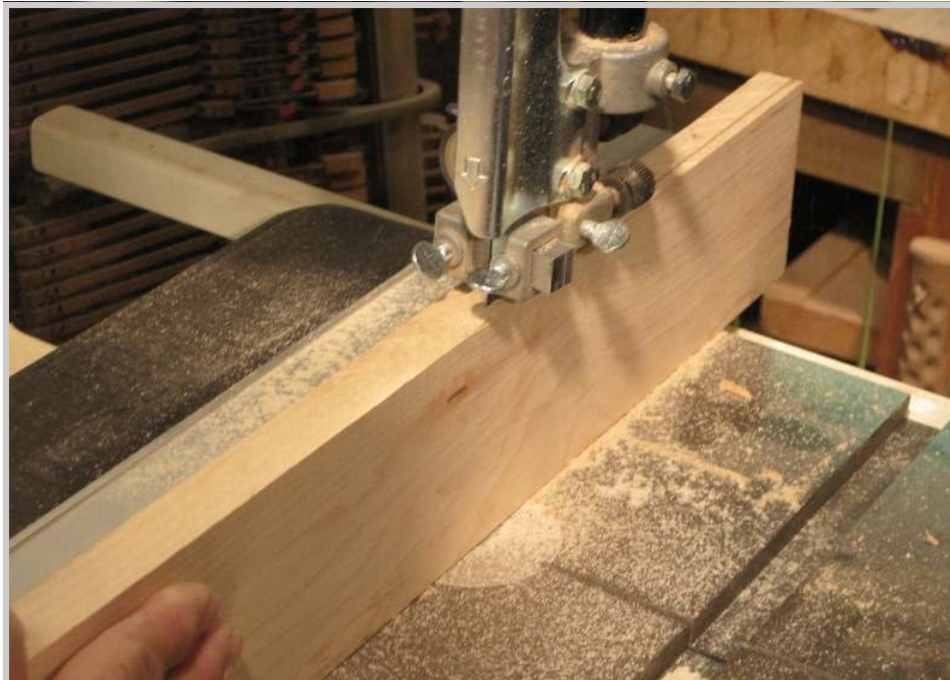
*Photo 335: An eight footer and a six footer are resawn on the band saw to provide adequate material to work with.*

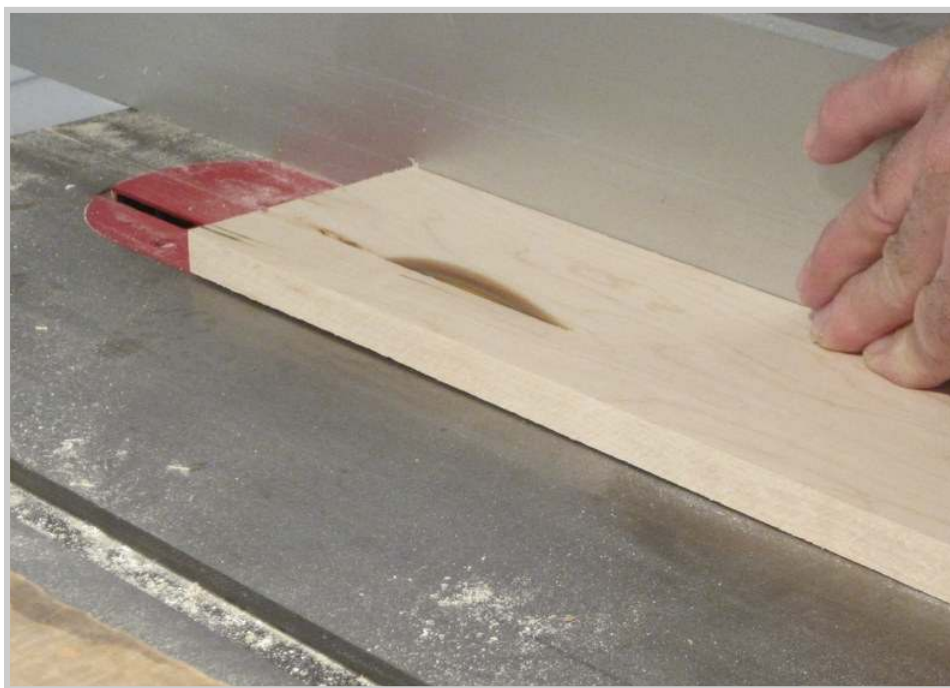
*Photo 336: The five replacement boards are first cut to length on the miter saw, then cut to width on the table saw.*

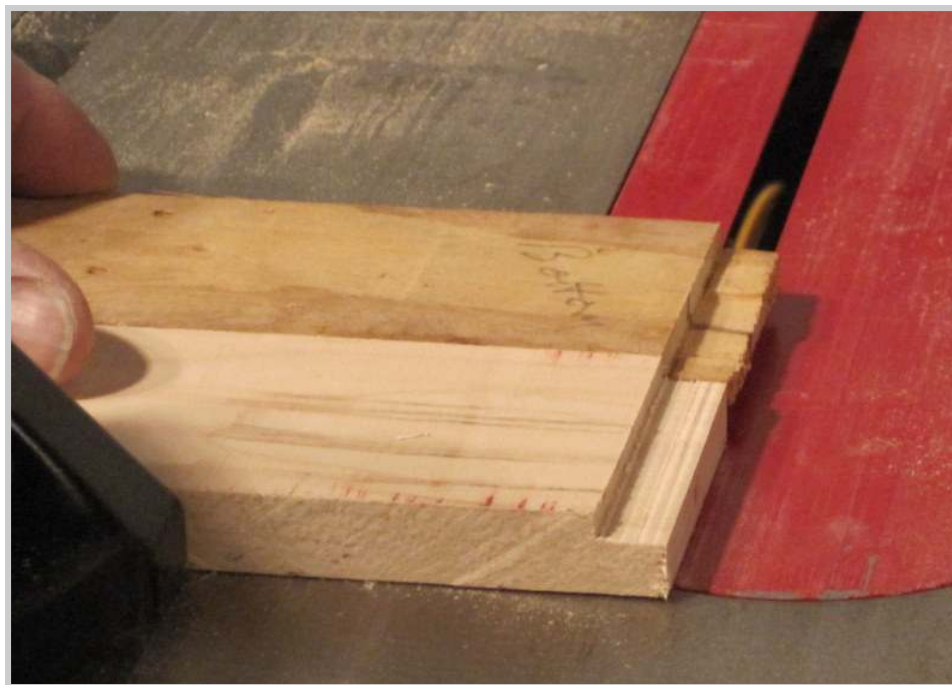
*Photo 337: The middle two front-to-back boards have mortise and tenon joints on the front end. Tenons matching the old are cut for these two pieces.*

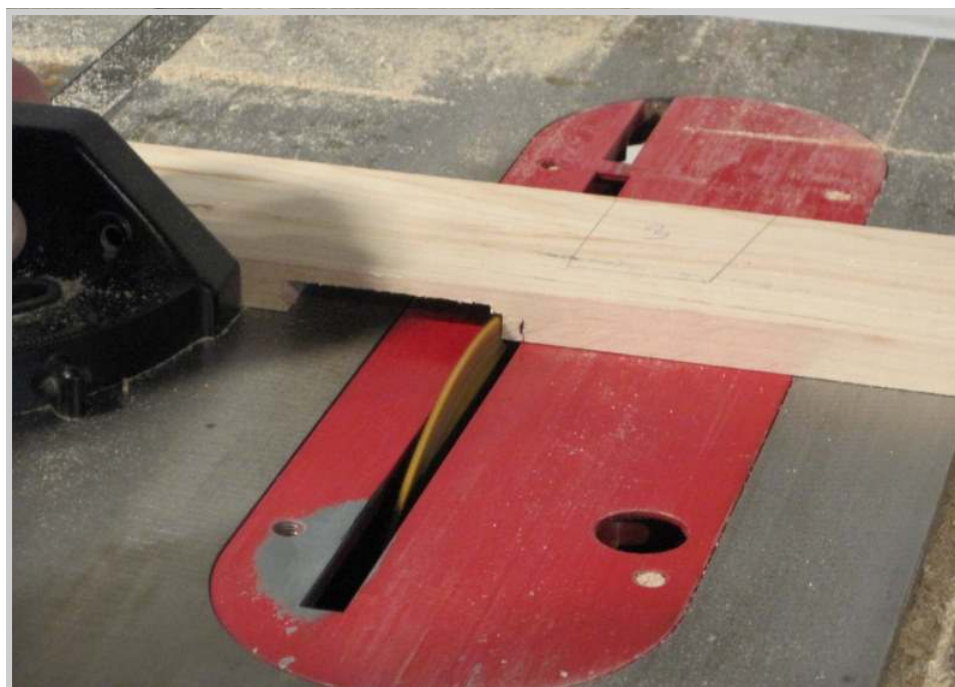
*Photo 338: The back rail has dado joints, here being cut into the new rail.*

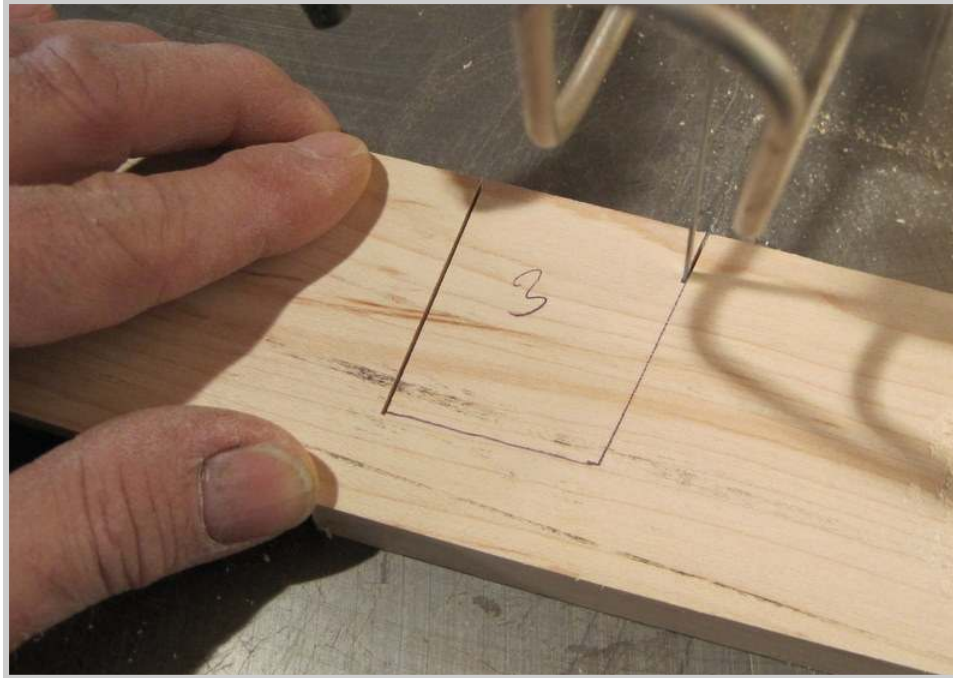
*Photo 339: Cut-outs in the back rail give clearance around the action posts.*

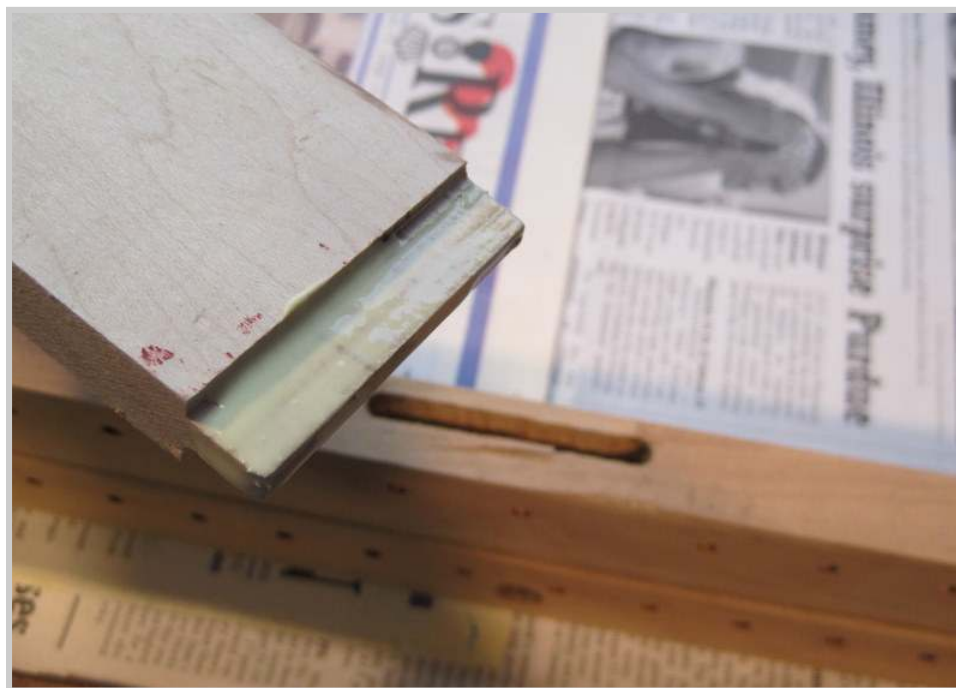
*Photo 340: Titebond is applied to the tenons before insertion.*

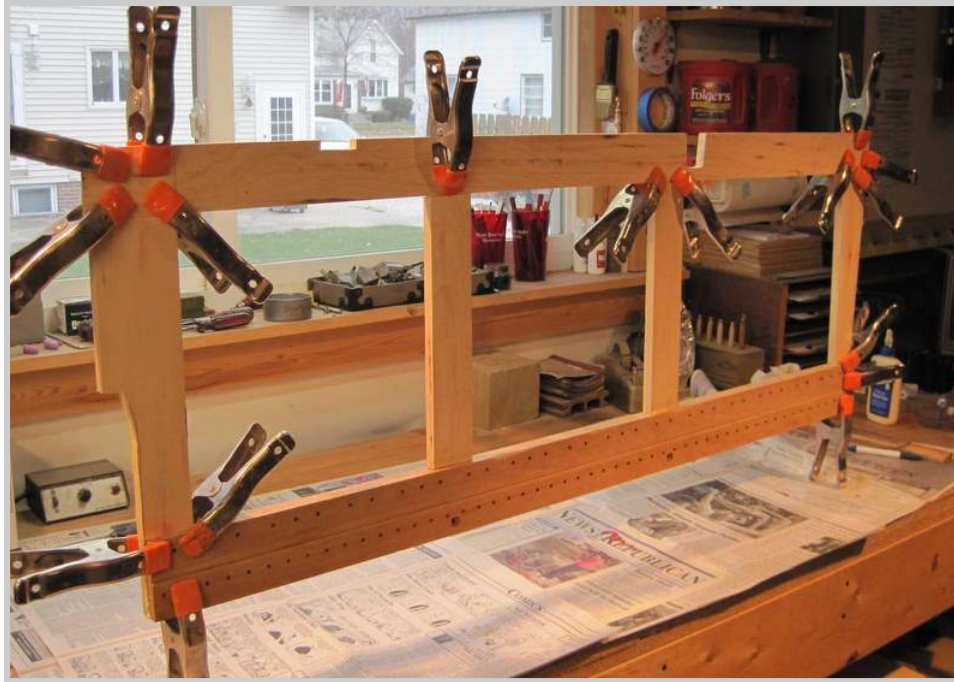
*Photo 341: With all the joints fitted and glued, the keyframe is clamped together and allowed to dry overnight.*

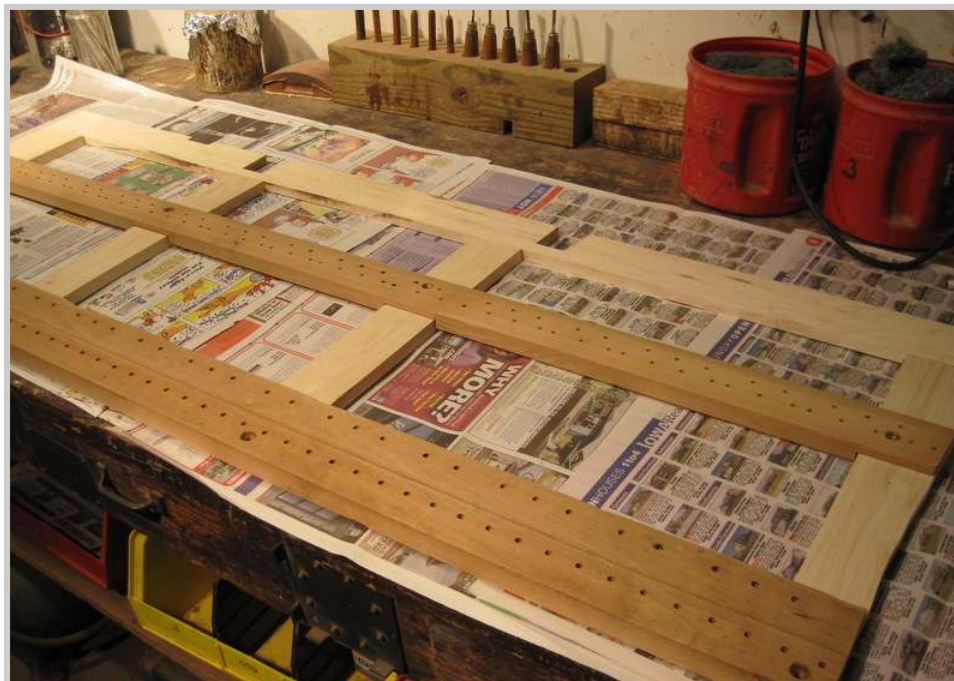
*Photo 342: The rejuvenated keyframe with clamps removed the next morning.*

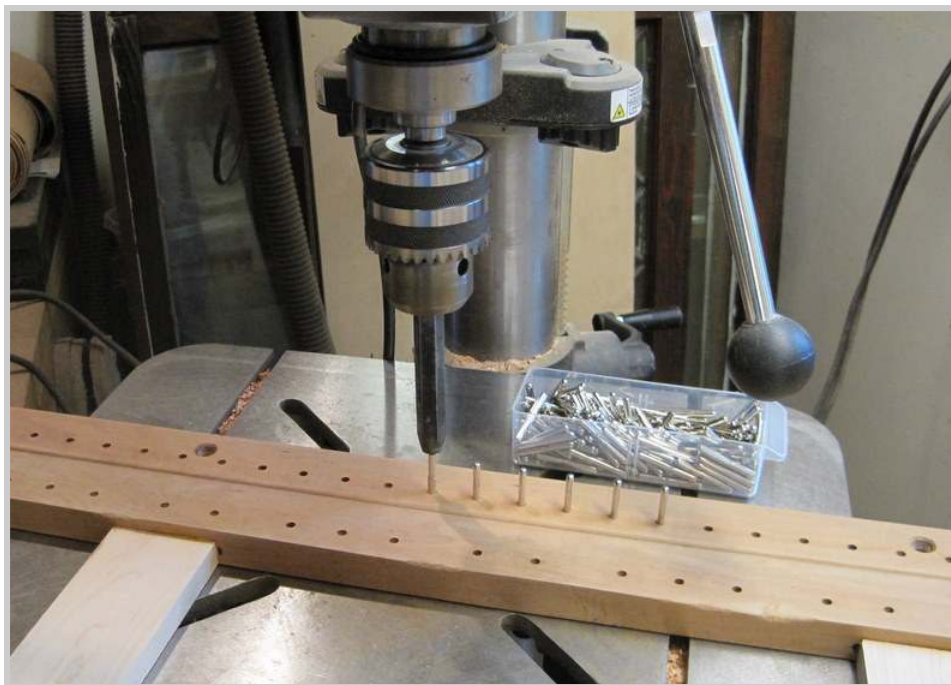
*Photo 343: Using the 'press' feature of the drill press, the correct size of front rail pins are pushed into place using the depth setting on the tool. A pin punch is the tool in the chuck of the drill press. The concave tip fits over the end of the pin without marring it in the process.*

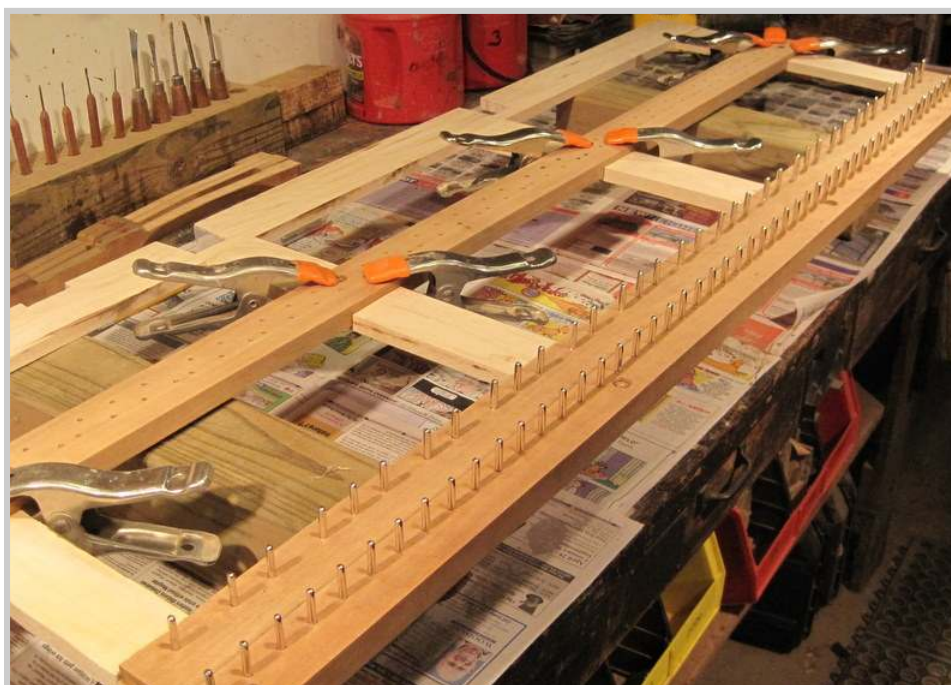
*Photo 344: The keyframe with front rail pins all in place, and the balance rail glued and clamped into position.*

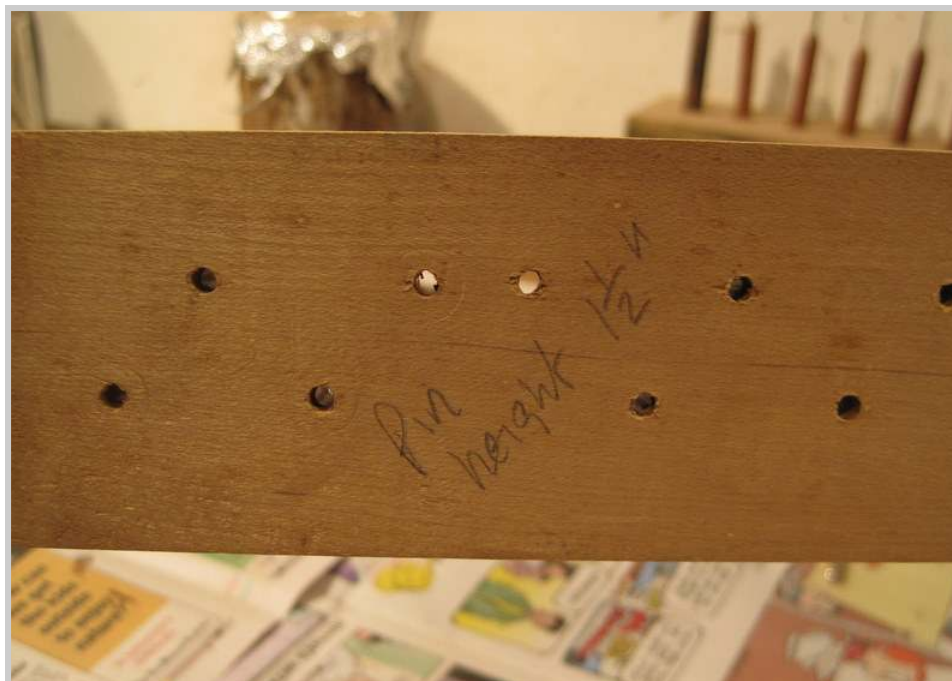
*Photo 345: Important measurements, such as this one concerning the height of the balance rail pins, are best recorded in a spot such as this on the bottom of the balance rail itself, where it won't be lost*

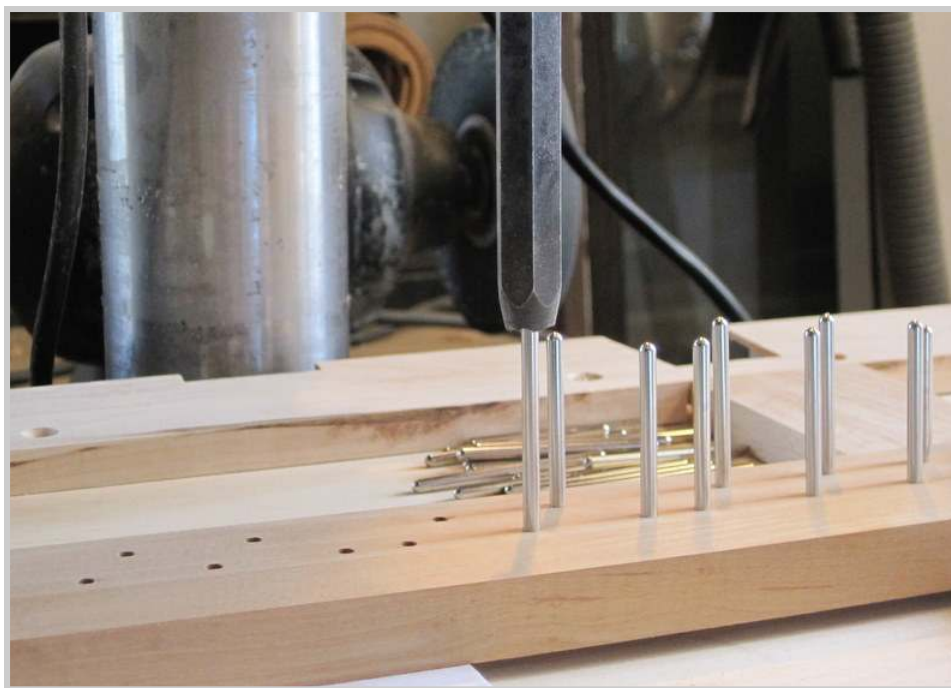
*Photo 346: The balance rail pins are pushed part way into the rail. Because of the flex of this rail, the final adjustment is not made on the drill press.*

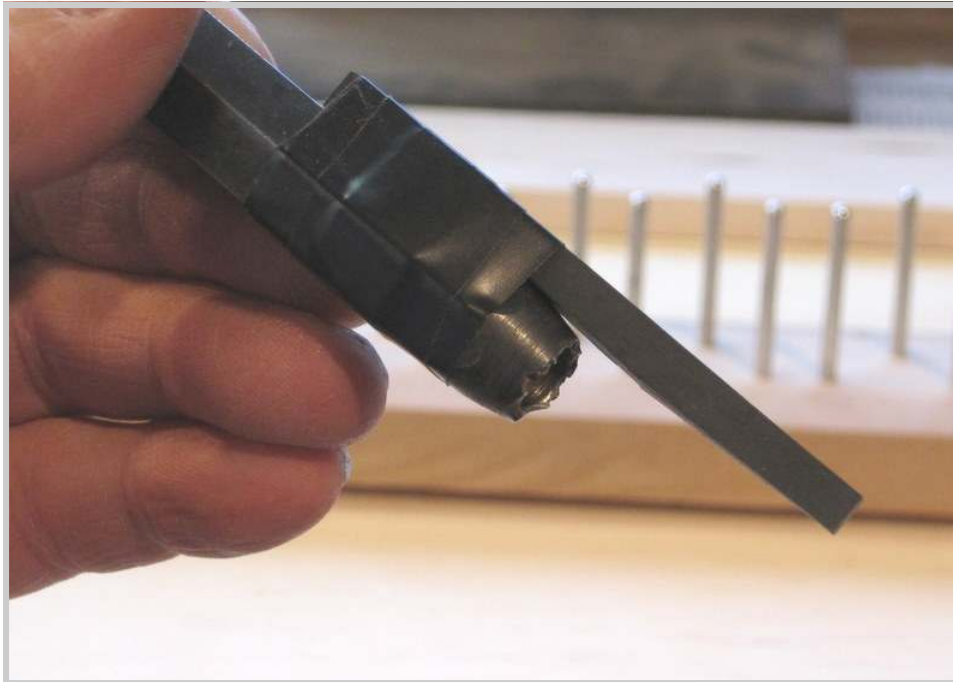
*Photo 347: A depth gauge, much like the one used for pounding tuning pins, is made from a piece of rubber wedge attached to the pin punch with electrical tape.*

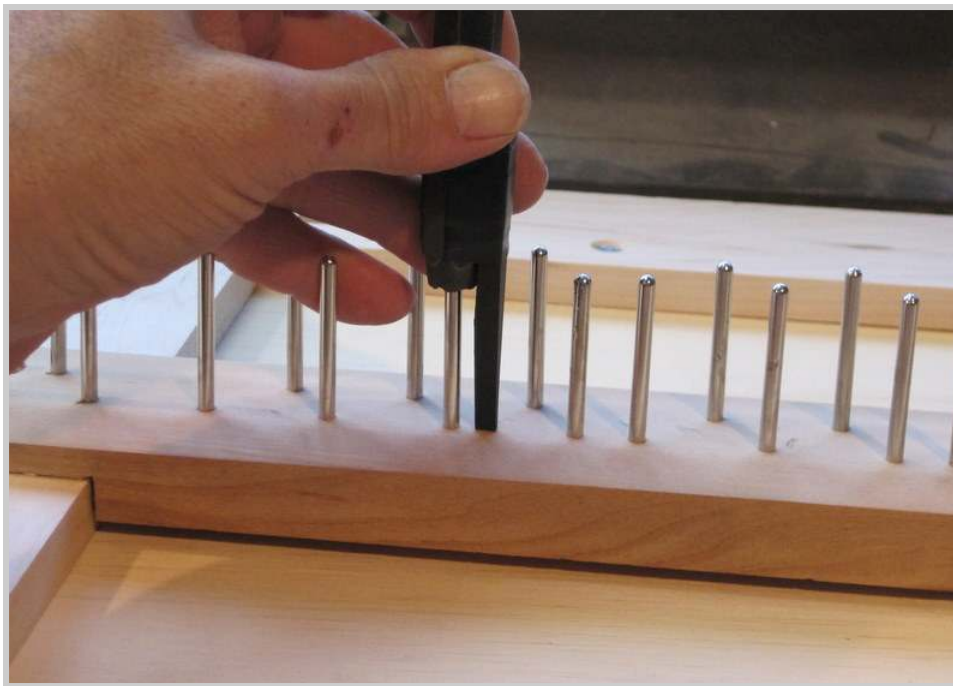
*Photo 348: Each pin is tapped in the final bit with a small ball peen hammer and the pin punch. Again, this method works to set the height of the pin without marring its surface.*

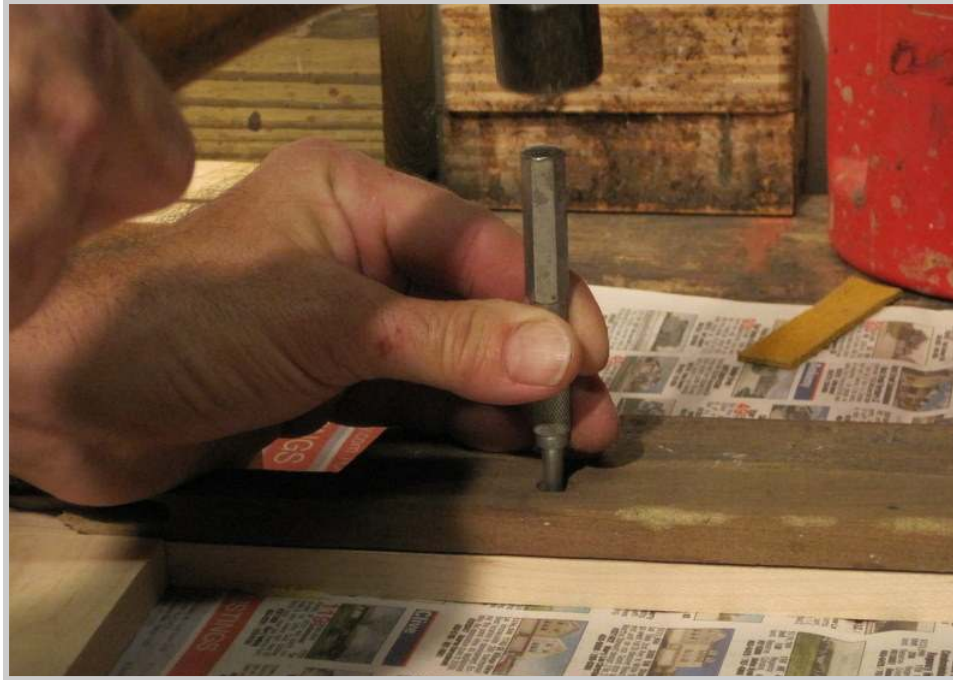
*Photo 349: The location for the screws holding the back rail to the keybed are marked using the old back rail as a template.*

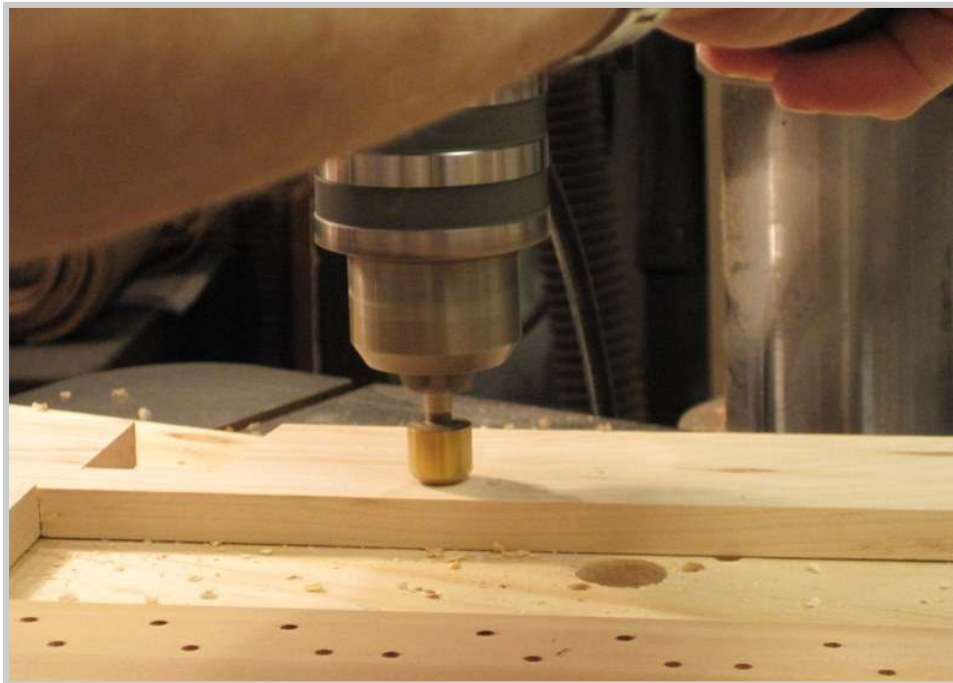
*Photo 350: The screw holes in the back rail are drilled, then countersunk on the drill press.*

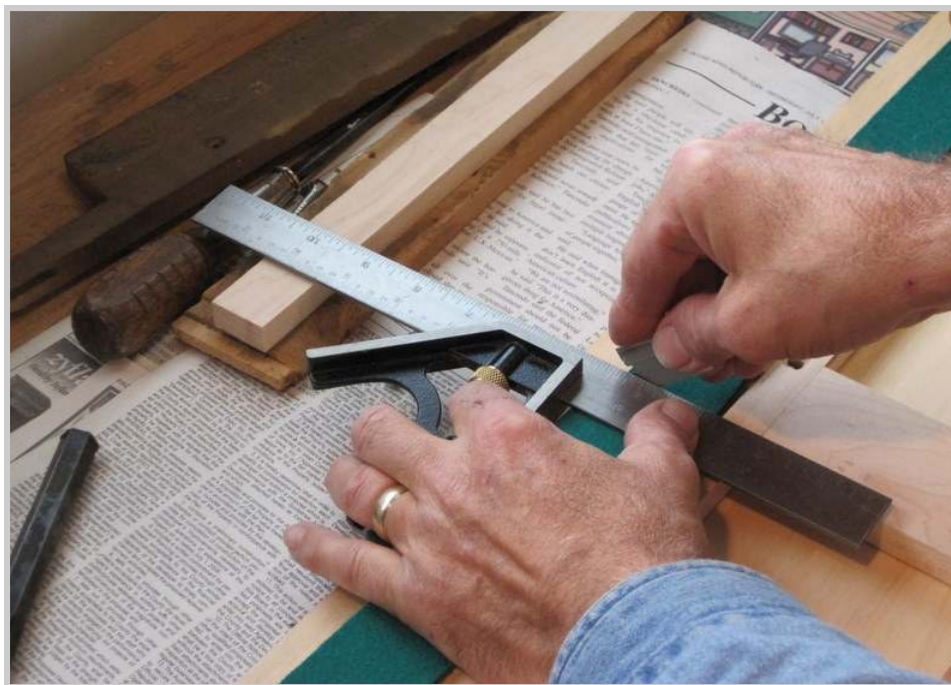
*Photo 351: The refelting of the keyframe begins by cutting the three sections of back rail cloth to size.*

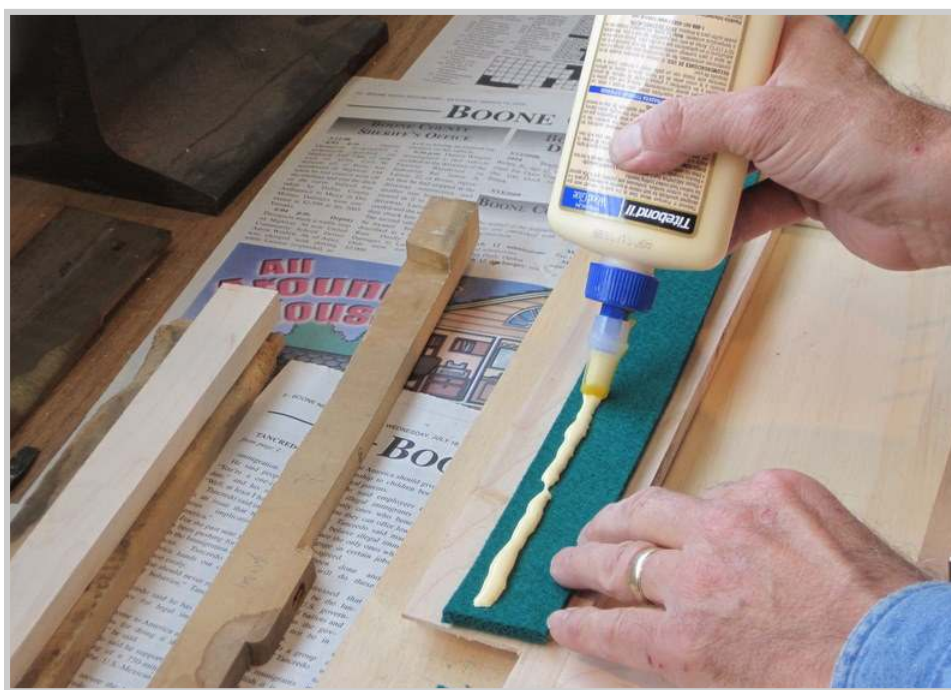
*Photo 352: Each piece of felt is flipped upside down and a bead of glue is applied to the back half of each strip.*

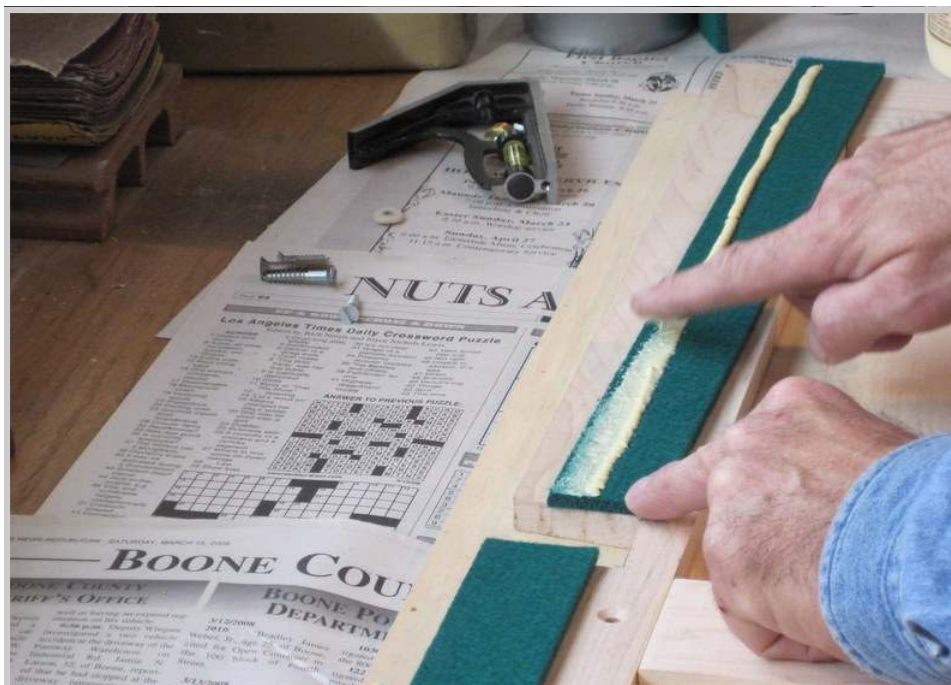
*Photo 353: The glue is spread onto the back half of each strip. When the felt is flipped back over, the glue will be on the front half of each strip only. The back half (where the bottom of the keys make the heaviest contact) is left loose in order to reduce the amount of noise transmitted to the body of the piano from the keys falling onto the felt.*
