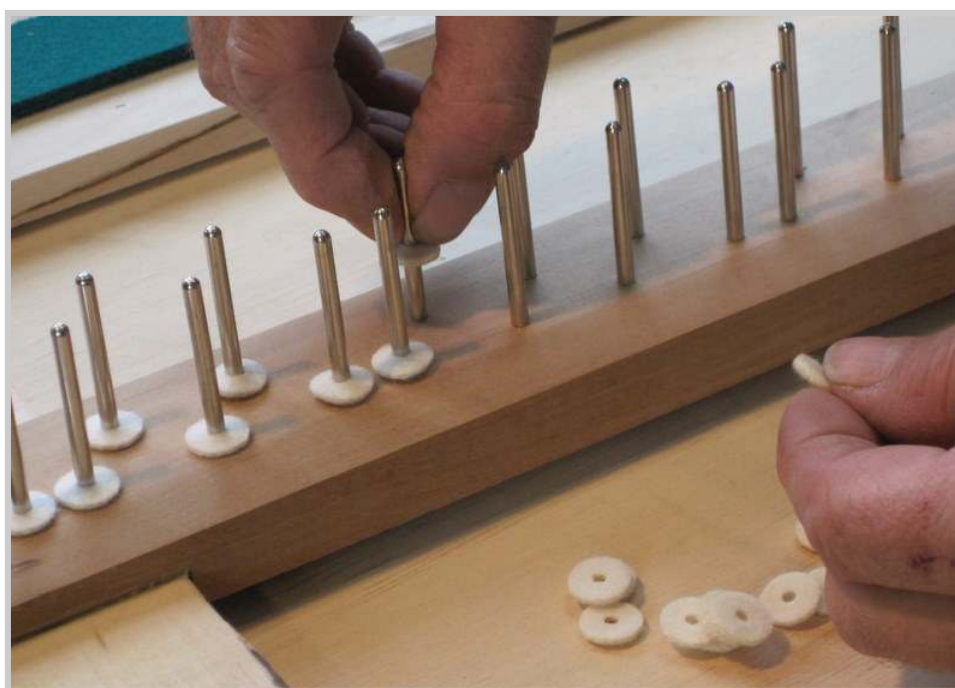
*Photo 354: Balance rail punchings are put in place . . .*

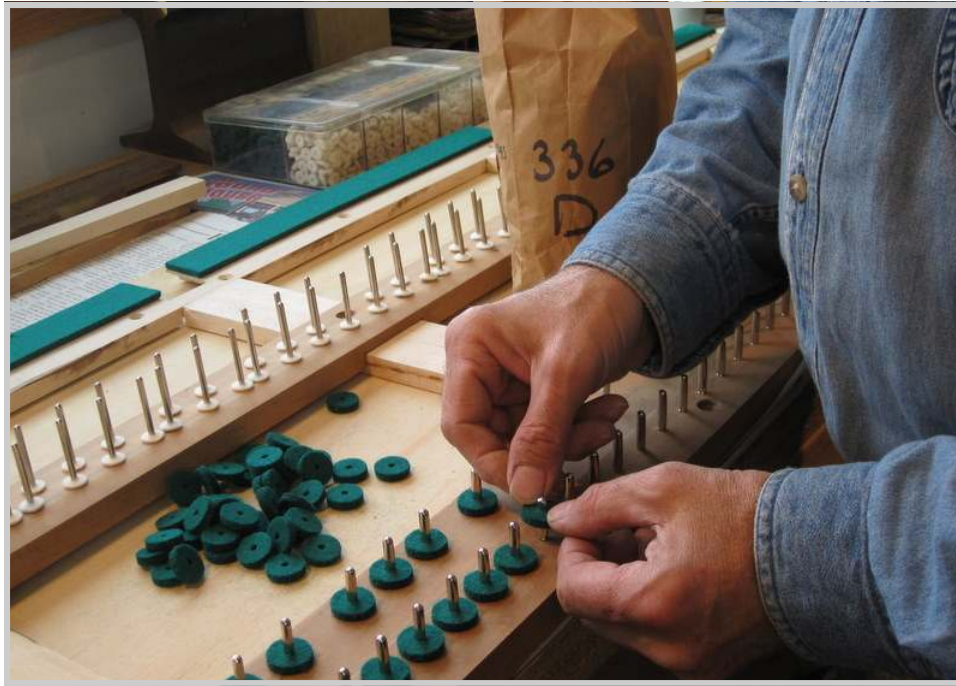
*Photo 355: . . . followed by the front rail punchings.*

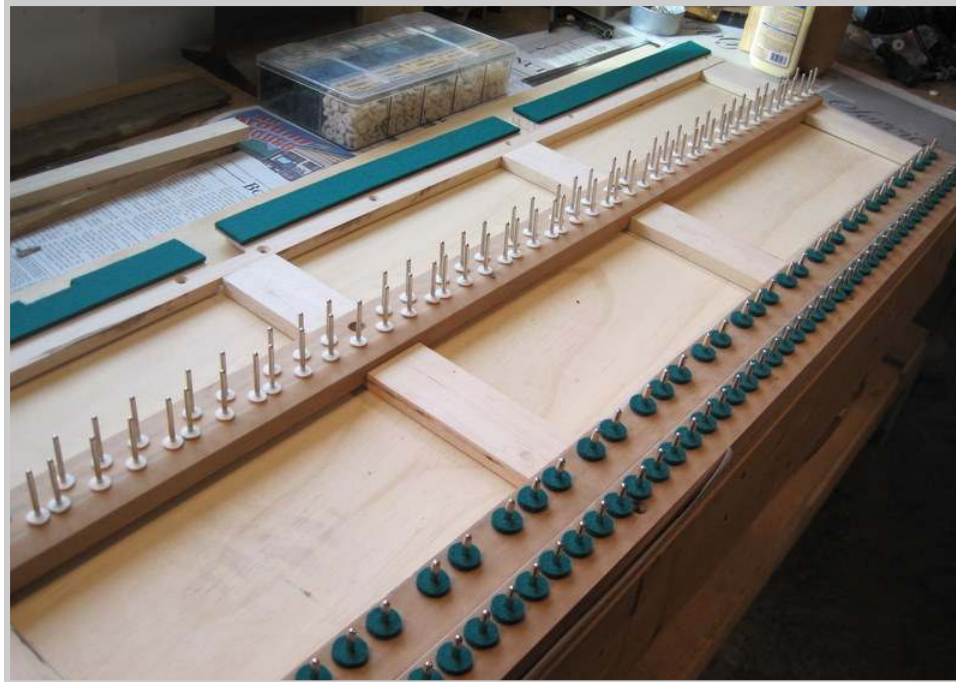
*Photo 356: The refelted keyframe, ready for reinstallation.*

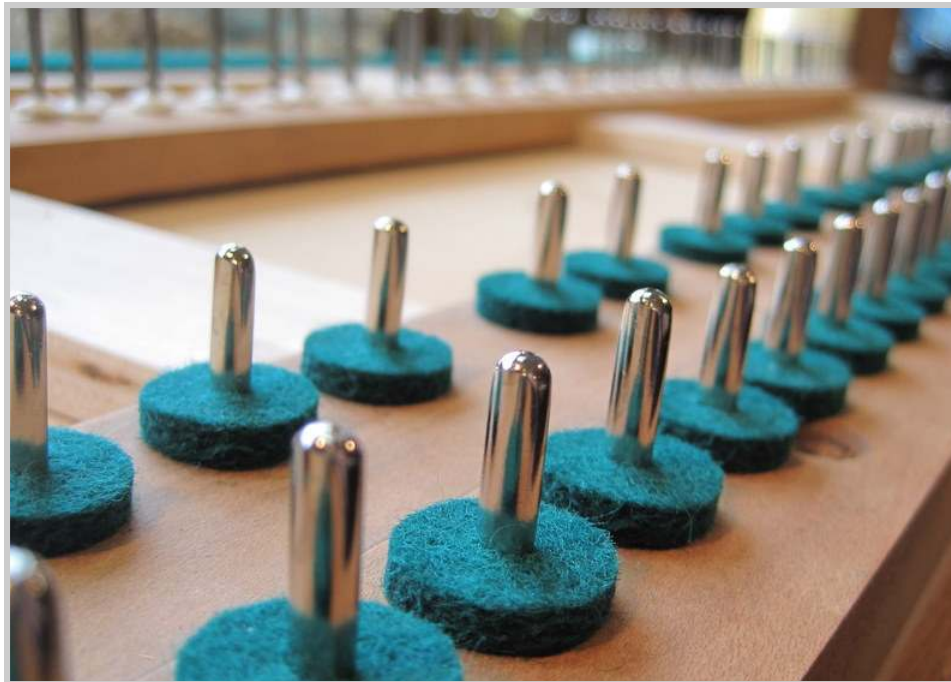
*Photo 357: The front rail pins stand like soldiers in a parade line.*

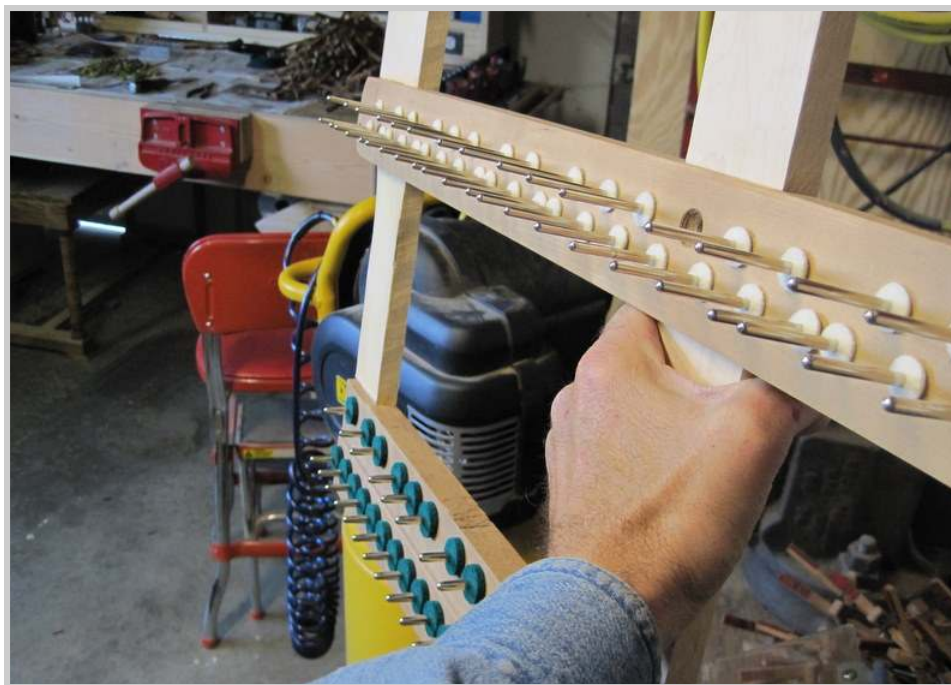
*Photo 358: The completed keyframe on its way back to the assembly room, where the piano is being put back together. This is where the project starts to be more fun than work.*

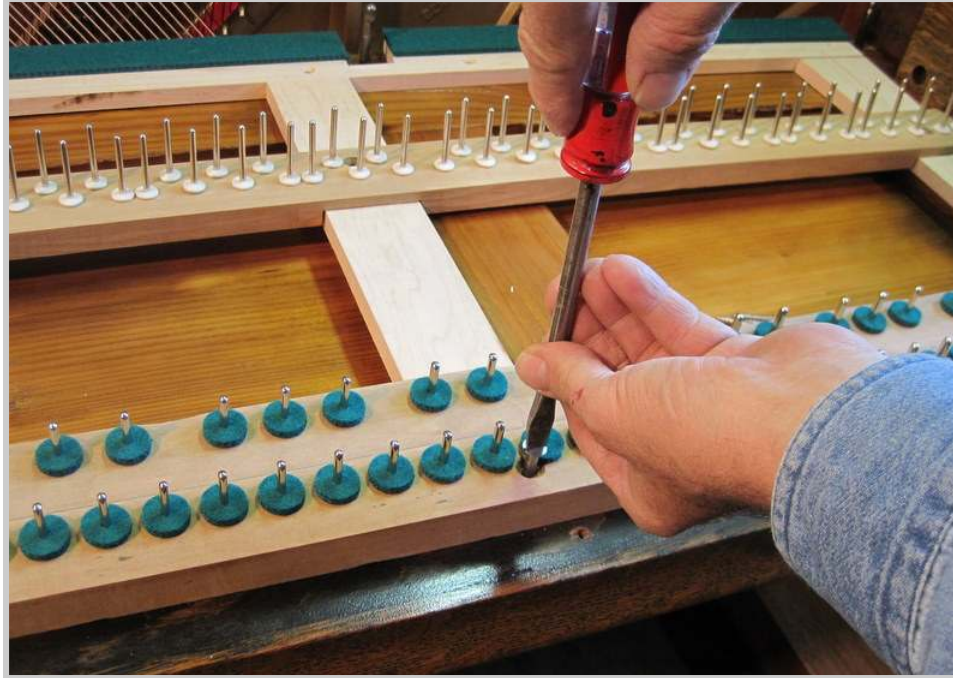
*Photo 359: The frame is secured with screws in the all three rails.*

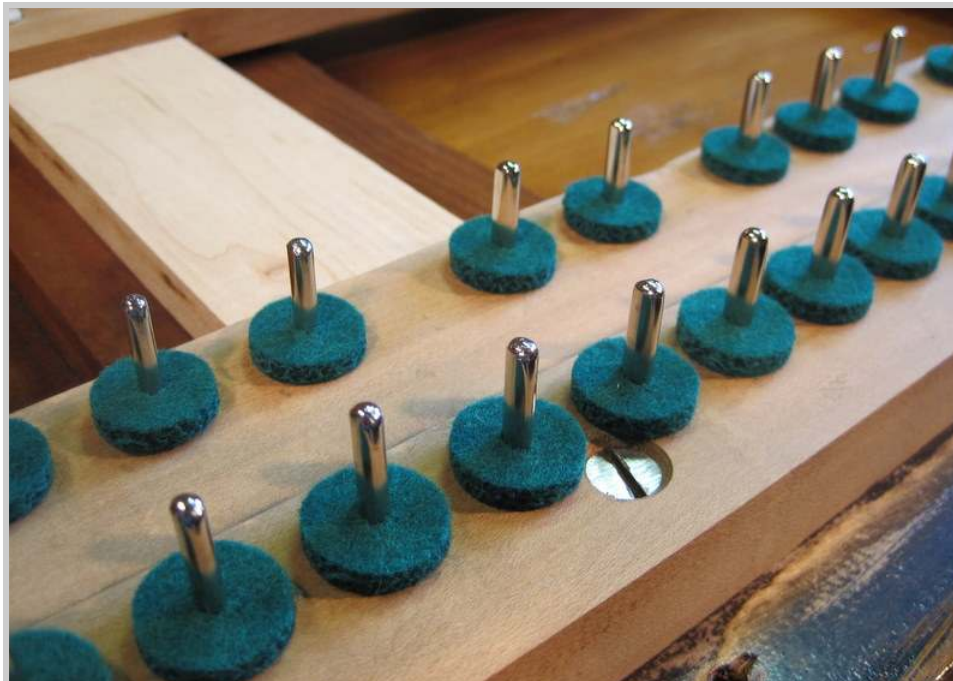
*Photo 360: Polished screw heads set the work off.*

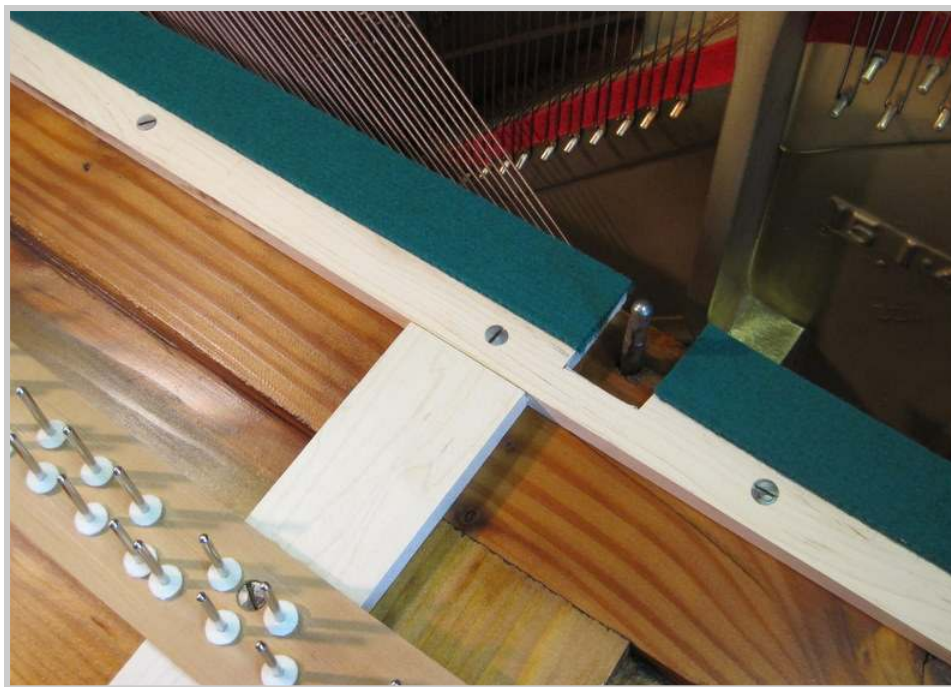
*Photo 362: The quality of the construction of these older instruments is apparent once they are restored and you're not looking at mouse debris anymore, but on the original workmanship. Compare this construction to that of a 1970's or 1980's P.S.O., and you'll see what I mean.*
