# The Piano Owner's Heads-Up Guide to Important Piano Maintenance

## Focus On: Replacing Abstract Felts in the Console Piano

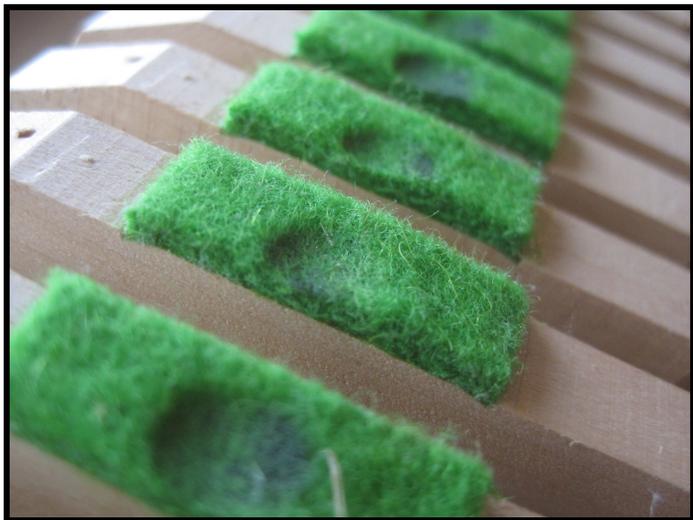
One cause of a noisy, clattering action in a well used console piano is the wear-and-tear that the felts of the action are subjected to. In particular, the abstract felts which serve as a buffer between the brass capstan at the back of each key and the wooden levers and parts of the upper portion of the action are particularly worn and compacted. **To help quiet the action of your piano, replacing these worn felts (as seen in the top photo) with new, high-quality abstract felt would be an important step.**

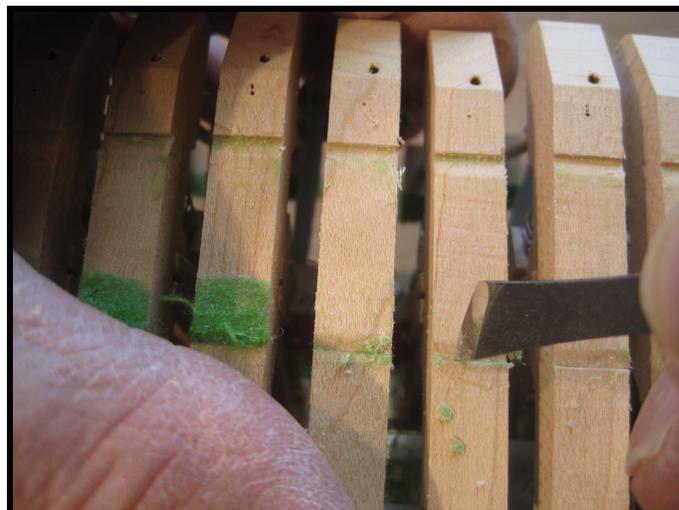
For this job to be successfully completed it is usually necessary to transport the action of the piano to the shop. With the action secured upside-down on the bench, the old abstract felts are carefully removed. Despite the amount of wear-and-tear on these felts, they typically are glued very firmly to the bottom of the wippens, and take a considerable amount of time to scrape loose, as seen in the opposite top photo.

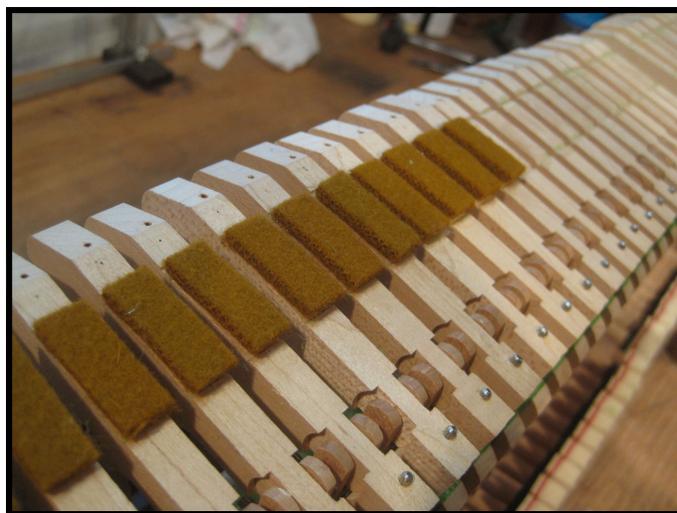
When the old felts have been removed and the undersides of the wippens cleaned, new high-quality abstract felt is carefully glued into place. These felts are glued at the front and the back, but not in the center, so that the transmission of sound between the brass capstans and the wooden parts of the action is kept to a minimum.

Once the new felts are installed and the action is replaced in the piano, adjustments will need to be made to the regulation of the action to compensated for the increase in thickness of the felts. In particular, the brass capstans will most likely to be adjusted for the action to function properly.
