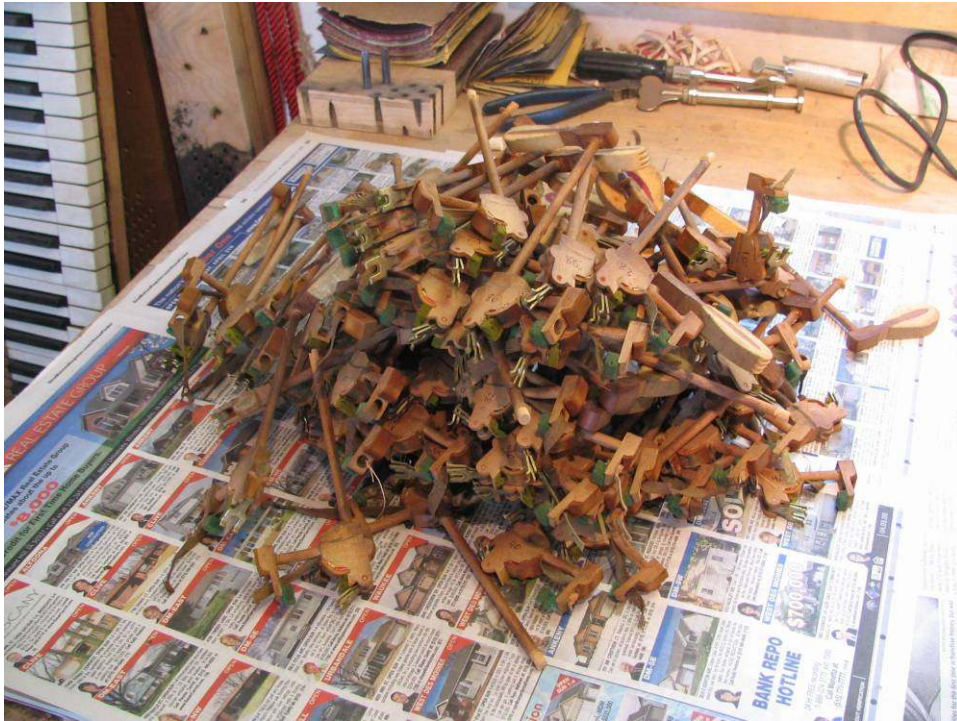
*Photo 61: Project for the day. All the buckskin and felt, except the center pin bushings, will be stripped from the old hammer butts in preparation for new. This stack of parts, by the way, represents a victory over my obsessive /compulsive nature. Five years ago, these parts would have all been neatly stacked in ranks and columns. Looking at the stack as I write this, I notice it is very symmetrical and neat. Hmmm.*

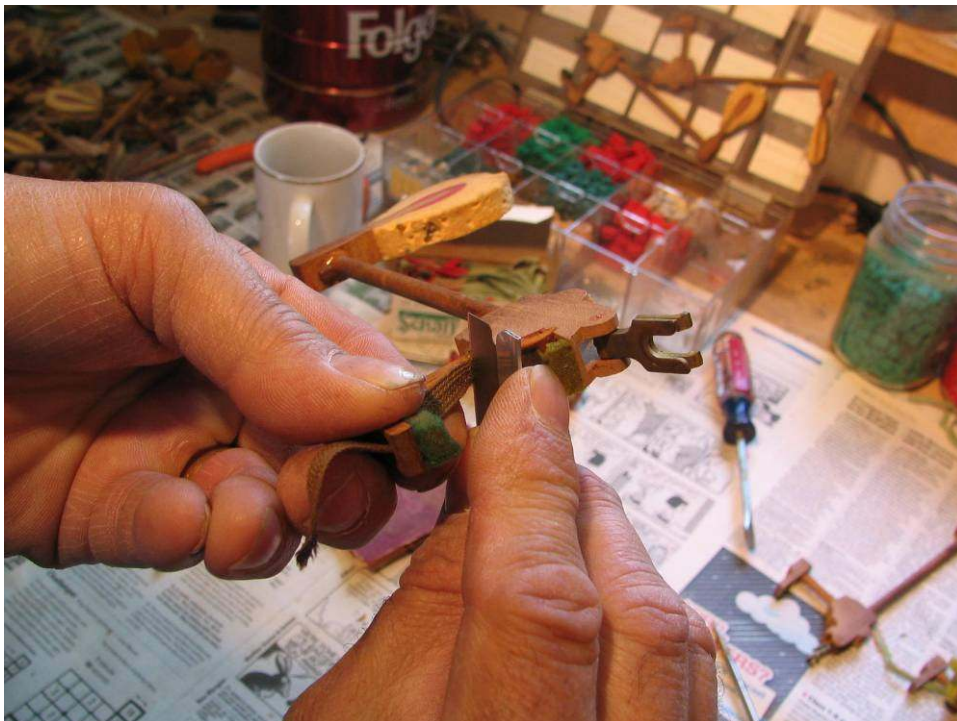
*Photo 62: Taking a hammer assembly from the pile, I begin the process of removing the old felt. Instead of just snipping the original bridle strap, I will be cutting the old strap flush to the hammer butt. The new braided strap will be cut to the correct length and glued to the underside of the catcher shank.*

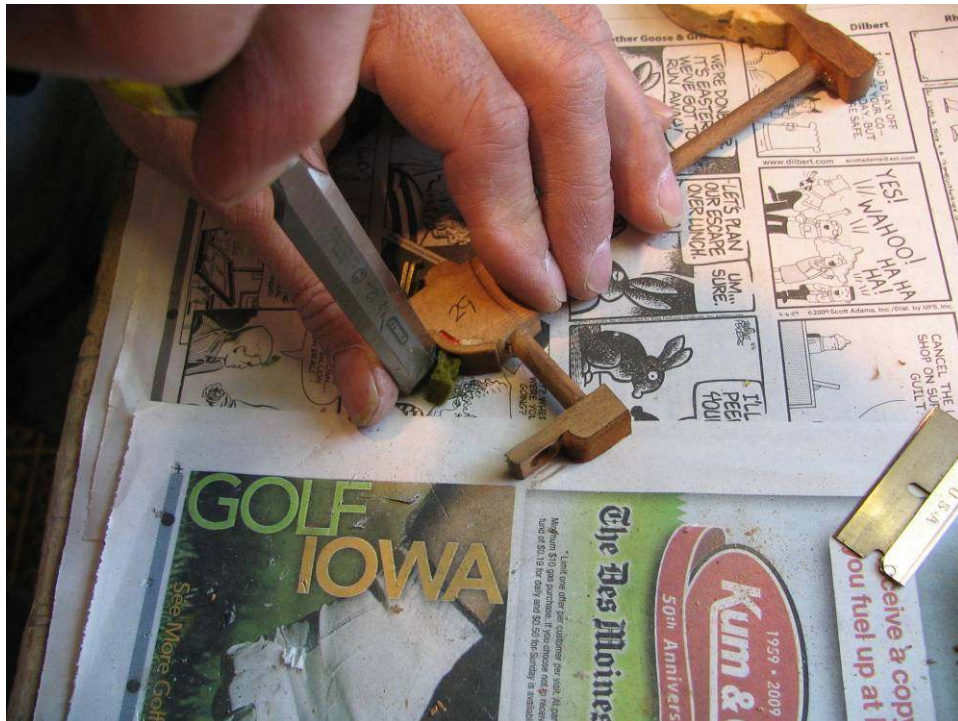
*Photo 63: Piece by piece, the felt and buckskin are removed with a chisel or razor blade. The necessity of this procedure becomes more and more evident as I proceed. The hammer butt felts and the felt squares on the inside of the catcher are the worst, but also the red and white felts under the hammer butt buckskin are in very bad condition, so much so that on some hammer butts, daylight can be seen under the buckskin. The result would be that support for the jack would be spongy at best.*

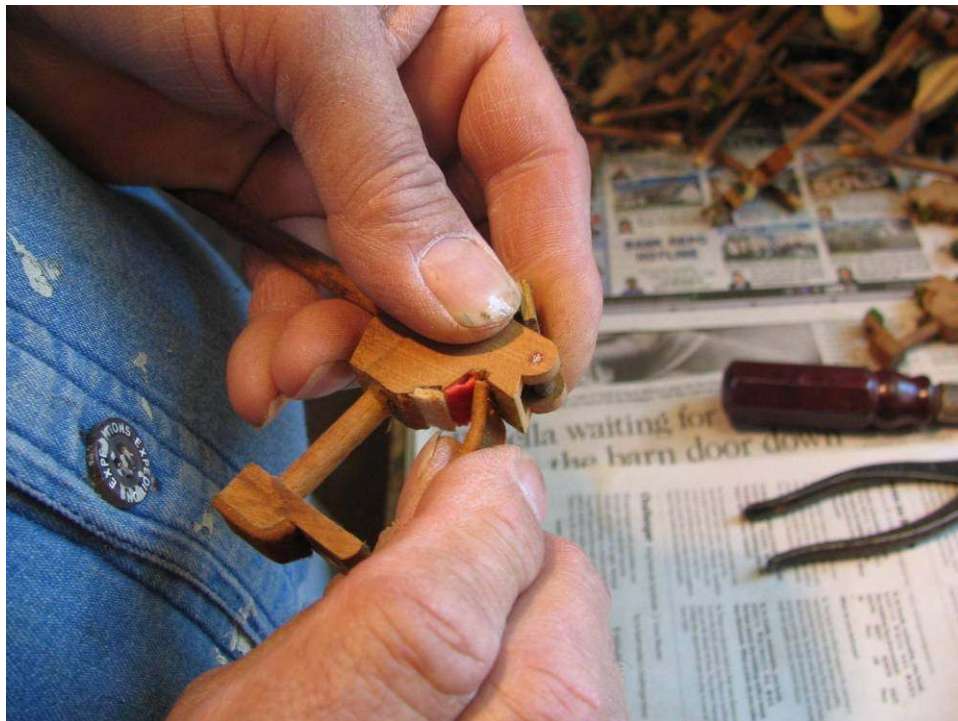
*Photo 64: Removing the hammer butt buckskin by pulling it free from the slot that it is inserted in. This piece is glued on either end and pulled tight over the underlying felt. The white felt is glued in place, and is removed by using a small, flat-bladed screwdriver to scrape it out of its recess. The red felt is glued on the slot end only, and is removed with a sharp chisel.*

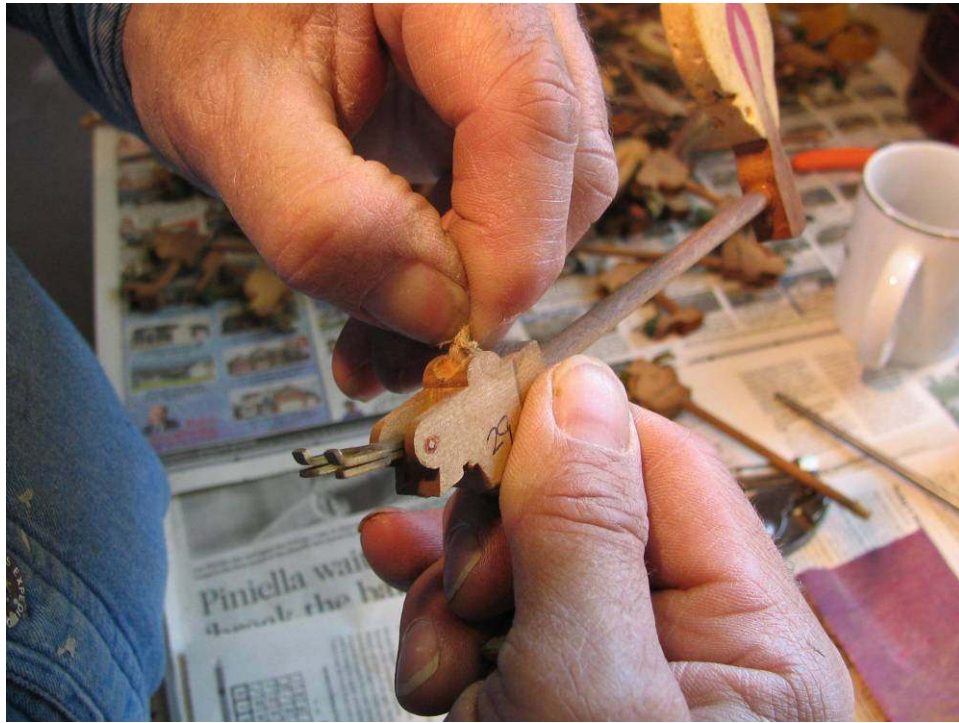
*Photo 65: The spring felt is easily removed by hand.*

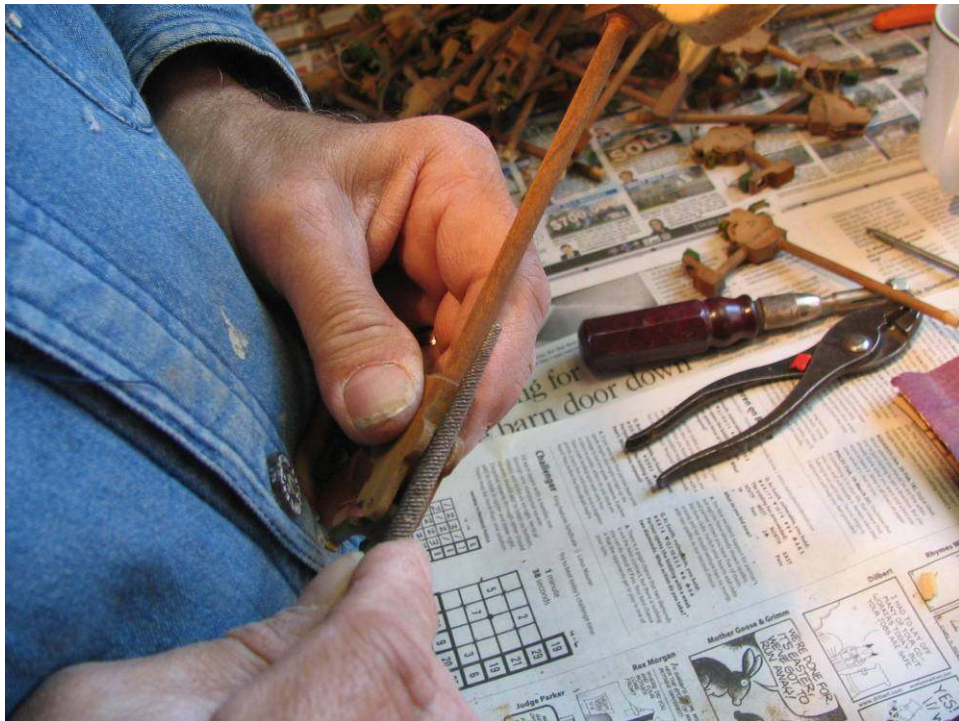
*Photo 66: Residue of the felt and glue is removed with a rat tail file. In all, seven individual pieces of buckskin and felt are removed from each hammer butt. The process takes a couple of minutes per butt.*

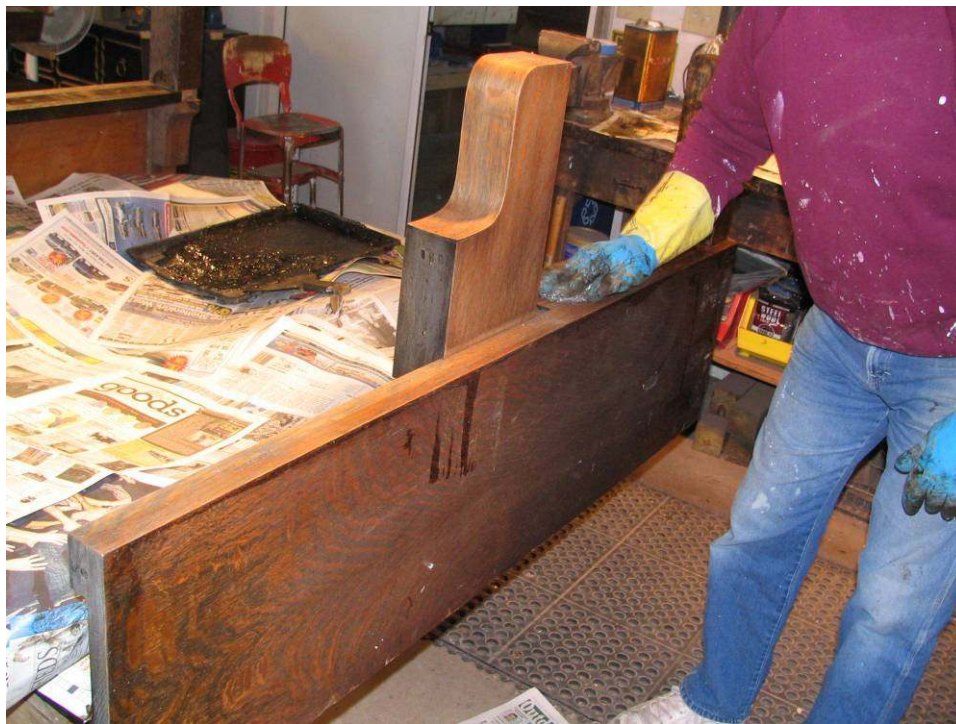
Photo 70: With his checklist ready to go (sometime in the future) Dave begins stripping the body. The cast iron plate is kept safe from stripper with layer upon layer of old newspaper.

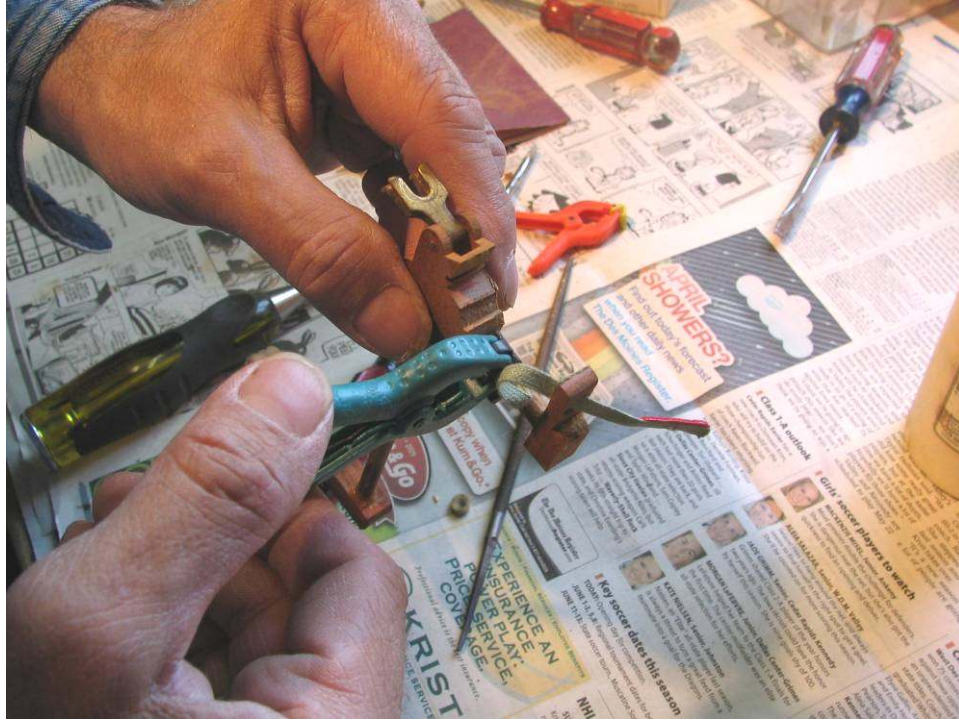
*Photo 71: At my bench, I apply a drop of Titebond to the end of the braided bridle strap. The strap is then clamped in place on the underside of the catcher shank. For some reason, I find that hot animal hide glue does not work particularly well on the braided strap.*

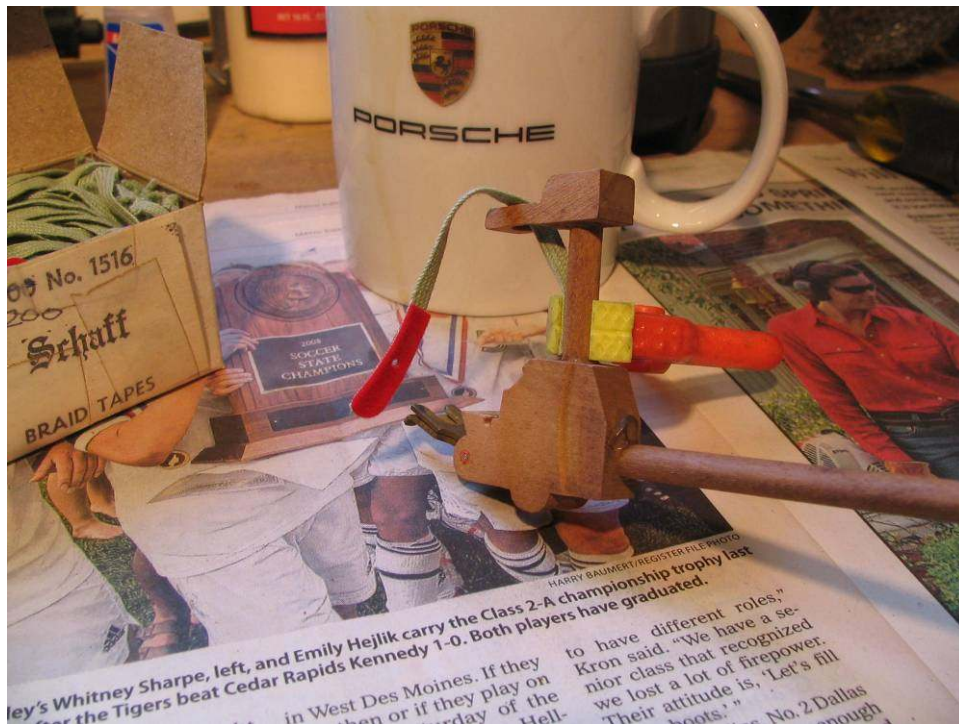
*Photo 72: Clamp in place, the glue is allowed to set. Another technique is to double up the end of the strap, and to use a tiny brad to affix it to the catcher shank. A true purist would, I suppose, insist on removing the catcher shanks to insert the end of the strap in the hole.*

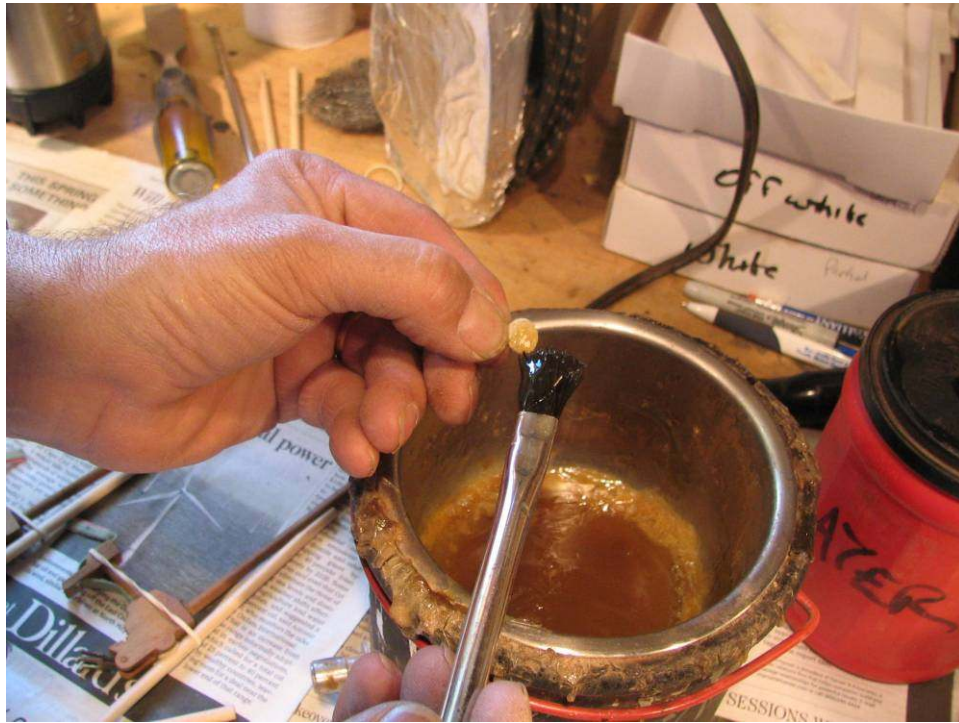
*Photo 73: Hot glue is applied to a spring felt.*

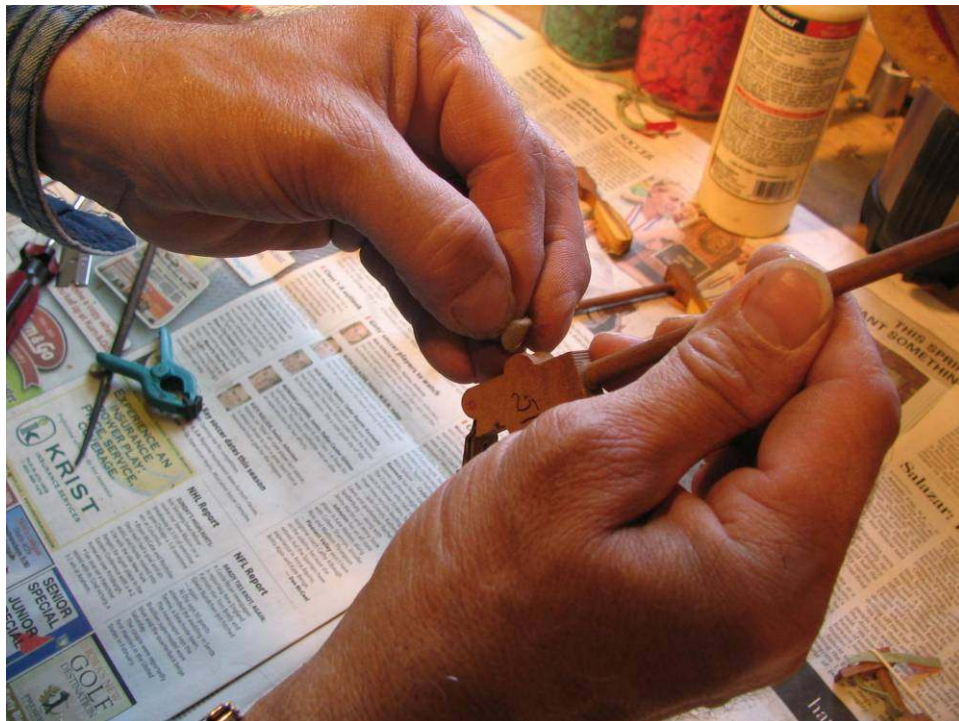
*Photo 74: Using a thumb and two fingers, the felt is creased slightly and placed in the groove.*

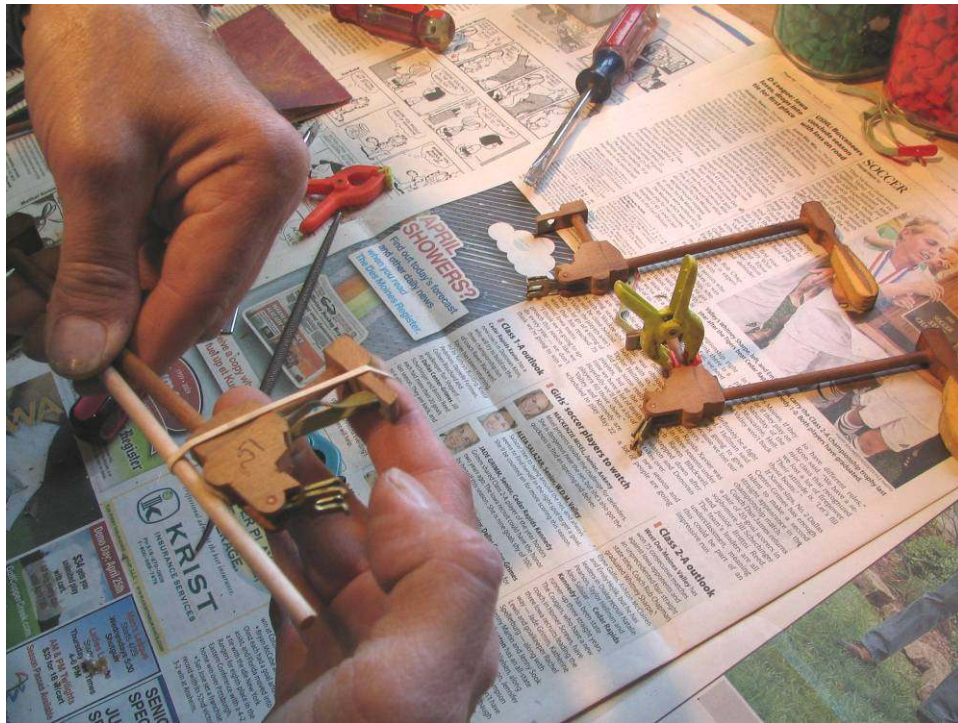
Photo 75: Using a hammershank flattened on one end, the spring felt is clamped into place. To work, the rubber band stretches from the catcher to above the position of the felt.
