**Replacement of Worn
Asian-Design Hammer Butts and
Flanges
Promo Set Preview**

Focus On: Replacement of Worn Asian-Design Hammer Butts and Flanges

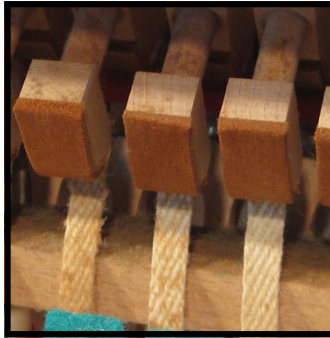
Old hammer butts

Yamaha, Kawai and other Asian-made pianos have hammer butt assemblies that rely upon a small braided cord to hold an essential spring in check. After years of use this cord is prone to breaking (as shown in photo above), which causes the action to perform unsatisfactorily.

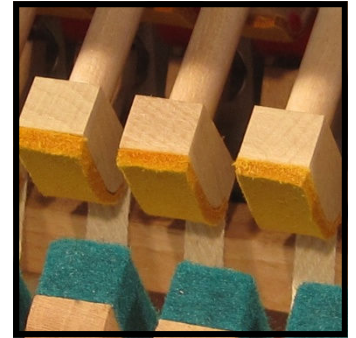
New hammer butts

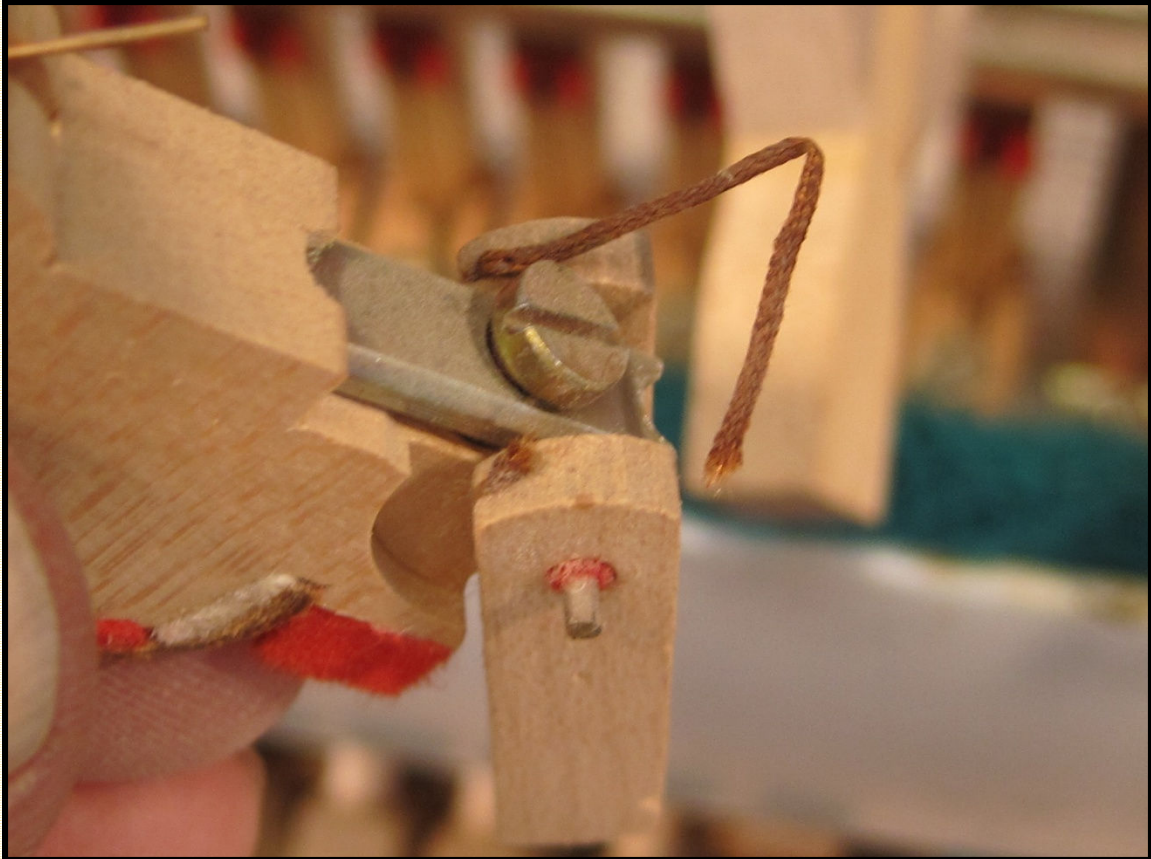
The Achilles heel of Yamaha, Kawai and other Asian-made pianos is a hammer butt assembly that relies upon a small braided cord to hold an essential spring in check. After years of use this cord is prone to breaking (as shown in photo on cover), which causes the piano action to perform unsatisfactorily.

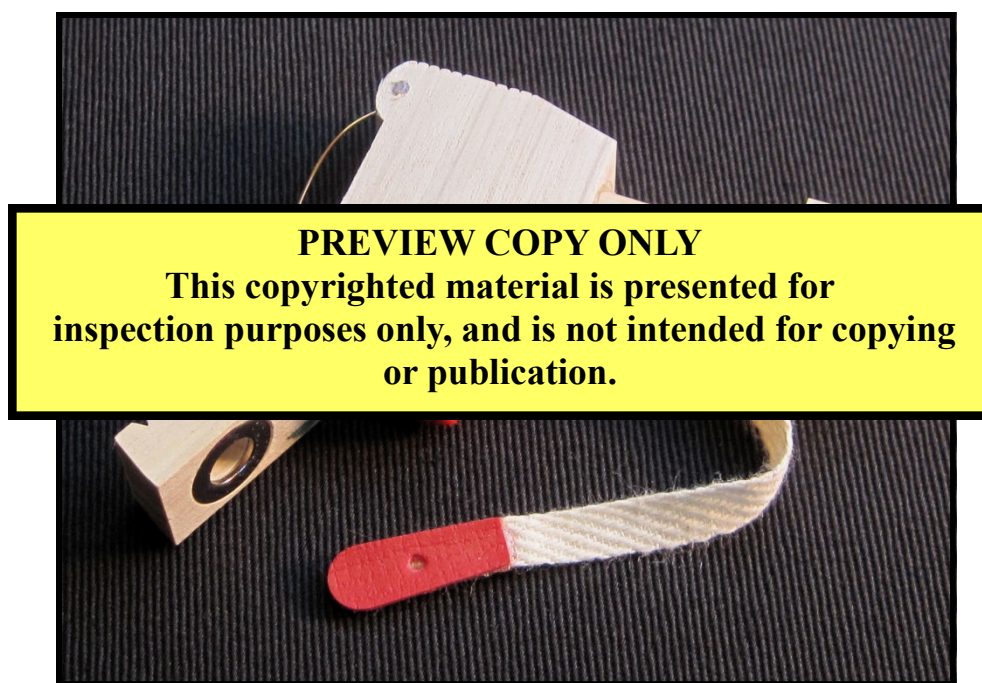
A new Asian-design hammer butt / flange assembly ready to install.

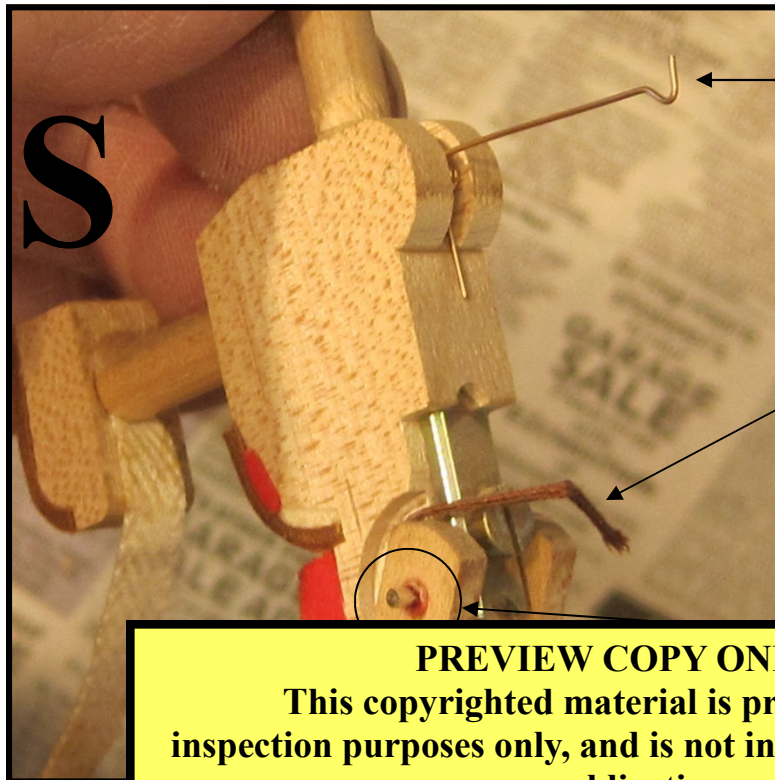
The following photos of used hammer butt / flange assemblies from a 1980s Yamaha studio upright illustrate the most common problem areas.

Hammer butt return spring: When held in check by the flange cord, this spring swiftly returns the hammer butt to its rest position so that it's ready to fire again the next time the note is played.

Flange cord: Although strong enough to hold the continuous tension of the return spring for decades, it eventually can give out and break.

Action center: The pivot point for the hammer butt. As the felt bushing and brass pin become worn, the fit of the pin loosens, causing sloppy play. The pins become loose of the wobble.

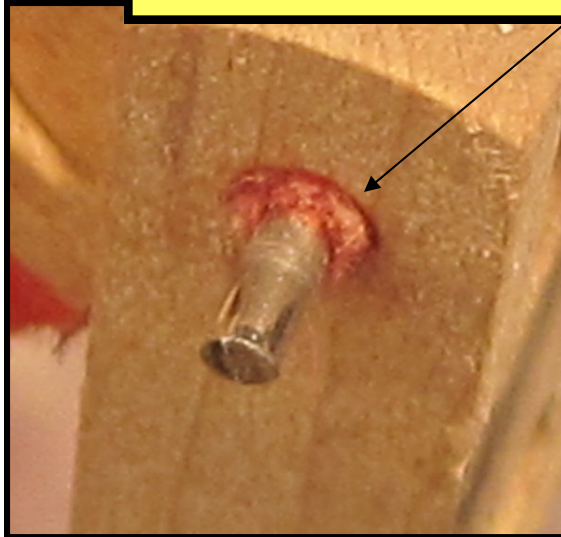
Although less obvious than broken flange cords, loose action centers also cause problems for the performance of the piano. Ordinarily, wear and tear of the felt bushing is the cause of overly loose action centers, but sometimes the brass pins themselves begin to wear away, as in the photo to the left. When an action center has thus loosened up, hammers wobble on their way up to the strings, striking less than a solid blow. In extreme cases, hammers may go off course to the point where they hit the wrong strings!

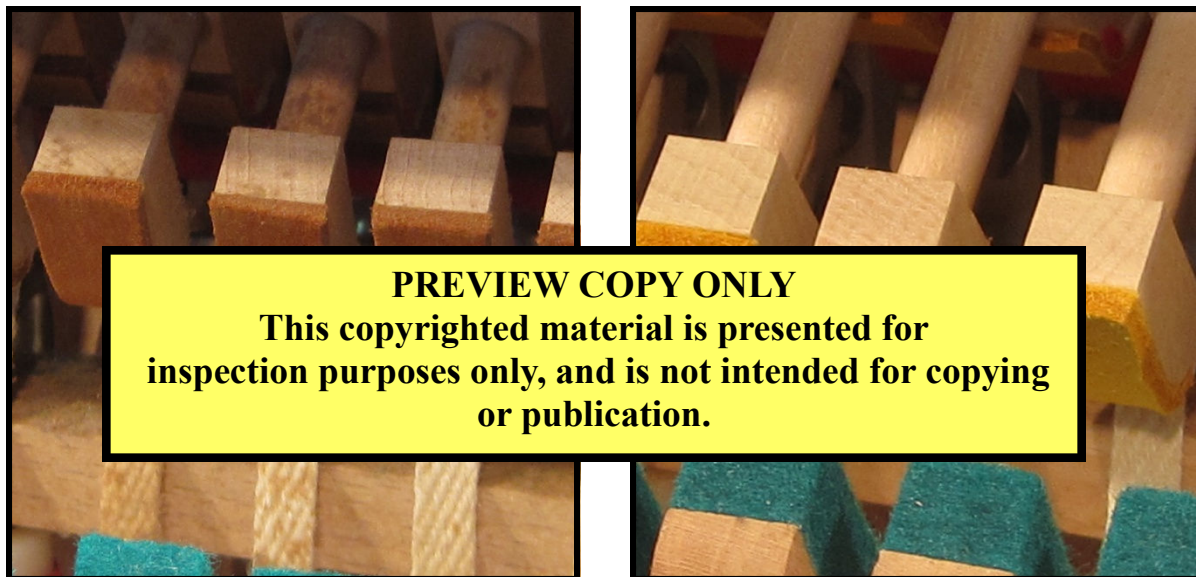
Old hammer butts

Replacement hammer butts

Consider the above photos showing a part called the catcher, which is faced with a buckskin (or similar) covering. When a note is played, this part is essential to preventing repeated strikes (called "bobbling" notes). The buckskin surface wears thin over the years, especially on portions of the keyboard which are played more heavily. In the photo on the left showing a set of original hammer butts, the buckskin covering the center catcher has worn thinner than the two adjoining catchers. The photo on the right shows the new catchers of replacement hammer butts. Not only is the buckskin covering uniform in thickness, providing a consistent cushion to the parts coming together, but it has a better ability to make a secure contact with the backchecks (the thick green felts at the bottom of the photo). The rougher texture of the new buckskin will grab the backchecks without slipping, as older, worn buckskin is prone to do.

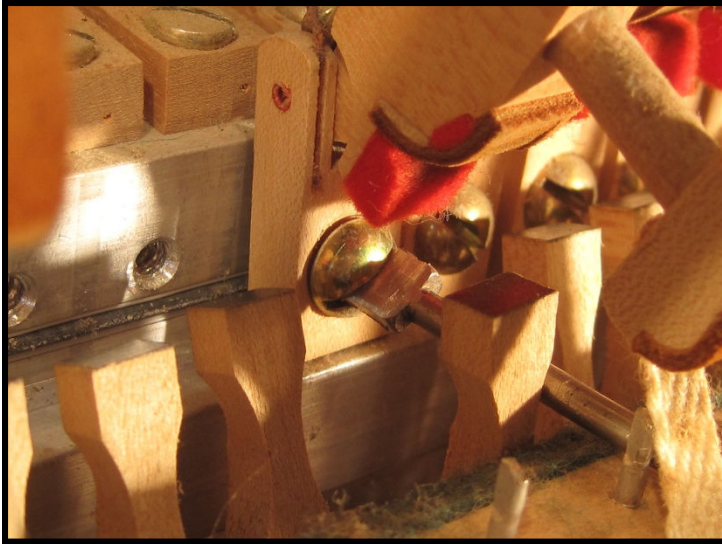
The first step is to remove the original hammer butt / flange assemblies from the piano action. These are taken from the action by carefully unhooking the bridle straps, then backing out the flange screws holding each assembly in place so that each unit may be lifted out.

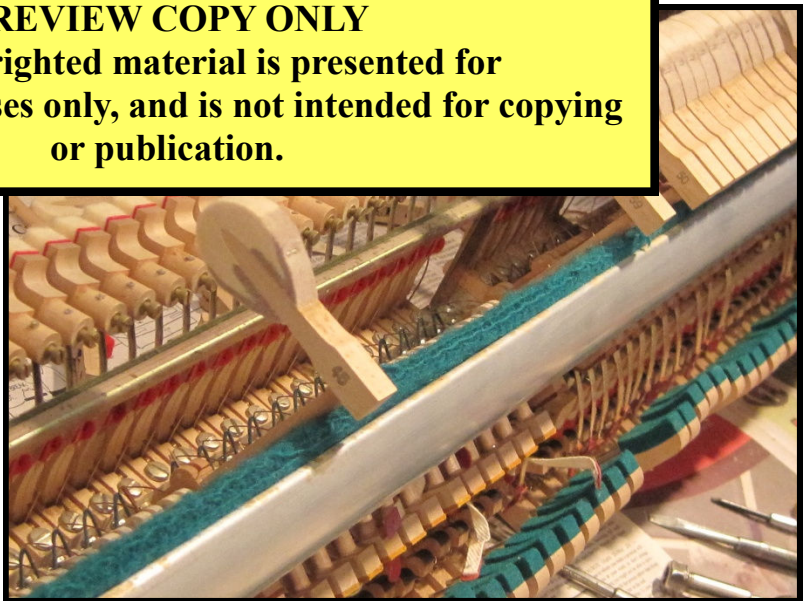
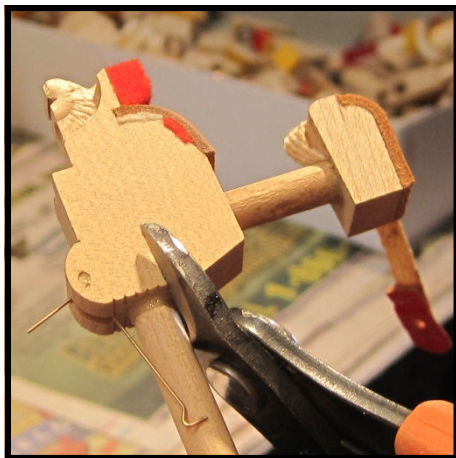
The old hammer butts are then removed from the hammer shanks, usually by using a pair cutters to cut along the grainline. Several cuts are required to remove the old part, at which time the shank needs to be cleaned of any remaining wood and glue.

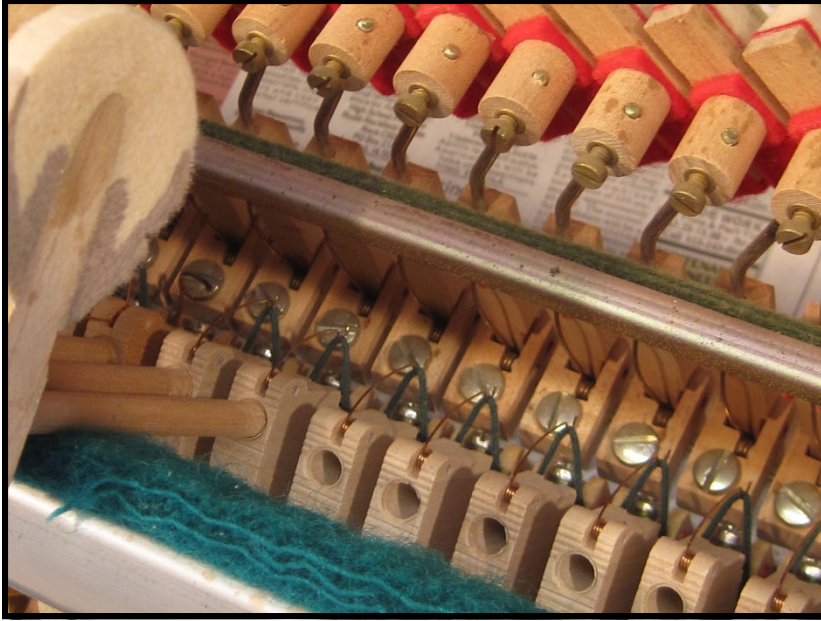
The hammer shanks are then dry fitted into the new hammer butt assemblies. With all the hammers in place, careful alignment will be done, and only then will the parts be glued together.

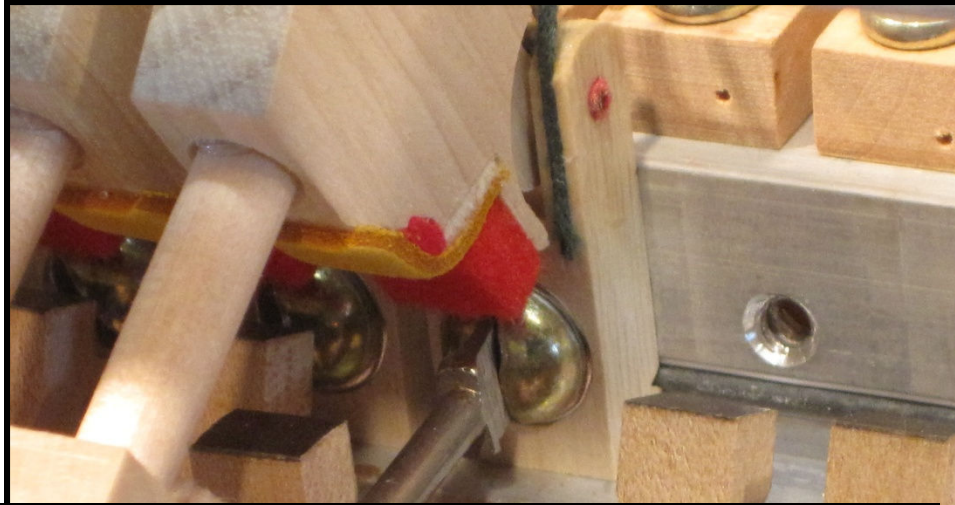
New hammer butt / flange assemblies being installed.
