The Piano Owner's Heads-Up Guide to Important Piano Maintenance

Focus On: Replacement of Worn Asian-Design Hammer Butts and Flanges

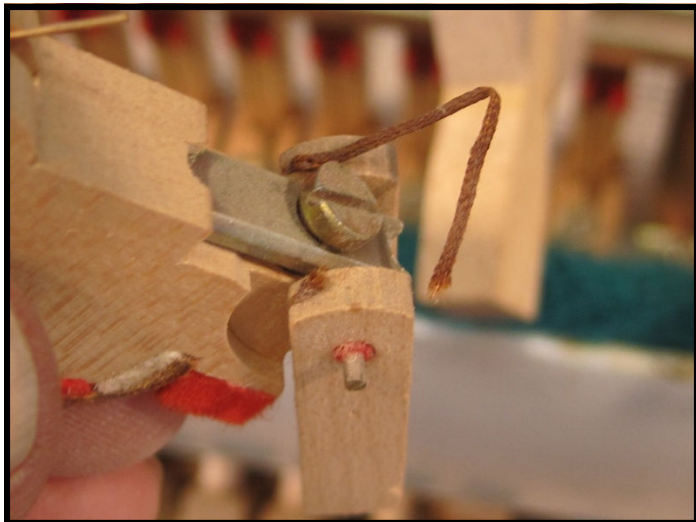
Yamaha, Kawai and other Asian-made pianos have hammer butt assemblies that rely upon a small braided cord to hold an essential spring in check. After years of use this cord is prone to breaking (as shown in photo above), which causes the action to perform unsatisfactorily.

I would suggest replacing the set of hammer butt / flange assemblies. Additionally, either shaping or filing the hammers must be done, to prevent problems caused but excessive wear to the hammer felt. Finally, to complete the repair package, voicing the hammers and regulating the action is necessary to bring the piano up to its potential.
