The Piano Owner's Heads-Up Guide to Important Piano Maintenance

Focus On: Brass Rail Repair

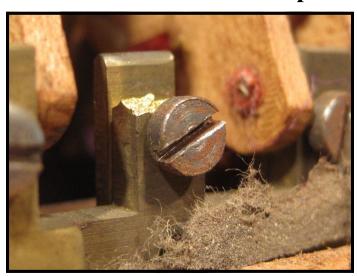
Replacement butt plate

When a butt plate breaks, the break is nearly always in line with the threaded hole which is intended for a machine screw to affix the butt plate to a tongue of the brass rail.

Individual butt plates may be replaced, but if more than a couple have broken the most practical repair may be to replace the complete set while the action is out of the piano. Once done this problem area will be taken care of for the foreseeable future.

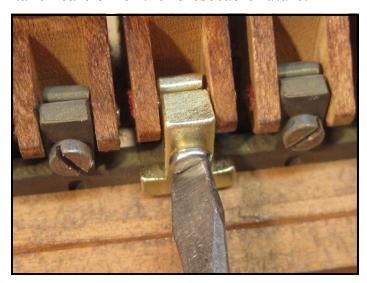
Repair clip for broken tongue being installed.

If a tongue of the brass rail has broken, a brass repair clip may be installed (above photo). Note: If upon inspection the total replacement of the brass rail seems advisable (due to a large number of broken tongues) you will be consulted.
