The Piano Owner's Heads-Up Guide to Important Piano Maintenance

Focus On: Splicing Broken Grand Hammer Shanks

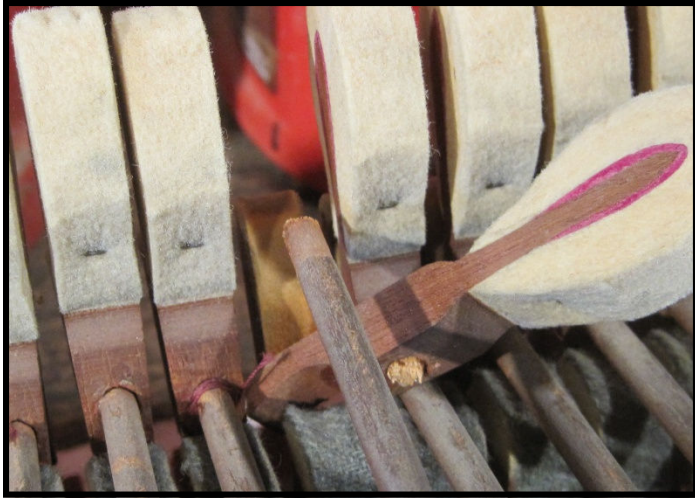
Grand piano hammer shanks are subjected to continual stress as the piano is being played, and upon occasion will break, usually in a section of the keyboard that is used most frequently. When this happens, as shown in the photo above, at least one note (sometimes more) quit working suddenly, and a repair is needed. **Your piano has broken shank/s needing repair.**

When the break in the shank is a long one (think of a pencil that has split apart) it may be possible to join the two halves together and reglue them. However, if the end of the break is more or less blunt, it is necessary to either replace the shank with a new one, or repair it with a splice.

Splicing the shank is an option which gets the piano up and running again, and is useful especially in situations where replacements for the old flanges are either not available, or need to be specially ordered. Done well, a repair splice will last for as long as needed.

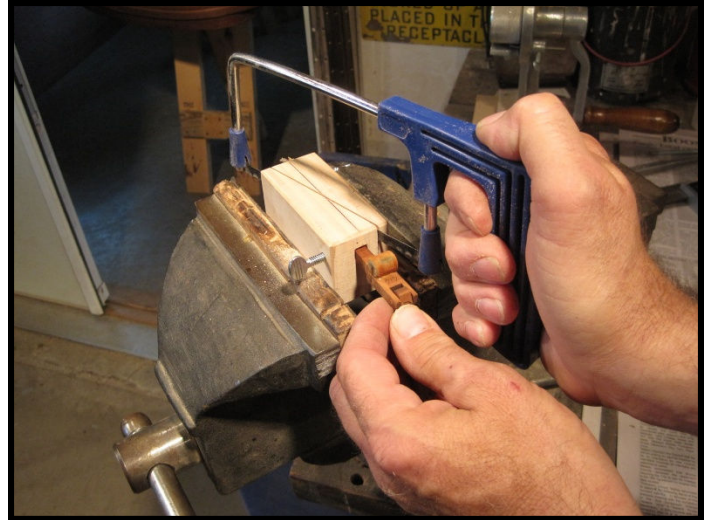
Special sawing jig required.

To make this repair, the action does need to be removed from the piano and is ordinarily transported to the workshop. While the action is in the shop, it would be an appropriate time to consider having other work done as well. If the hammers need shaping, or the action is in need of regulating, this would be the ideal time to consider having that type of repair completed.

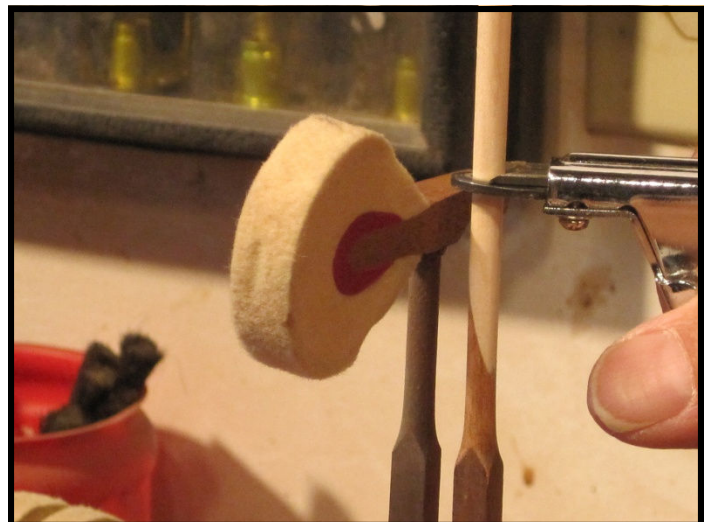
Newly spliced shank being cut to length.
