Small Shop - Big Results
Grand Action Reconstruction – Part 3
(Placement of Heels and Measurement for Risers)
By Chuck Behm
Central Iowa Chapter

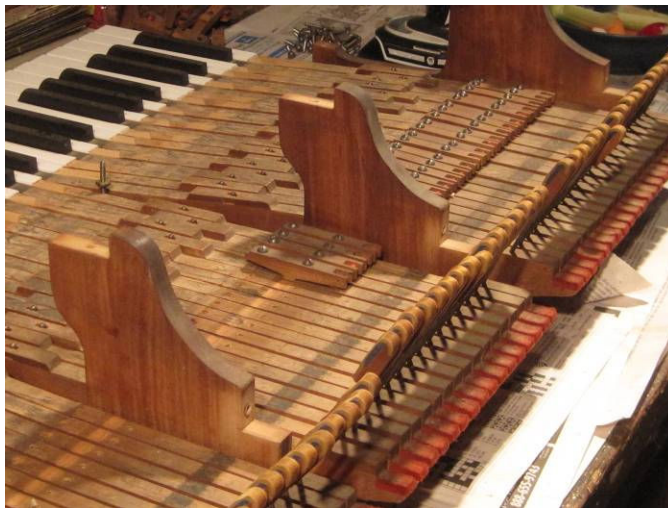
Photo 1: What to leave in, what to take out?

In rebuilding this action, I needed to make decisions about what parts would be replaced, what parts would be kept but repaired or modified, and what parts would be saved as is. The wippens, hammer shank / flange assemblies along with the hammers themselves, rocker arms / sticker assemblies (being removed, in Photo 1 above) and the backchecks would all be removed and replaced. The wippen rail and keysticks were kept, but modified. The keyframe, wooden action brackets, and hammer flange rail remained untouched.

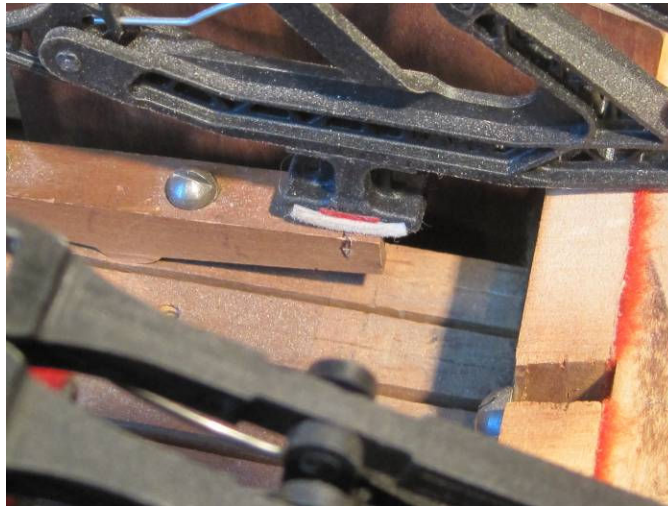
Photo 2: Aligning the heels.

I felt a good starting point for replacing the rocker arm assembly would be to position the new wippen heel to match the alignment of the original set-up. To do that, I put one of the rocker arms that I had removed back onto its position on a keystick, then screwed the wippen rail onto the action brackets with a couple of wippens removed for visibility. A pencil line marked where the center pin connected the rocker arm to the sticker. I put a heel in place and adjusted its position until the center of the felt was on the center of the line (Photo 2).

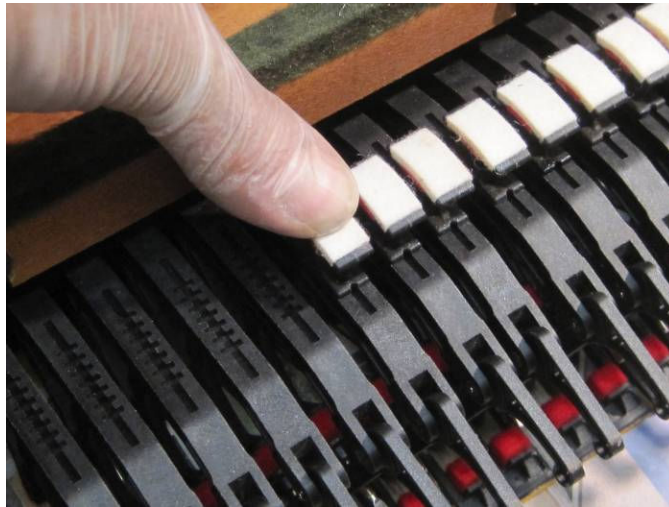
Photo 3: Gluing the heels.

The heels were cemented in place with C.A. glue. Notice the 7 slots in the underside of the wippen (Photo 3), for which there is corresponding offset positioning tab on the bottom of the heel. This system gives the technician a total of 14 positions for which the heel may be placed at and makes it easy to get each heel at exactly the same position on the wippen. No guesswork involved – a nice job of engineering, in my opinion.

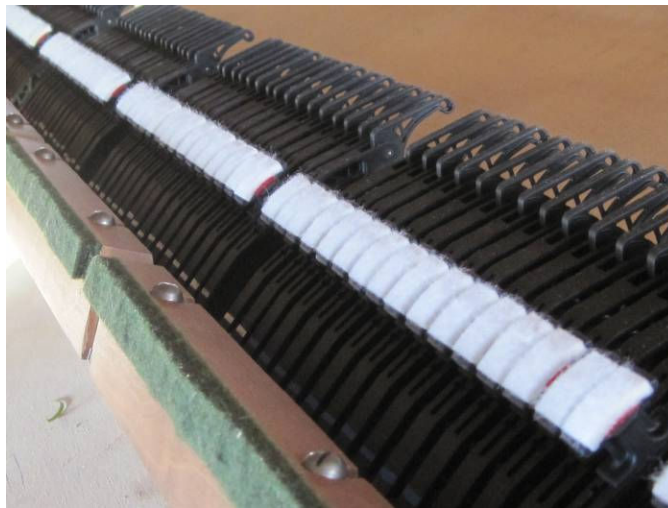
Photo 4: A chorus line of wippens with their heels up in the air.

Once the heels were all in place (Photo 4), work on the wippens was for the time being complete. I could now get to what seemed at the time to the more challenging step—modification of the keysticks to take up the excess space between the capstan and the heel.

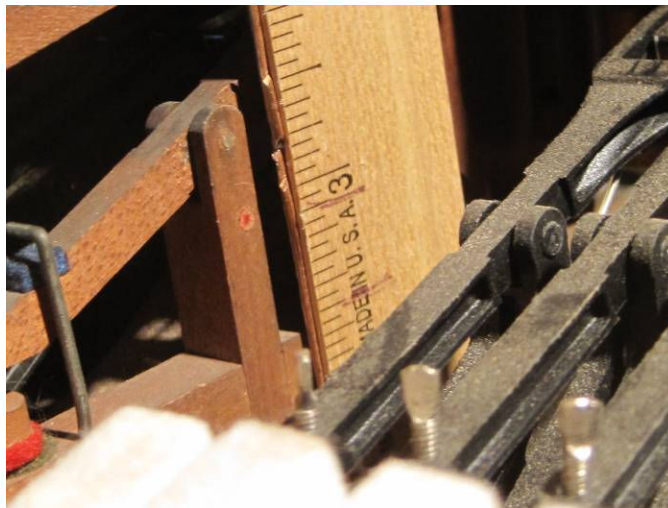
Photo 5: Measuring the center pin height.

I first reassembled an entire rocker arm / sticker / whippen assembly to measure the height of the action center for the repetition lever flange from the top of the keystick for that note. In that my intention throughout this process was to replicate what was in the piano originally, I wanted to make sure that the new capstan / heel arrangement would allow the wippens to stand at the same height as they did with the old action parts.

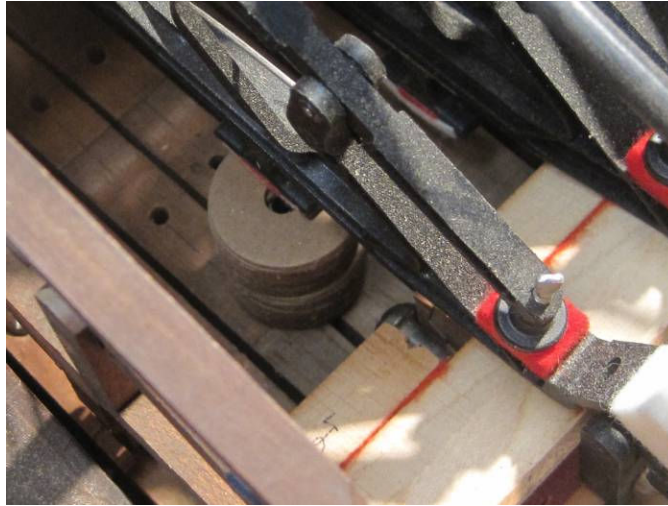
Photo 6: A tower of punchings.

Next, I used a stack of thick front rail punchings to build up the height of a new wippen / heel over the tops of the keysticks (Photo 6). This method made adjusting the height of the test wippen up and down easy by simply adding or subtracting punchings.

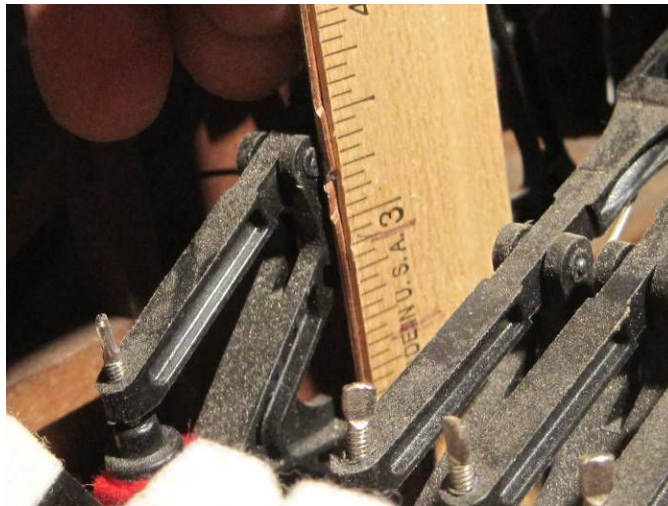
Photo 7: Bringing the new part up to the correct level.

When the exact number of punchings needed to bring the action center of the new wippen up to the target level were ascertained (Photo 7), the punchings were removed for measurement.

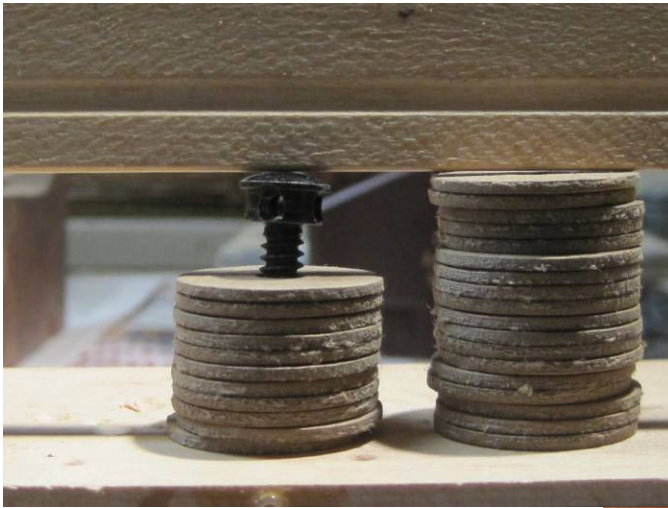
Photo 8: The stack of punchings with and without capstan.

With the number of punchings needed to fill the space determined, the rest was simple. I made a second, shorter stack of punchings with a capstan protruding from the center holes so that the top of the capstan lined up with the top of the original stack (Photo 8). I made sure that an appropriate amount of thread was showing (so that the capstan would be adjustable up or down), and then measured the thickness of this second stack (Photo 9).

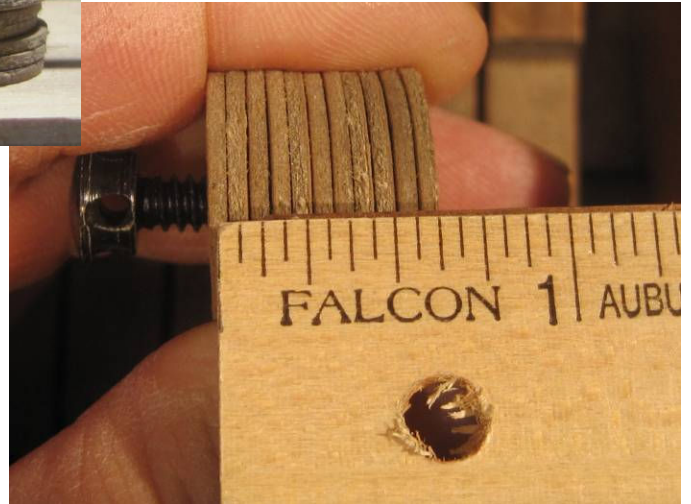
Photo 9: The critical measurement.

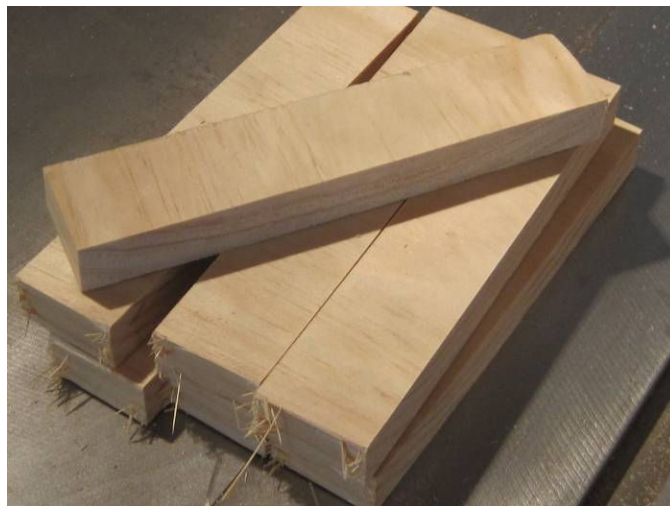
Photo 10: Material for risers, planed to thickness.

With a measurement of 5/8" in hand, I then planed down enough 1" yellow pine stock to make the set of risers (Photo 10). The production of the risers in preparation for the installation of new WNG capstans will be the topic of next month's installment. Until then, best of luck with your own challenging projects. Stop by the shop anytime. The coffee pot's on.
