Small Shop - Big Results  
**Grand Action Reconstruction – Part 5**  
**(Installation of Capstans and Backchecks)**  
By Chuck Behm  
Central Iowa Chapter

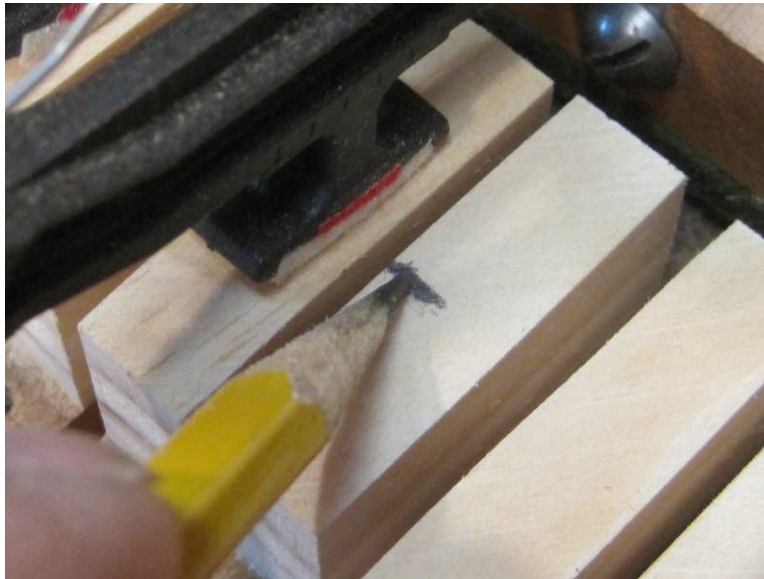
*Photo 1: Another line to mark.*

Before drilling pilot holes a line needed to be drawn to mark the location for the capstans. With the keysticks in place on the keyframe, I temporarily installed the wippen rail in place, screwed it down tightly, and marked a pencil line where the center of the wippen heels made contact with the risers (Photo 1). I did this near the outer end of each set, then removed the rail with the wippens, and used a ruler to make a line on each of the risers from one end of the keyset to the other.

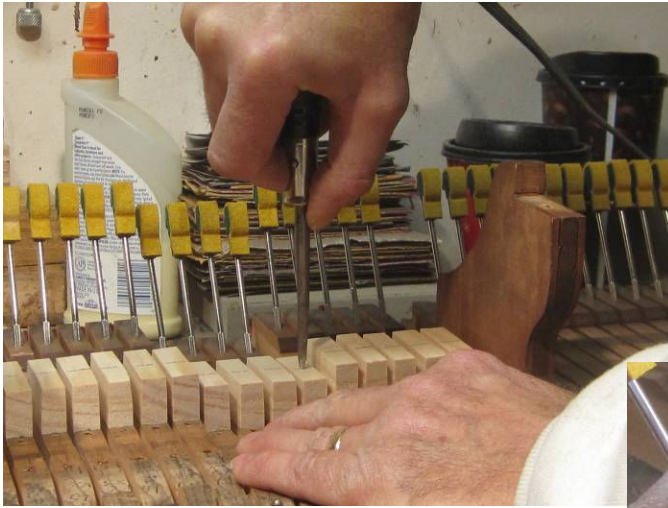
*Photo 2: Marking the center point.*

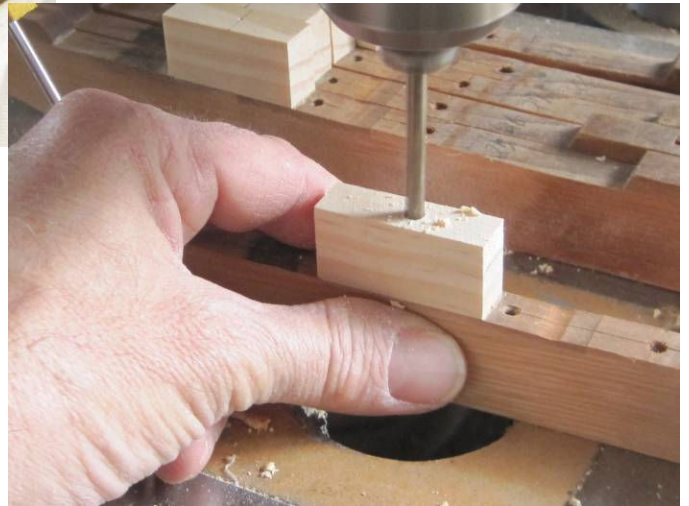
*Photo 3: Drilling on the drill press.*

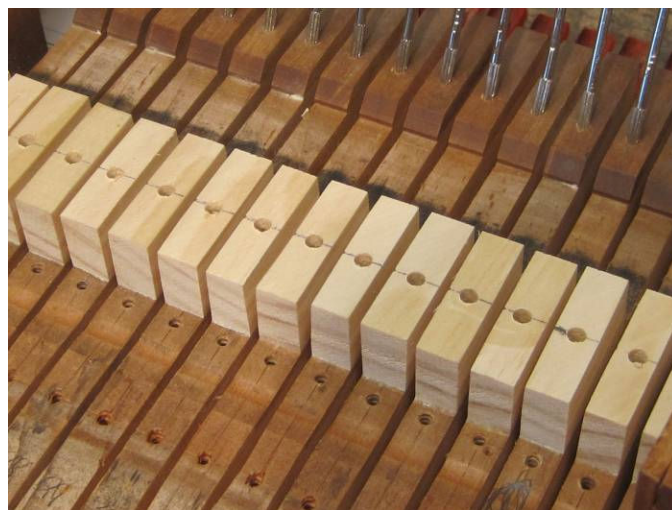
*Photo 4: Pilot holes.*

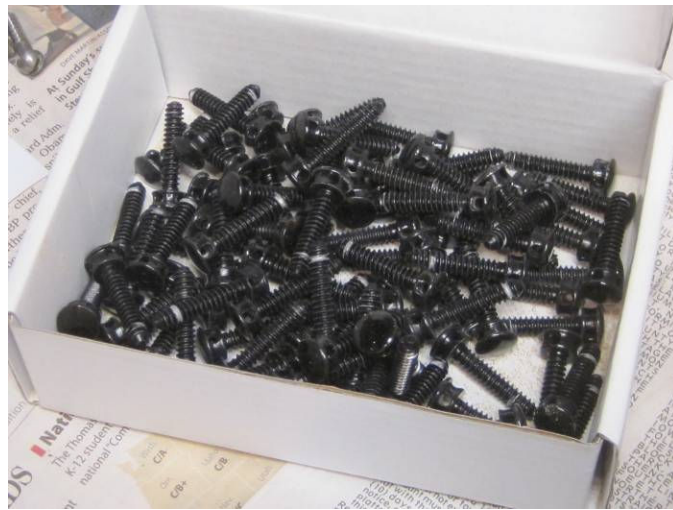
*Photo 5: Box of capstans from WNG*

The capstans were from WNG, meant to compliment other WNG parts. Although I have always worked with brass capstans, I had read over the literature concerning the manufacture of these capstans, and was very willing to give them a try. According to WNG, these capstans are made from aluminum—much lighter ( $1/3$ ) than brass. The capstans are anodized in a process that coats them with a hard surface of aluminum oxide. This surface is then given a high polish which will never tarnish and which will provide a long-lasting slippery surface to make contact with the repetition cloth of the wippen.

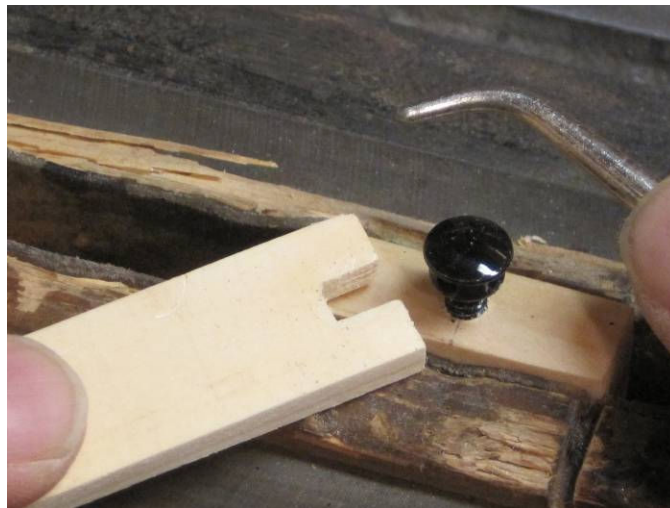
*Photo 6: Depth gauge.*

In order to get the capstans in the ball park of where they would end up, I improvise a little depth gauge of sorts (Photo 6) and proceeded to use a regulating tool to turn each capstan down. Although the material and finish of the capstans are a new idea, their shape is very familiar- nothing that you would need a special tool for.

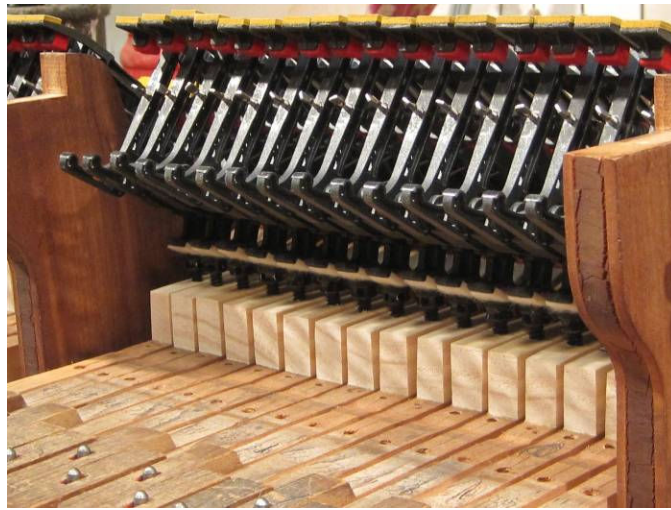
With the capstans in place, I installed the wippen rail once again, and delighted in the simple efficiency of the capstan / riser system. Sometimes, simpler is truly better, and I'm convinced this is one of them.

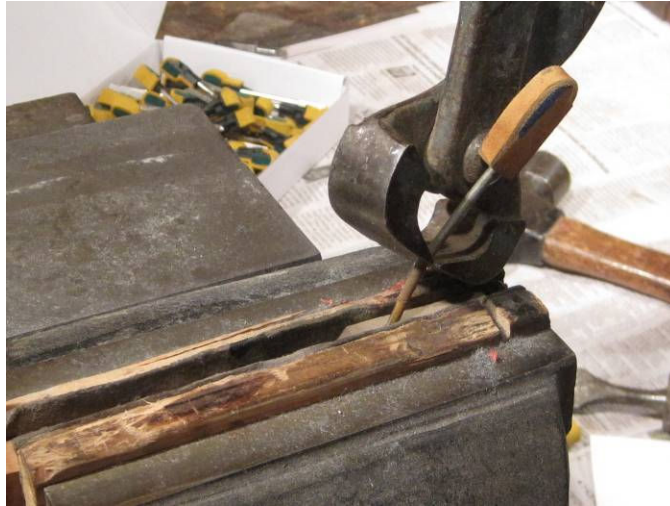
*Photo 9: Removing the old wires.*

The WNG manual recommends using a pair of side cutting wire cutters to grasp the old wire and a 1/2" dowel as a fulcrum to rotate the cutters on. The nail remover I used worked essentially the same and pulled the old wires out without a problem (Photo 9).

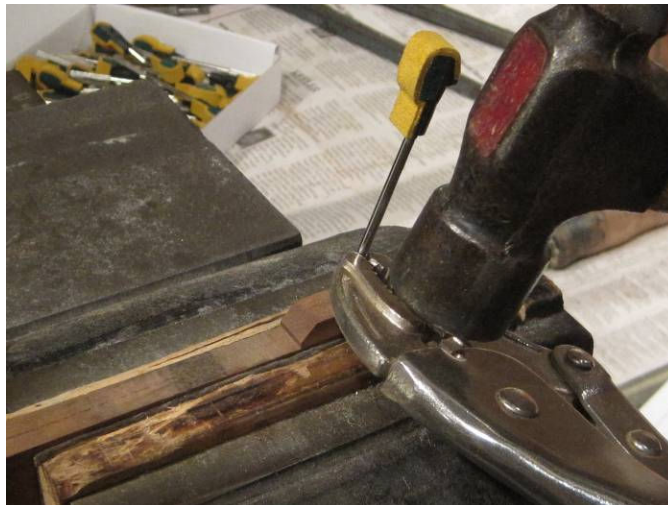
*Photo 10: I can see heads shaking at WNG. "Nooooooo! Not that way!!"*

After that point, however, my methodology (if it merits that label) was much too simplistic, using nothing more than a pair of Vise-grips and a hammer to install the new wires in the old holes (Photo 10). The procedure as laid out in the manual is very detailed, very precise, and sure to give the absolute best results. Follow those procedures. Although in the end, there have been no problems with the backchecks doing their job in the Weber action, I think that is more a result of dumb luck on my part, and good design of the backchecks on the part of WNG.
