Small Shop - Big Results
Grand Action Reconstruction – Part 6
(Installation of Hammer Shanks and Knuckles)
By Chuck Behm
Central Iowa Chapter

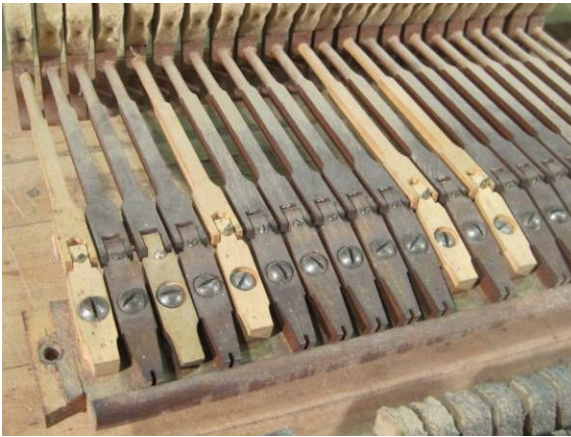
Photo 1: Original parts

The brittleness of the original action parts was clearly evident when I first pulled the action from the piano for a careful look. The number and variety of replacement shanks and flanges on the old action was an indication that parts had been breaking on a regular basis for quite some time. The replacement of the entire set of shanks and flanges, along with the other components of the action prone to breakage, was to me the only sensible course of action.

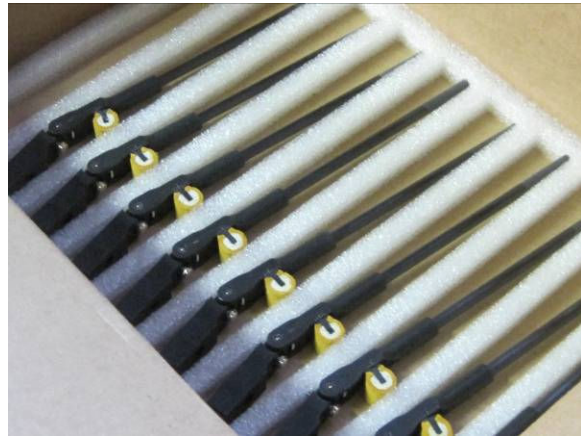
Photo 2: Replacement parts

The new shanks and flanges had been ordered at the same time as the wippens, and were still in the box they came in. Opening the box up now for the first time, I was impressed by the quality of the parts and more anxious than ever to see them installed in the piano.

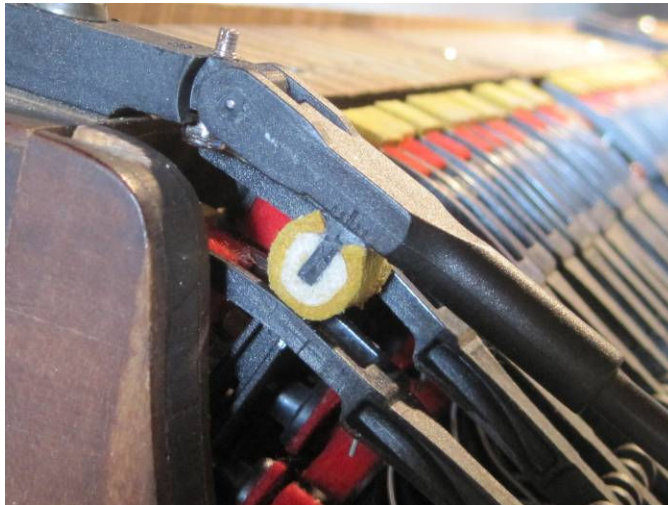
Photo 3: Positioning the knuckle.

The WNG knuckles, much like the wippen heels discussed in an earlier segment, are made to fit in a several positions. The markings along the side of the shank where the knuckle goes are meant to provide a reference point for the technician to make sure that they are all installed identically. Once I had determined the desired placement for the knuckle (Photo 3), I was ready to glue them in place.

Before installing the hammer shanks, I needed to glue the knuckles in place. I positioned the hammer shank rail on the action brackets and screwed it in place. (Hmm, is that the rumble of thunder I hear off in the distance?) I then put one flange / shank in its spot and screwed it down to check where the knuckle should be glued.

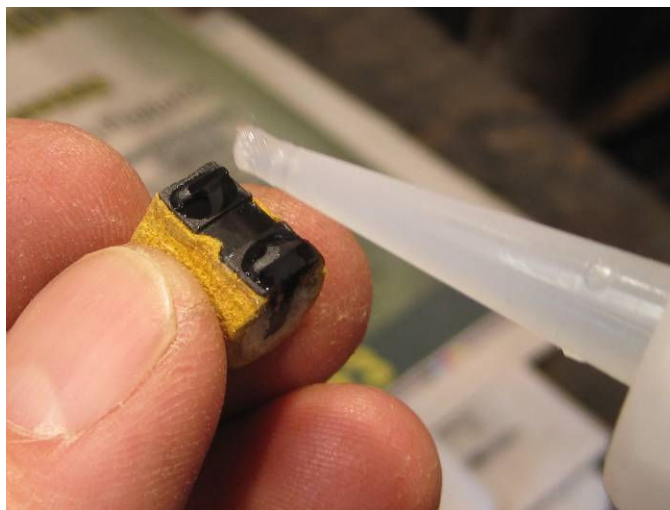
Photo 4: Application of glue.

This time, at least, I had called WNG to make sure of the gluing technique for attaching the knuckle (Photo 4). I used the correct CA glue in the correct amount (“a little dab will do ya.”[and if you’re too young to understand that reference – Google it!])

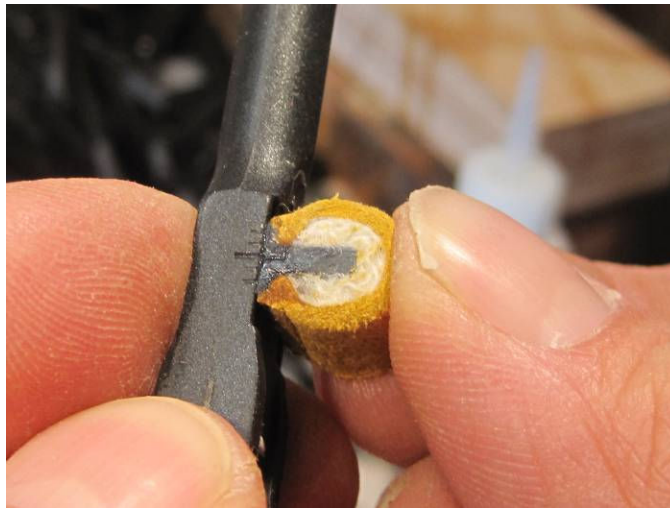
Photo 5: Applying pressure.

With a couple of drops of glue on, I then applied pressure for approximately 30 seconds. (Latex gloves would be an excellent idea in this situation – were my box of gloves not empty I would have had some on myself.)

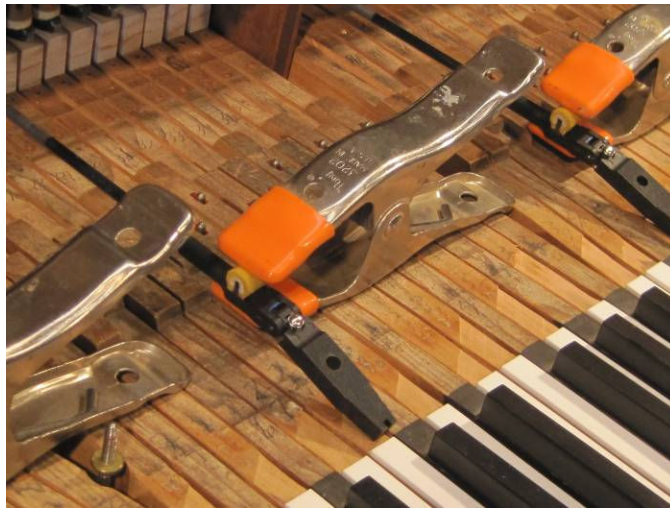
Photo 6: Too much?

In what I suspect amounted to overkill, I then applied clamps to the knuckles for another 10 minutes or so (Photo 6). These medium strength spring clamps would probably not be condoned by WNG, but I imagine smaller clamps would be a good idea. I did have the presence of mind to try this on a spare shank and knuckle first (the Weber is short of 88 notes), and found no noticeable change to the shape of knuckle.

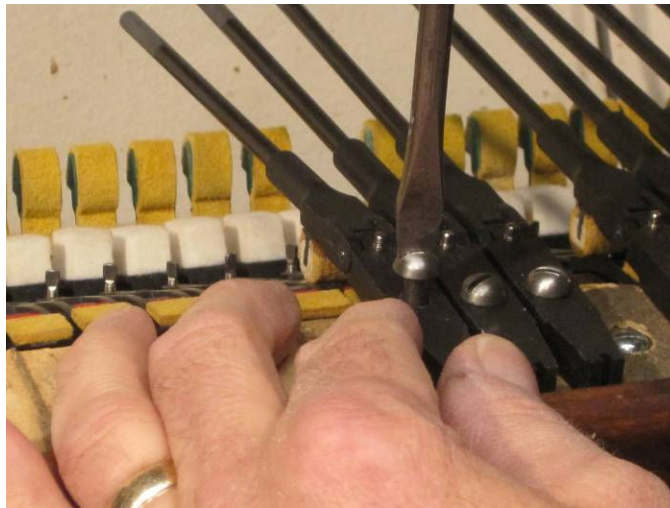
Photo 7: Screwing down the flanges.

With the knuckles affixed, I began screwing the flanges down to the hammer flange rail. I hadn't replaced the sandpaper covering the surface to which the flanges were attached (as I had for the wippen rail), and was feeling a bit guilty about it. As it turned out, my worry about that small detail was to be overshadowed.

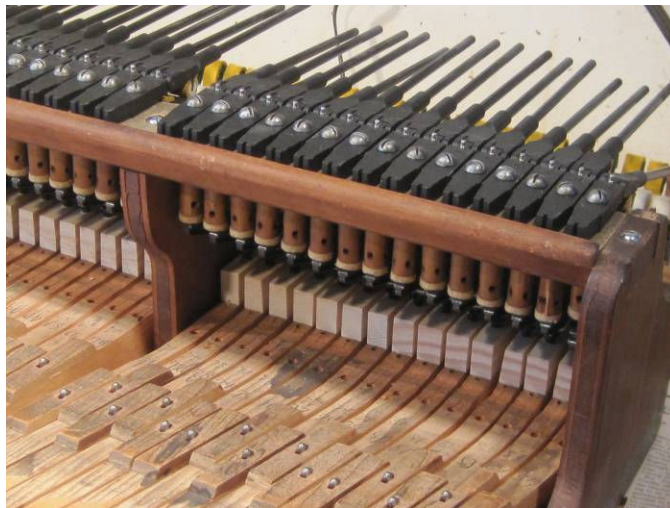
Photo 8: The cloud slips over the horizon.

It was at this moment, with the entire set of hammer flanges installed, that I finally took a moment to look things over. Looking underneath the hammer flange rail, I noticed a funny thing about the jack / let-off button alignment. There wasn't any! The toe of the jack was not only not aligned with the center of the let-off button felt, it wasn't even hitting the felt!!

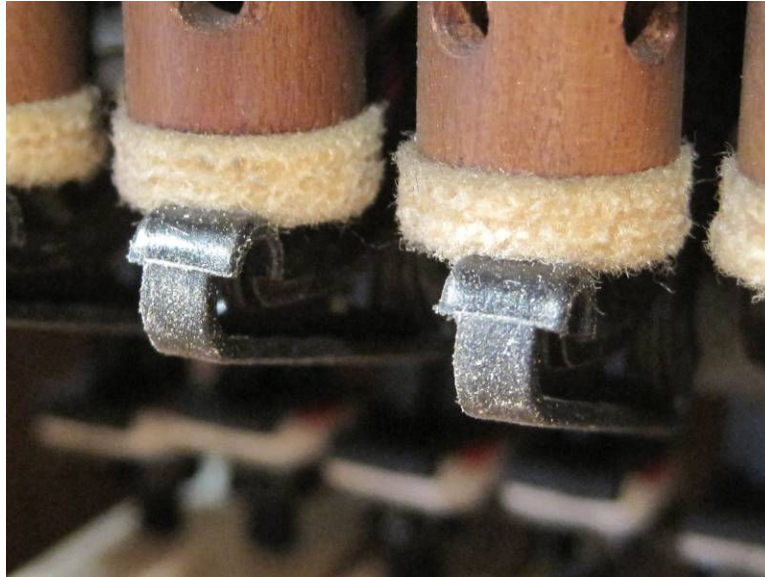
Photo 9: There's trouble – right here in River City!

There have been moments from time to time in operating my shop that I have questioned my intelligence. This was definitely one of those moments. I thought back to when I had looked over the new WNG parts over and had noticed what seemed to be a slight difference in the dimensions of the jacks – the end of the toes didn't line up perfectly with the original jacks. From that moment in time to this moment in time, I hadn't given this fact a second thought. "WHY NOT!" I asked myself.
