Small Shop - Big Results
Grand Action Reconstruction – Part 7
(Realignment of Let-Off Buttons)
By Chuck Behm
Central Iowa Chapter

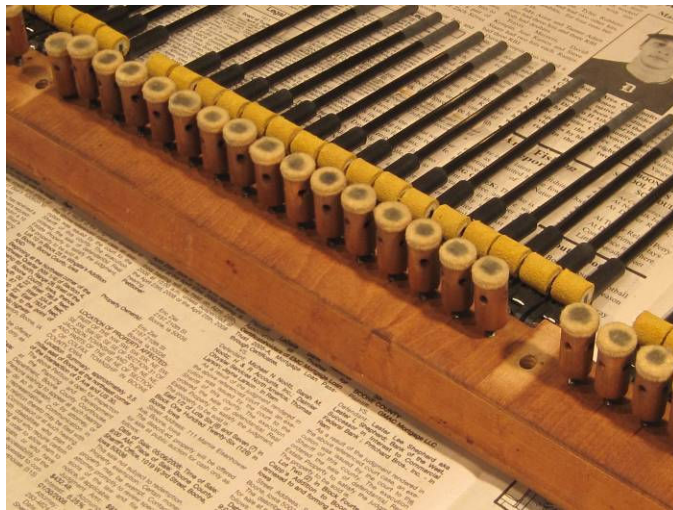
I therefore tried applying that mind-set to this particular problem and imagined the repair done, with all the jacks lining up ever-so-nicely with the let-off buttons. What I needed to make this happen was a plan. I removed the rail with the let-off buttons and hammer shanks attached from the brackets to mull things over.

Photo 1: Decisions, decisions.

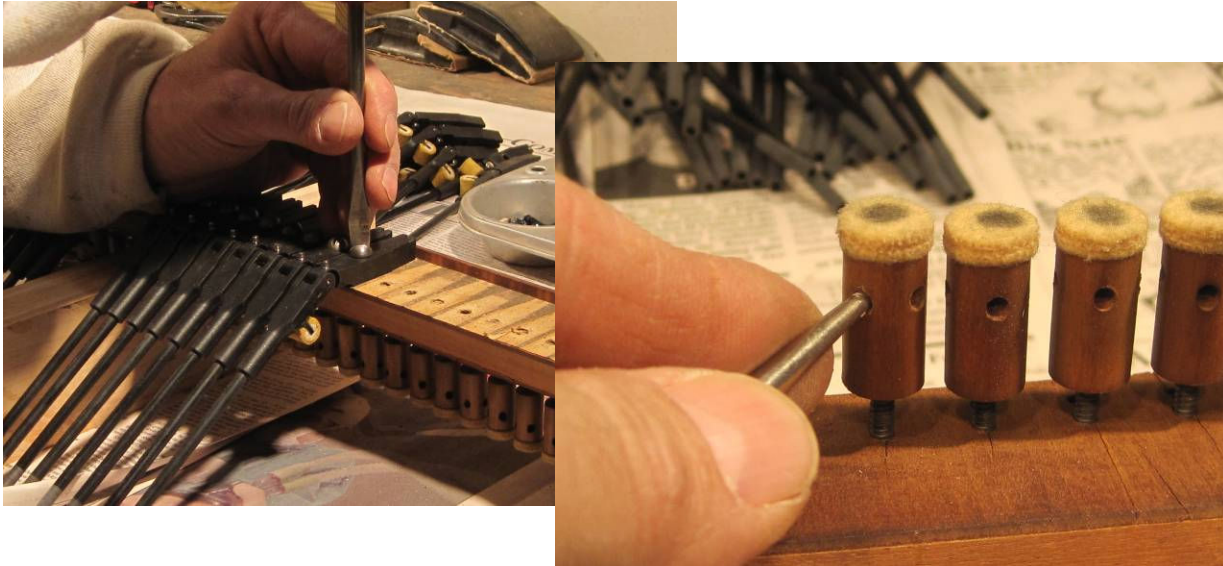
Photos 2, 3: Two steps backwards

With a sigh, I began removing the hammer flanges from the rail. The good news with this was that now I could peel off the sandpaper that I had felt guilty about leaving on. Once the hammers / flanges were all removed, I flipped the rail over and used a regulating tool to begin backing off the let-off buttons. These were, I learned quickly, both tight on the threaded shaft, and brittle, with a number of them breaking upon removal.

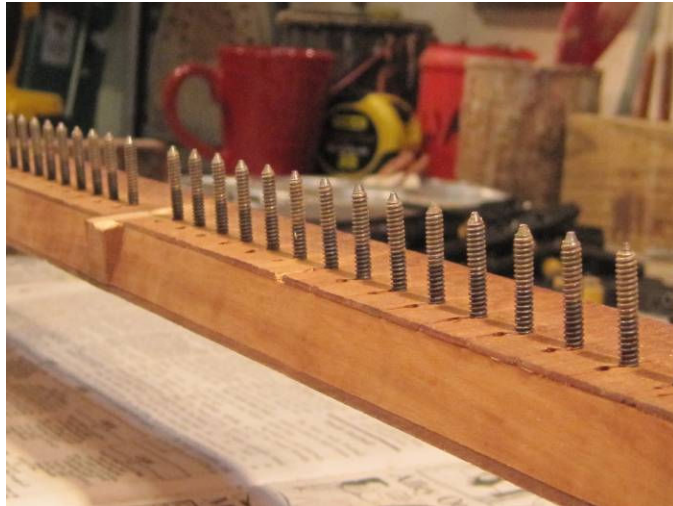
Photo 4: Down to the bare bones.

In less time than it took to watch a movie on my VHS player, I had all the parts removed from the rail with the exceptions of the posts that the let-off buttons had been screwed on to. An easy job for after lunch, I remember thinking.

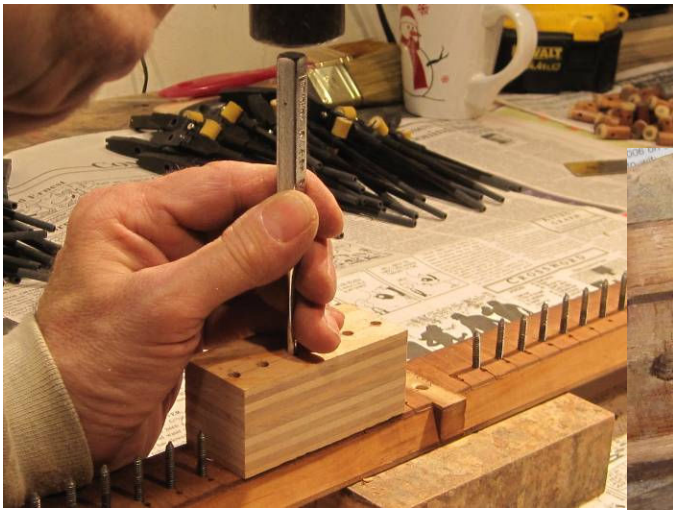
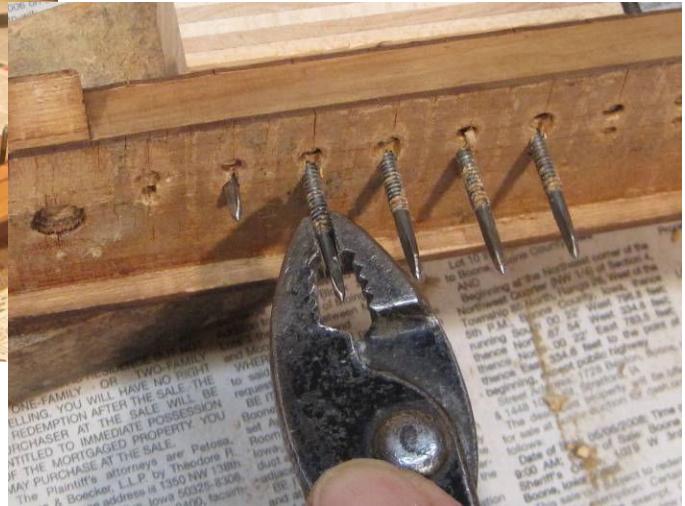
Photos 5, 6: A headache in the making.

The first thing I tried when I got back to the shop was to fish a pair of tiny nuts from my collection to lock together on the end of the threaded post to give me a spot to lock onto with Vise-Grips and pull. This plan went nowhere. The threaded posts were beyond me to simply yank out.

Plans B and C met with failure as well. Finally I decided to try pushing instead of pulling. I made a jig that would fit over 6 posts at once (Photo 5), drilled for a punch to fit into on the top end, and pounded the posts through the top side of the rail. I then was able to use a pair of pliers to pull the posts all the way though from the other side, spade end first (Photo 6). Pretty? No. Effective? Yes.

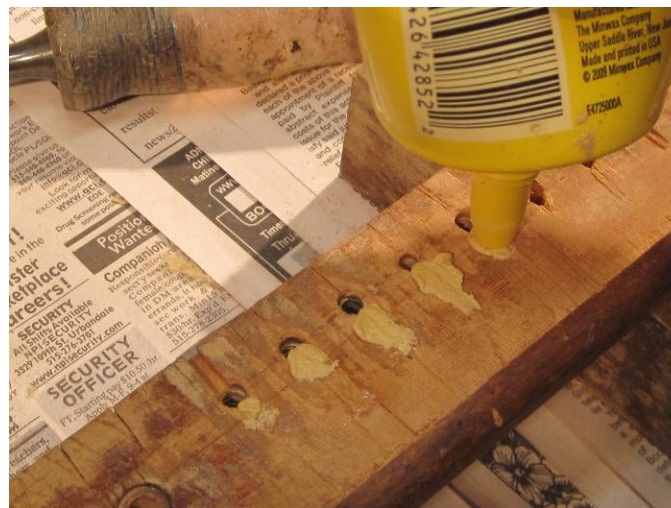
Photo 7: Repairing the damage.

With the entire set of post removed, I set about repairing the damage. As I filled the old post holes with filler, the old “Where do you draw the line?” dialogue began through my head. Should I be plugging these holes with dowels? I suppose, but also I realize that I would at some point in the foreseeable future I would like to have this piano finished. I used filler and took the dog for a walk while it dried. Upon returning to the shop, I sanded the rail smooth.

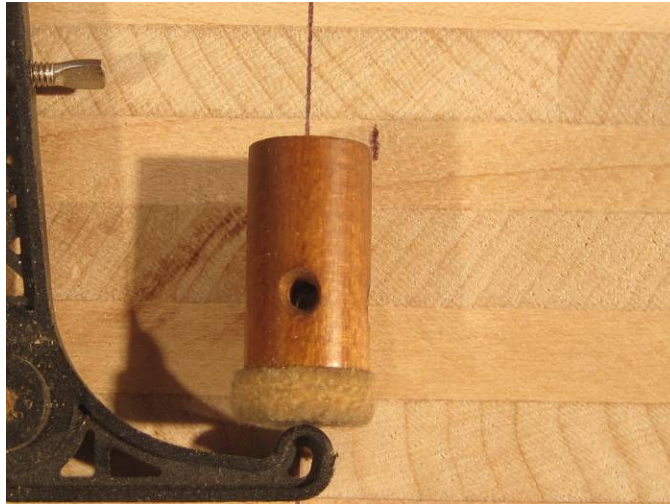
Photo 8: A careful measurement, to say the least.

One step remained before drilling the new post holes, and that was to take a careful measurement of exactly how far to move the posts. I lined up a let-off button in reference to a jack in the position that the average capstan had been lined up before and drew a line along the edge of the button. I then repositioned the button centered on the toe of the jack, and drew a second line (Photo 8). I measured that distance, to determine how far from the center of the old holes I would be drilling. I marked that distance as a line along the rail and then marked in cross lines using the position of the old hole as the reference (Photo 9).

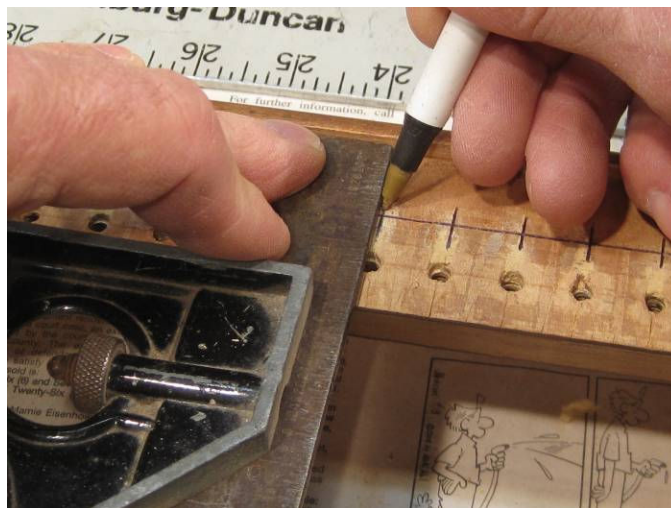
Photo 9: X marks the spot.

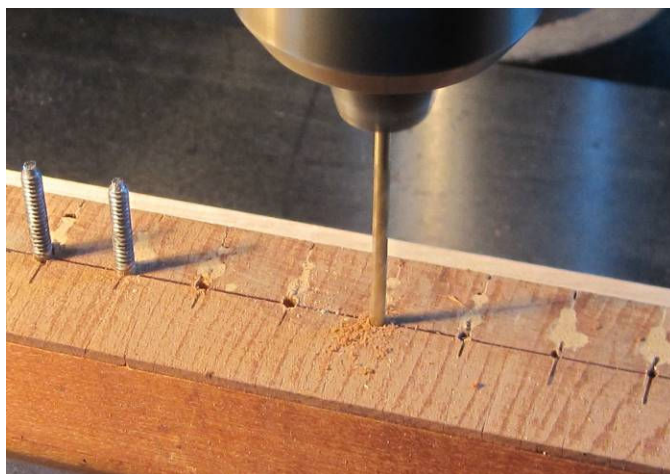
Photo 10: Pilot holes.

New pilot holes were then drilled. Before this picture was taken, I did double check the placement of the holes by drilling all the way through with a small bit, then screwing the rail back in place and making sure that the bit, when pushed through from the top, lined up with the toe of the jack. It hit the toe square on. One would hate to go to all this trouble, only to find that the buttons were now too far the other way!

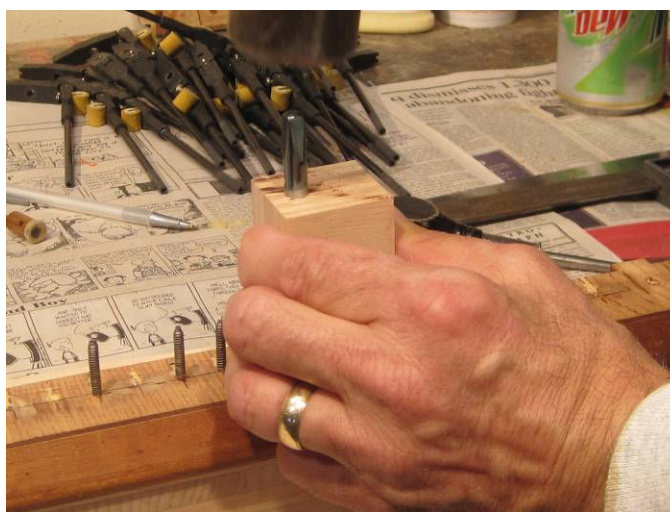
Photo 11: Reinstallation of the posts.

The jig for reinstalling the posts was slightly different than the one used to remove them in the first place. A small diameter hole that a post could just drop through was drilled through a piece of scrap pinblock material. Then, from the top, a larger hole was reamed out following the smaller hole so that a tuning pin would be able to drop down to the height required for driving in the posts. The post was then held in place over the pilot hole, and given a starter tap so the spade end was driven in just a bit. I then lowered the jig over the post, drop in the tuning pin, and pounded the post down to the correct depth by hammering on the end of the tuning pin.

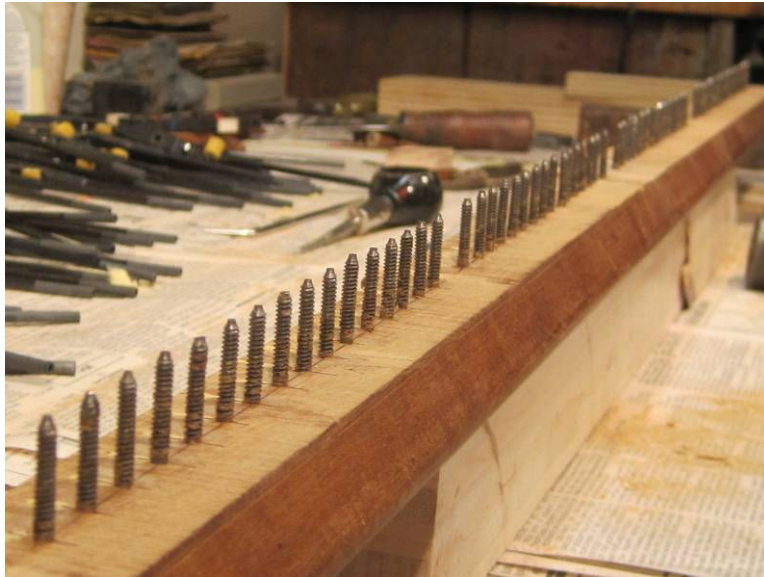
Photo 12: Back to normal.

Finally, with everything back together (to a degree, at least) I was able to knock off for the evening.
