Small Shop - Big Results  
**Grand Action Reconstruction – Part 8**  
**(Replacement of the Original Let-Off Buttons)**  
By Chuck Behm  
Central Iowa Chapter

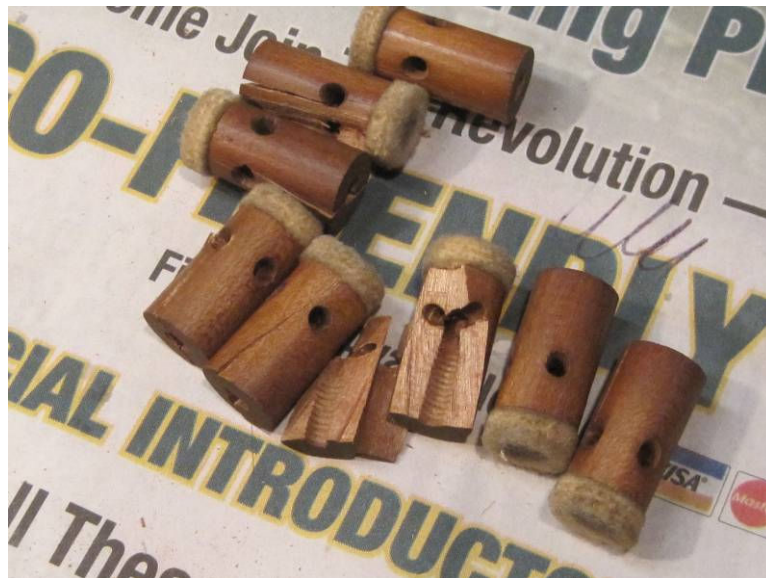
The old let-off buttons, however, did not want to cooperate when it came to being put back on the old posts. At a rate of approximately one of every four buttons, they cracked in half when pressure was applied to twist them back on.

I tried various approaches to putting them on. I scrapped the idea of reaming the holes out after I tried it on a couple buttons and found that redrilling even slightly produced too loose of a fit – the buttons could be easily turned on with my fingers only. I attempted to keep pressure on the button with the fingers of my left hand while slowly turning the button onto the post using the capstan screw regulating tool with my right. Upon the third try using this method, the button broke so completely that it fell off the post altogether in two pieces (center button in Photo 1 below).

*Photo 1: Not out of the woods yet, I'm afraid.*

By the time I had installed one section of buttons on the posts, I had a collection of eight broken buttons. This did not bode well. The problem, I decided, was not in the size of the pilot hole for the threaded post, nor was it in the method of putting the buttons back on. The problem was that the buttons, like the rest of the parts of the action, were over a century and a quarter old, and they were brittle.

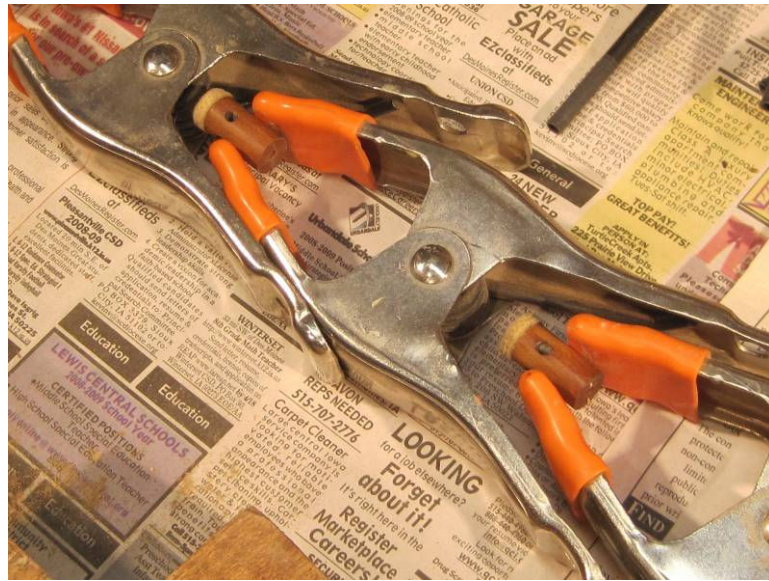
*Photo 2: Ducks in a row.*

Before giving up for the day (and it had been a long one), I decided make a stab at fixing the problem by applying Titebond to the broken buttons (Photo 2), then knocked off for the day.

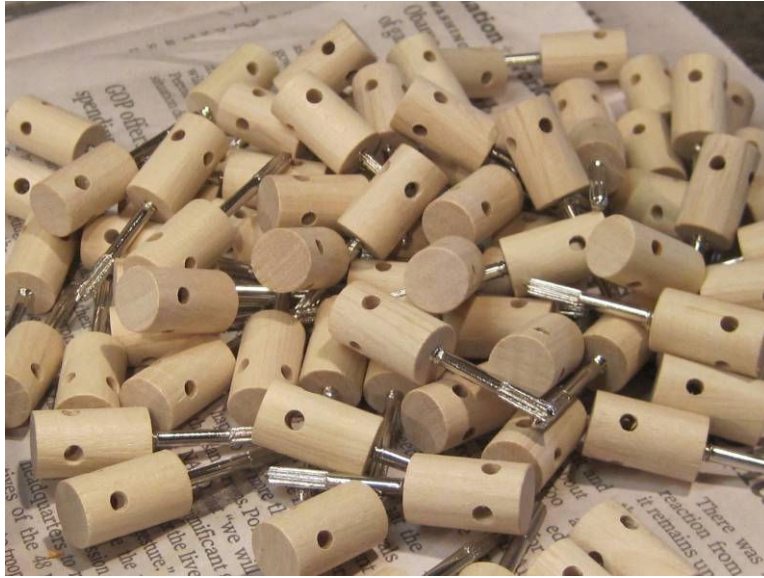
*Photo 3: Reinforcements sent from Lake Zurich.*

Several days later, when the package from Schaff Supply arrived (Photo 3), the hammers were successfully installed (details to follow), and I was ready for a fresh start on finishing the hammer let-off rail, now that I was armed with new parts.

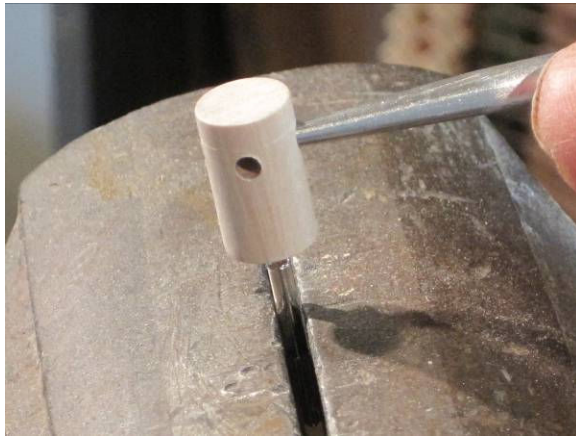
*Photo 4: Backing up and off the new posts*

The first step was to remove the posts that the new buttons came installed with. I was not about to pound out the old posts for a second time!

One at a time, I put each button / post assembly in the vise, and backed the post out with the capstan tool (Photo 4). The new posts being a smaller diameter than the old versions, I then reamed out each hole for a tight (but not overly-tight) fit (Photo 5).

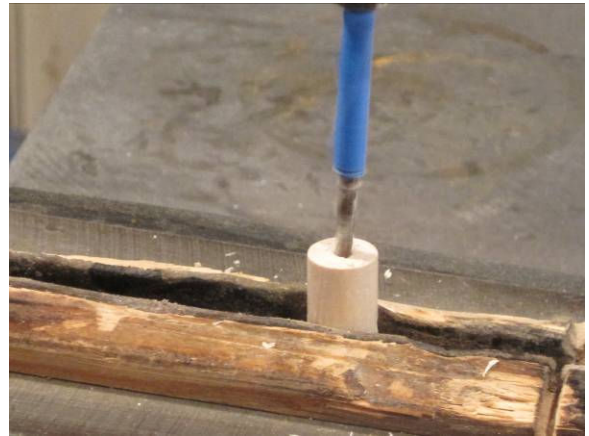
*Photo 5: Enlarging the pilot hole.*

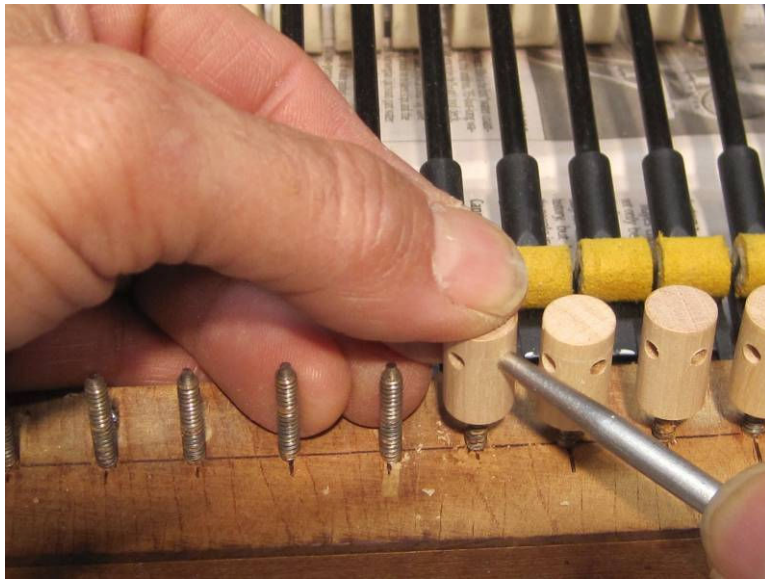
*Photo 6: Smooth sailing.*

Finally, things were back on track. The new buttons from Schaff went on the old posts without a hitch (Photo 6). I felt good, knowing that potential problems down the road had been eliminated.

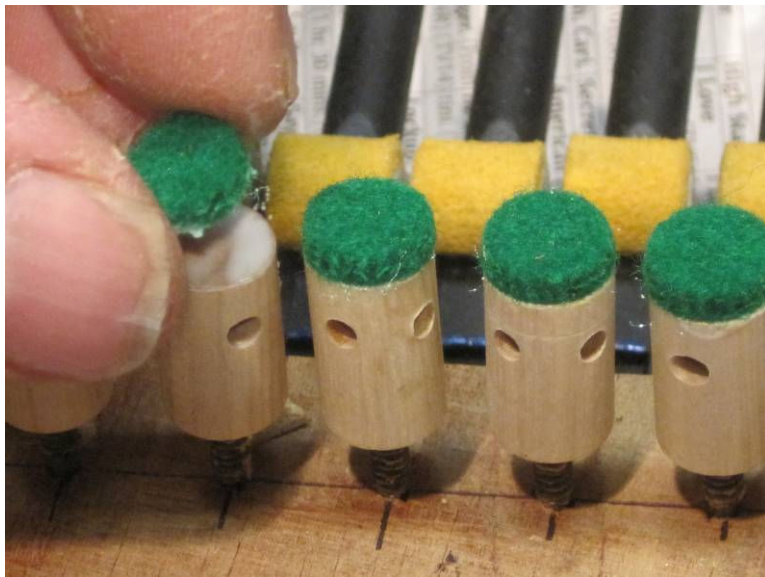
*Photo 7: Putting a cap on it.*

Felt punchings are supplied with the new buttons, but not attached. I used PVC-E glue to finish the job (Photo 7).

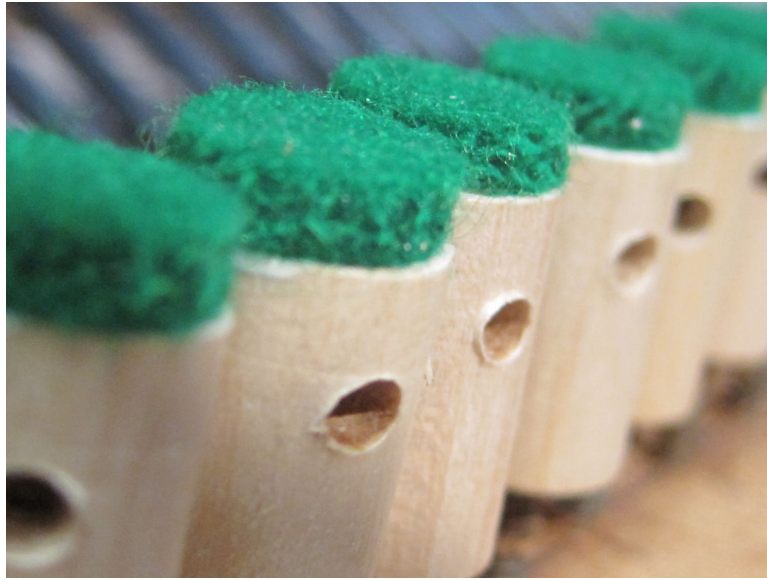
*Photo 7: Ahh! Mission complete.*
