Small Shop - Big Results
Grand Action Reconstruction – Part 10
(Rebuilding the Back Action)
By Chuck Behm
Central Iowa Chapter

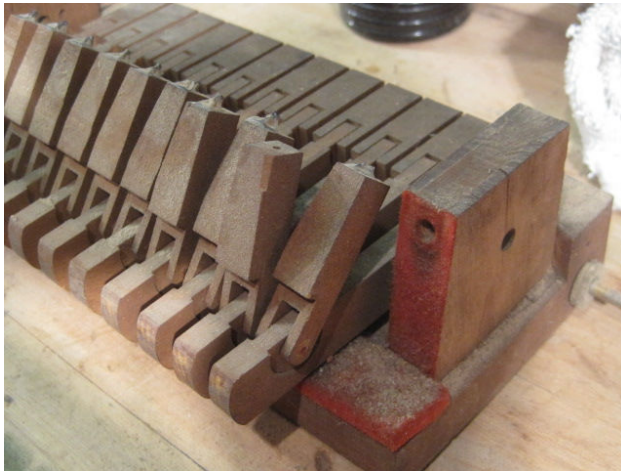
Photo 1: Epoxy collars on the tops of the damper blocks.

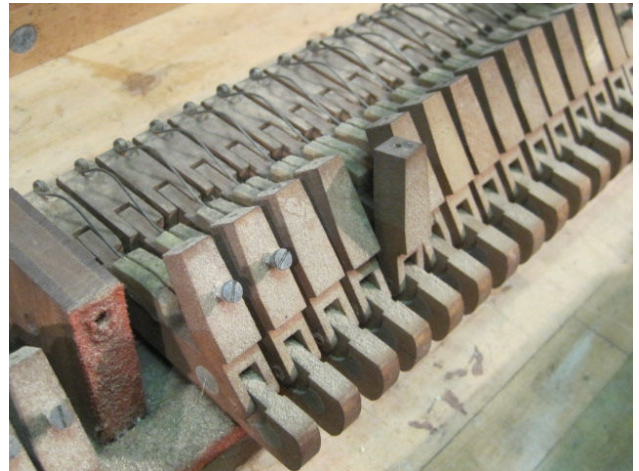
Photo 2: Added-on set screws.

The old back action had been fiddled with in the past, apparently causing other technicians headaches down through the years. The damper wires to the Weber were threaded and meant to be turned into the under lever top flanges. Over time, however, some of the damper wires had evidently become loose in the flanges and required bolstering by with collar of an epoxy-like substance around the juncture between wire and flange(Photo 1). Other efforts to correct the problem were made as well, as evidenced by the addition of set screws (Photo 2). These were installed hit or miss, however, and when the piano first arrived in the shop and was disassembled I noticed that despite these previous efforts, some of the damper wires simply slid out of the top flanges without resistance.

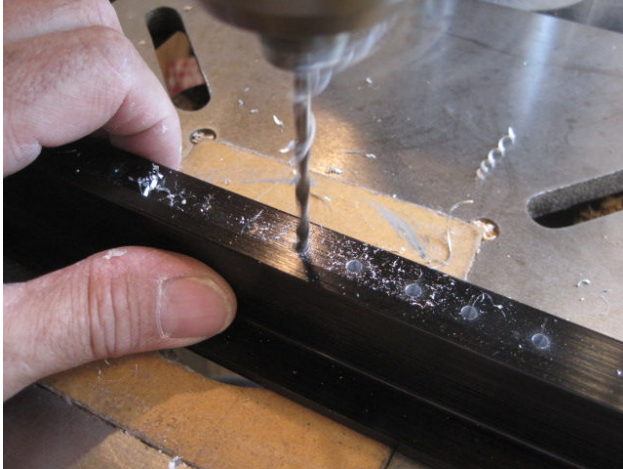
Photo 5: Drilling the flange screw holes

With the center points marked, the next step is to drill the holes for the flange screws (Photo 5), then tap them with the proper thread size (Photo 6). Since the WNG damper lever rails are made of heavy gauge aluminum they are easy to drill and tap.

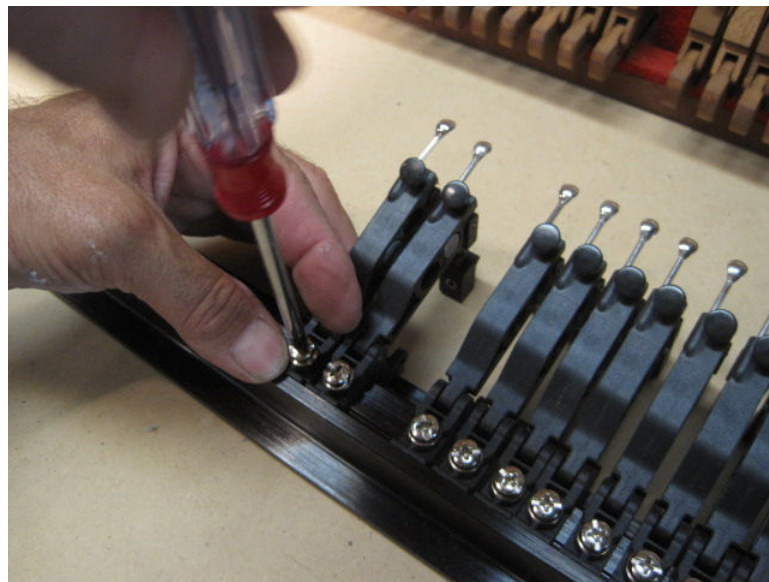
Photo 7: Screwing the damper levers down.

By the time I started screwing the under levers in place (Photo 7), starting with the more heavily weighted levers on the bass end, I had to say that everything was going much more smoothly than I had anticipated. The 1885 Weber didn't have a sostenuto assembly to worry about, which I was glad of. I would rather deal with a simpler system for my first time trying a job out than having to deal with a more complex assembly.

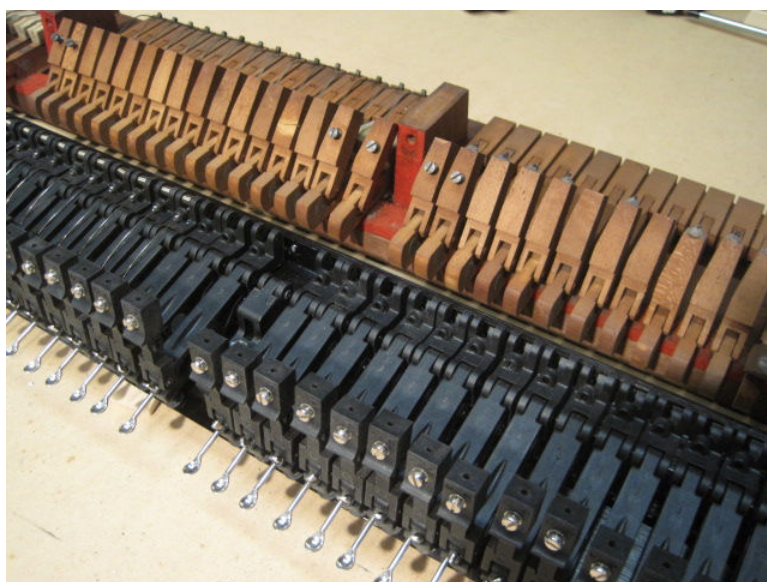
Photo 8: New back action compared to old.

Having installed the pickup tray, I compared the new back action assembly with the old (Photo 8), and found no discrepancies. It was time to make a decision about the installation of the new back action into the damper cavity of the Weber. According to the literature that came with the parts from WNG, the heavier damper flange rail which I used, “Only requires mounting at each end as the rail is stiff enough to anchor the under levers without additional support.” The old back action, however, had been secured to the keybed by three large flat-head screws, which I decided to duplicate. To do so, I cut a length of pinblock stock to run underneath the back action (Photo 9). The damper lever rail was then screwed to the pinblock material, which in turn could be screwed down to the keybed, as the original back action had been.
