Pinblock Replacement Project / Hamilton grand– Photographic Journal Page 19

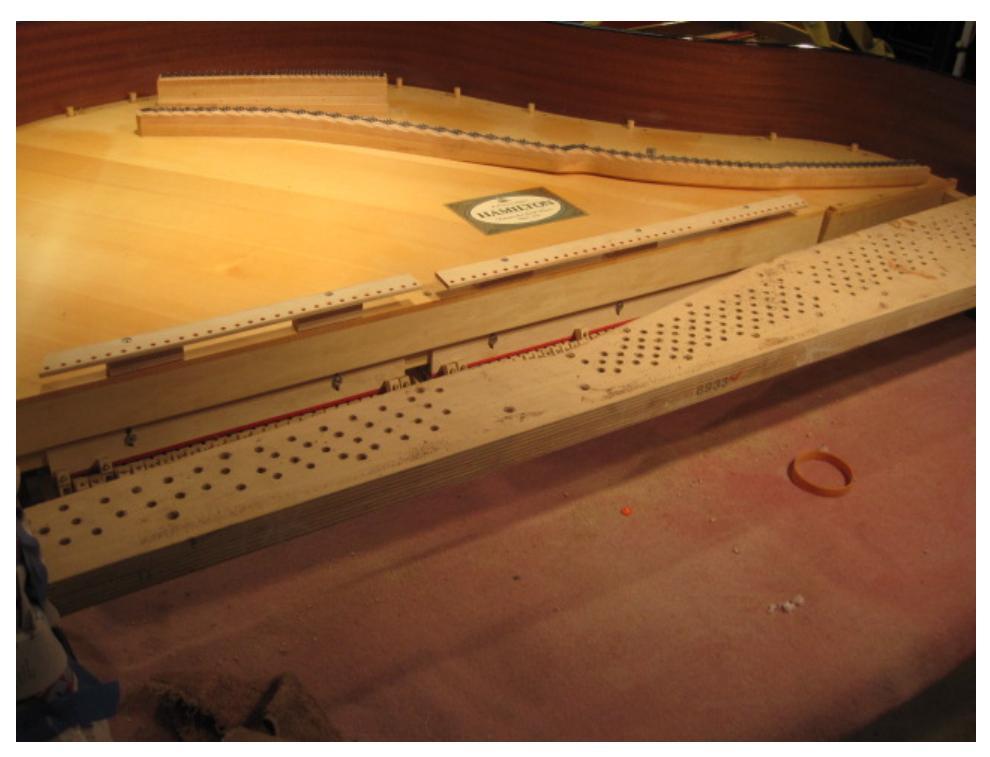
Photo 35: The pinblock on this grand is not the "free-floating" type that comes out with the cast iron plate. Instead, it is firmly attached to the ledges on the inside of the rim.

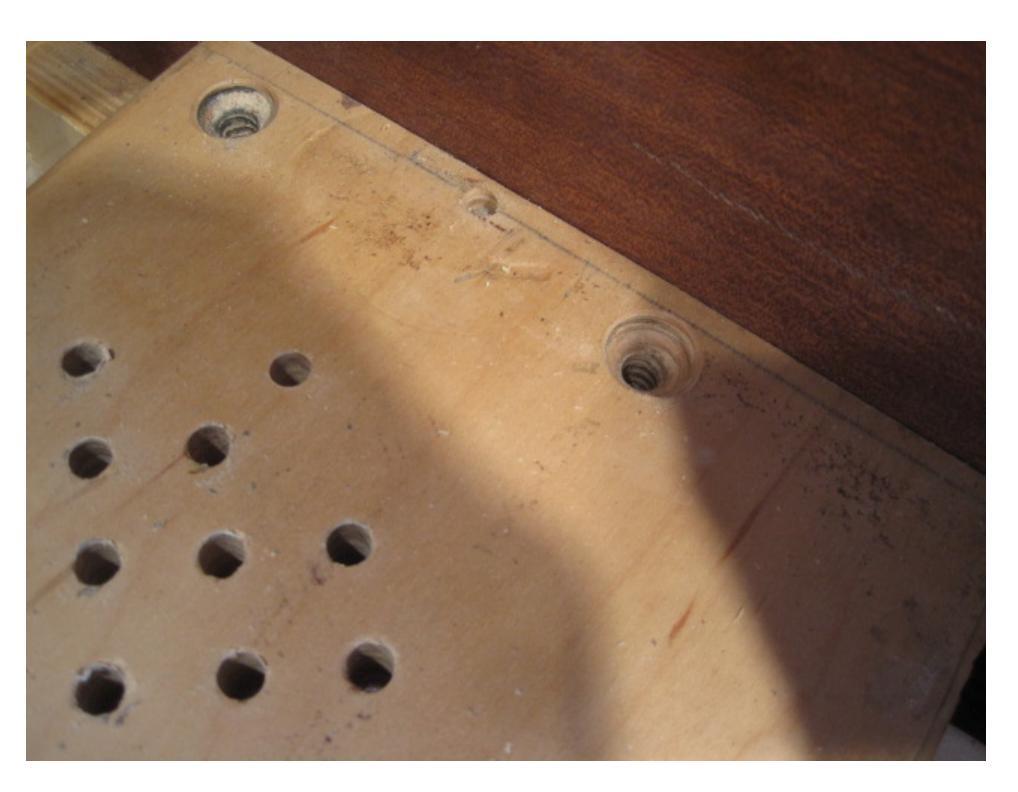
Photo 36: Two large Phillips screws on the treble end come out without incident.

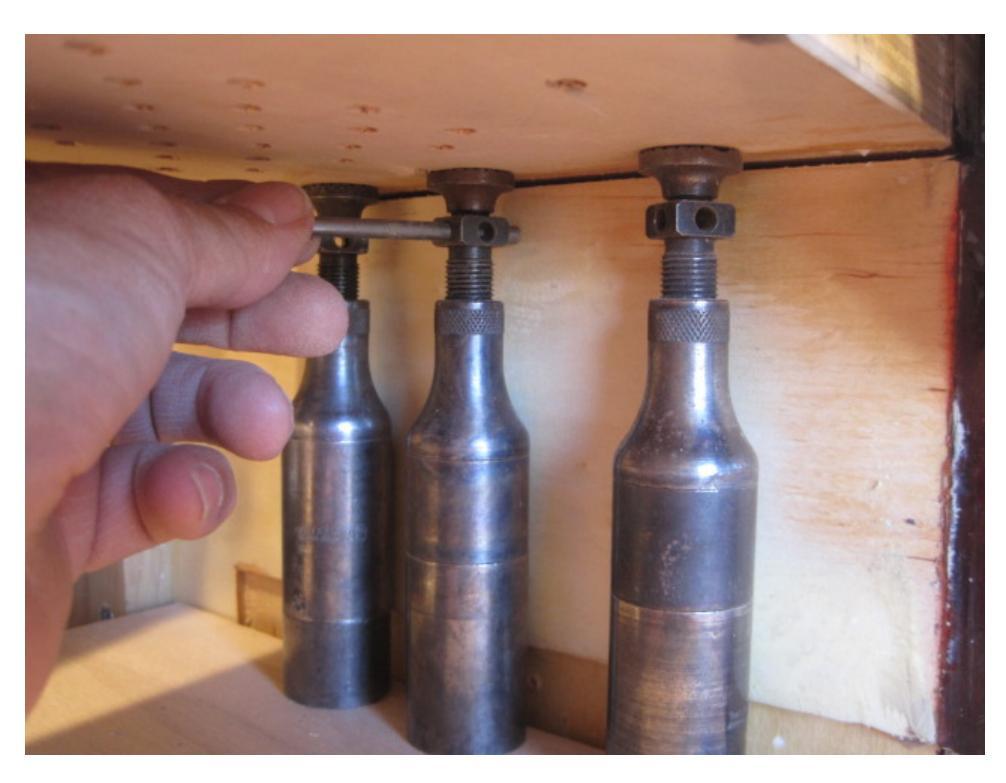
Photo 37: Besides the screws, the pinblock is glued to the ledge as well. It takes pressure from 3 pinblock jacks to break the seal.

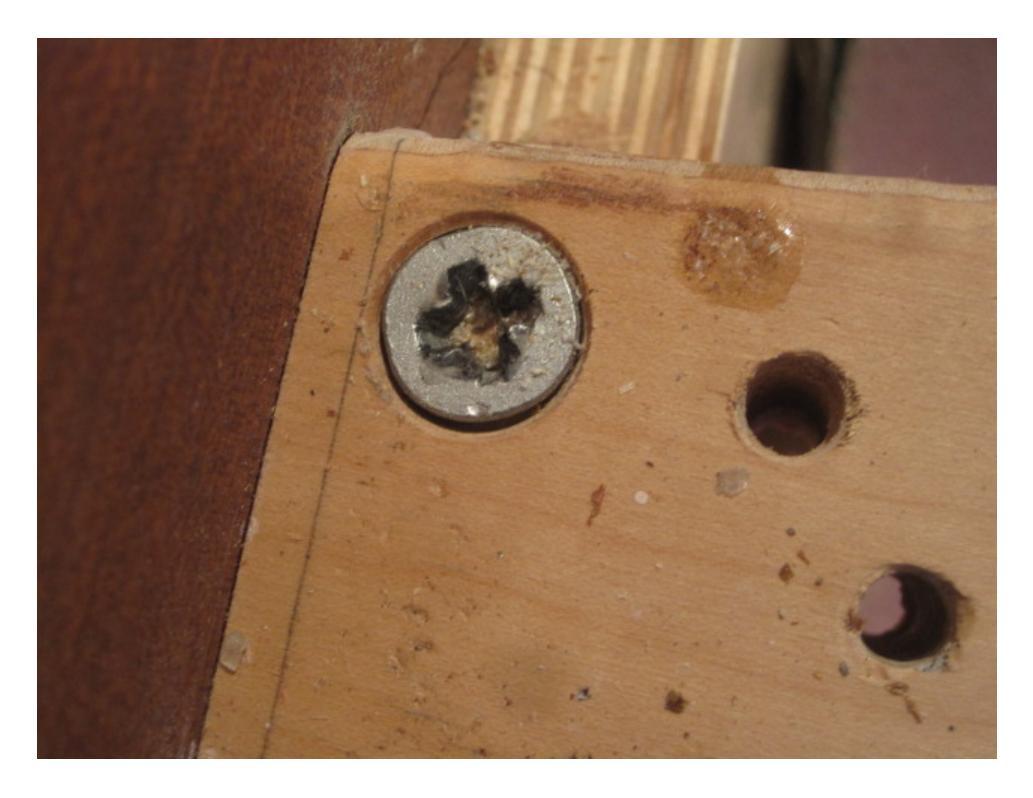
Photo 38: A single badly chewed up screw on the bass end resists backing out.

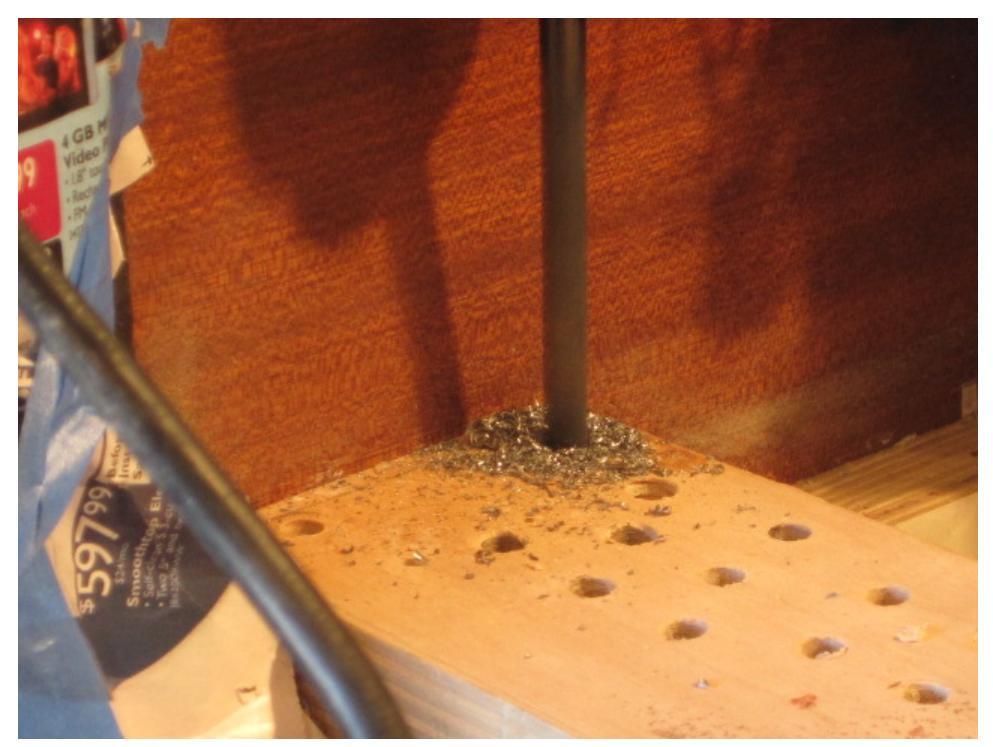
Photo 39: Drilling the head out is the only method. All 3 of the ledge screw holes will be plugged and redrilled anyway, with new screws, so drilling the screw out is of no consequence.

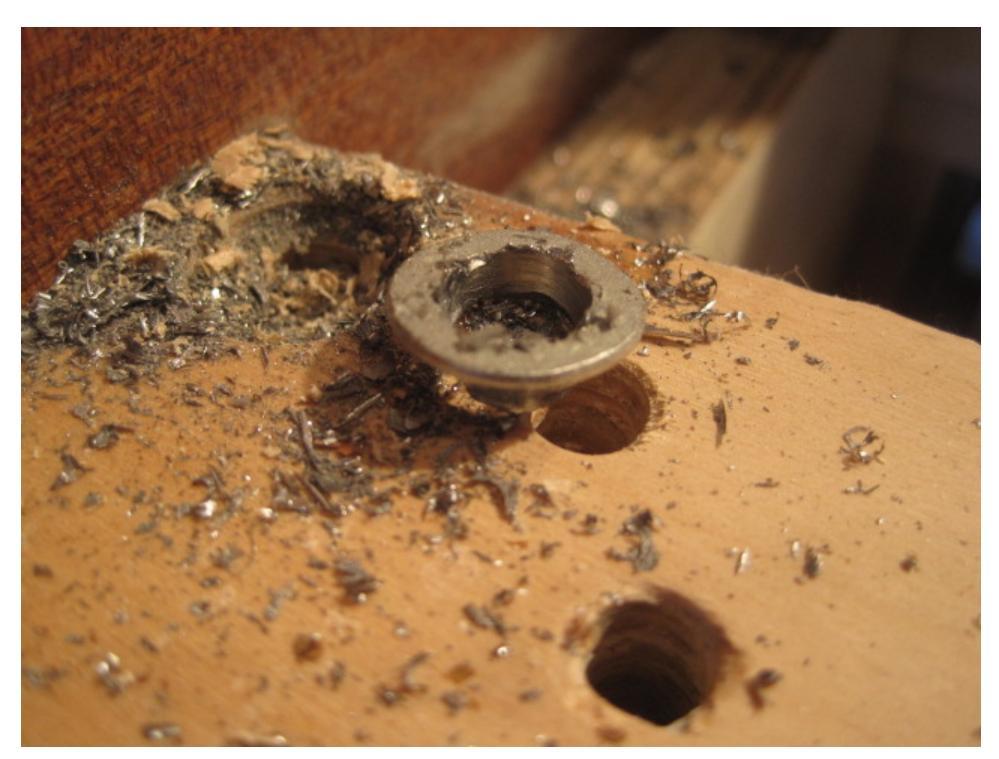
Photo40: The screw head is successfully removed. The screws have a long unthreaded shank at the top, so that the remaining portion still in the pinblock doesn't bite into the wood.

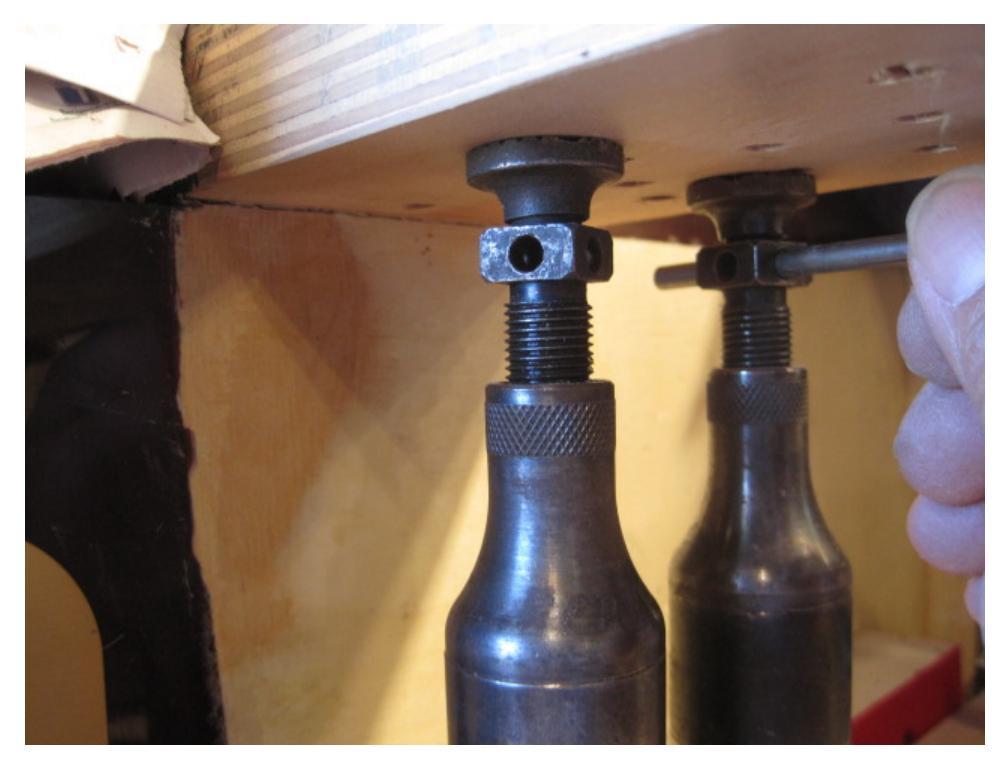
Photo 41: Two pinblock jacks are used to break the glue bond on the bass side, and are then used to continue pushing the pinblock up until it is clear of the shank of the screw..

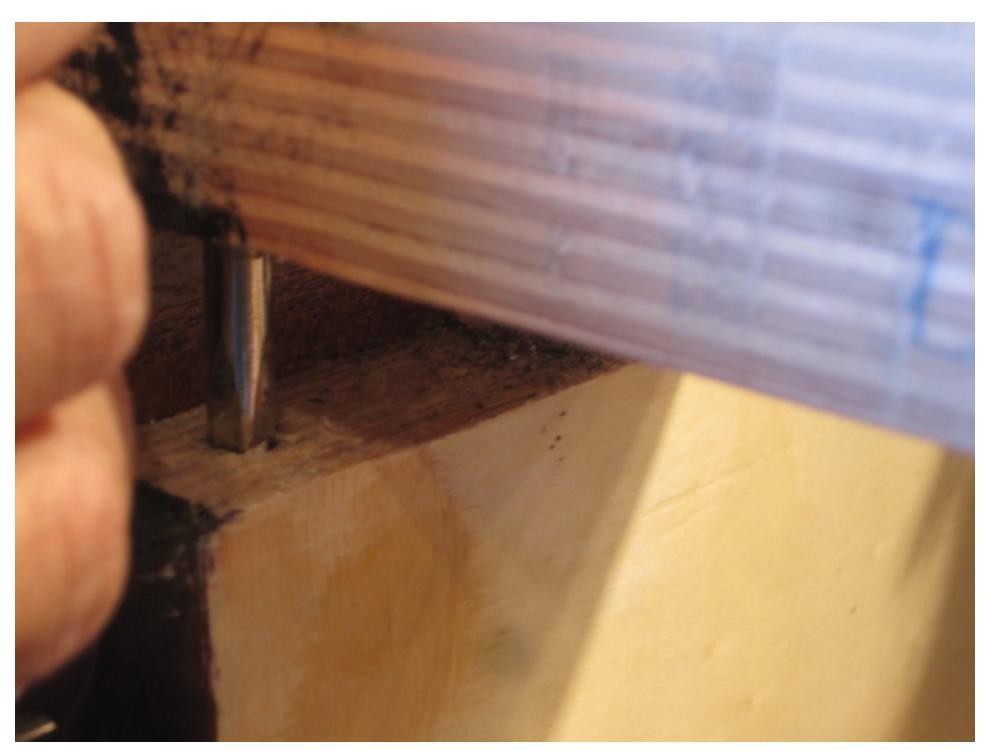
Photo 42: Both sides of the pinblock also have an indexing pin in addition to the screws to help position the pinblock in the assembly process. New indexing pins will also be used on reassembly.

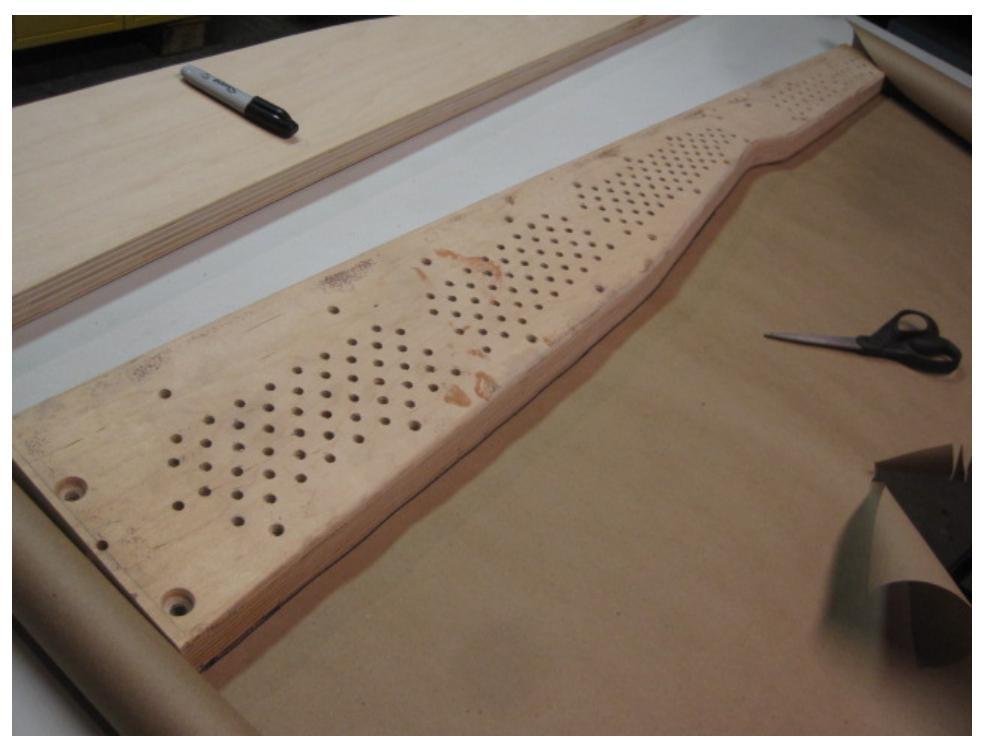
Photo 43: Once out of the piano, the pinblock is placed on construction paper to make a paper pattern. The curved edge of the pinblock is cut on a bevel, so it does not work to directly trace the shape of the pinblock directly onto the new pinblock material.

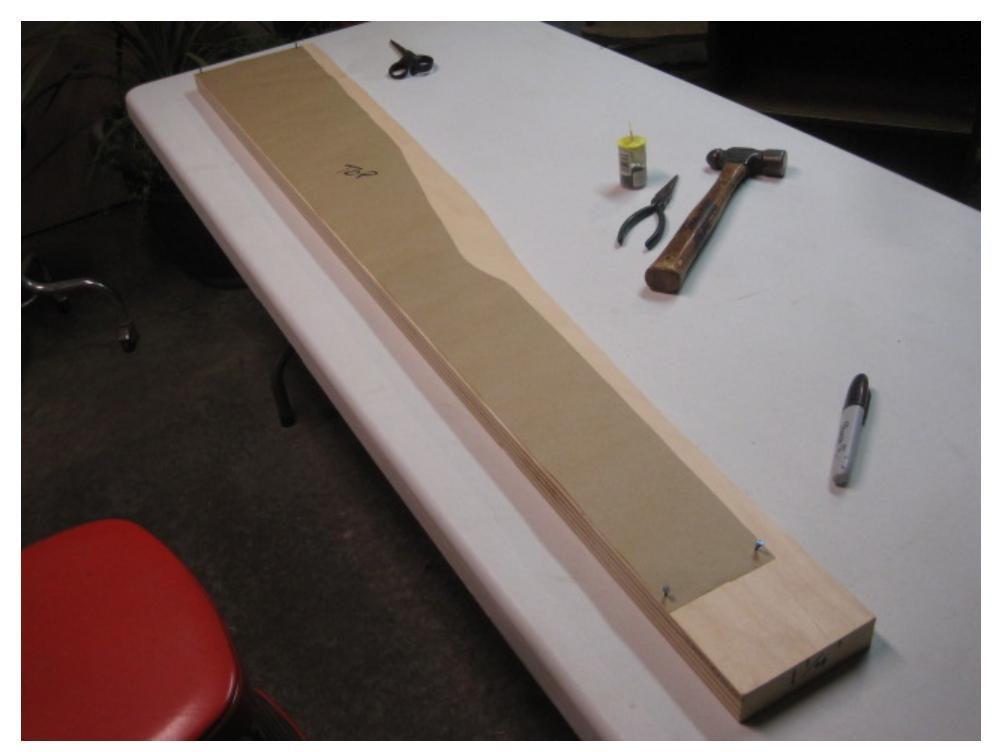
Photo 44: The pattern is tacked down to the pinblock blank. Notice the word "top" printed on the pattern. It is very important to make sure the right side of the pattern is up – otherwise a mirror image of the pinblock would be cut and I would have a very expensive piece of scrap wood.

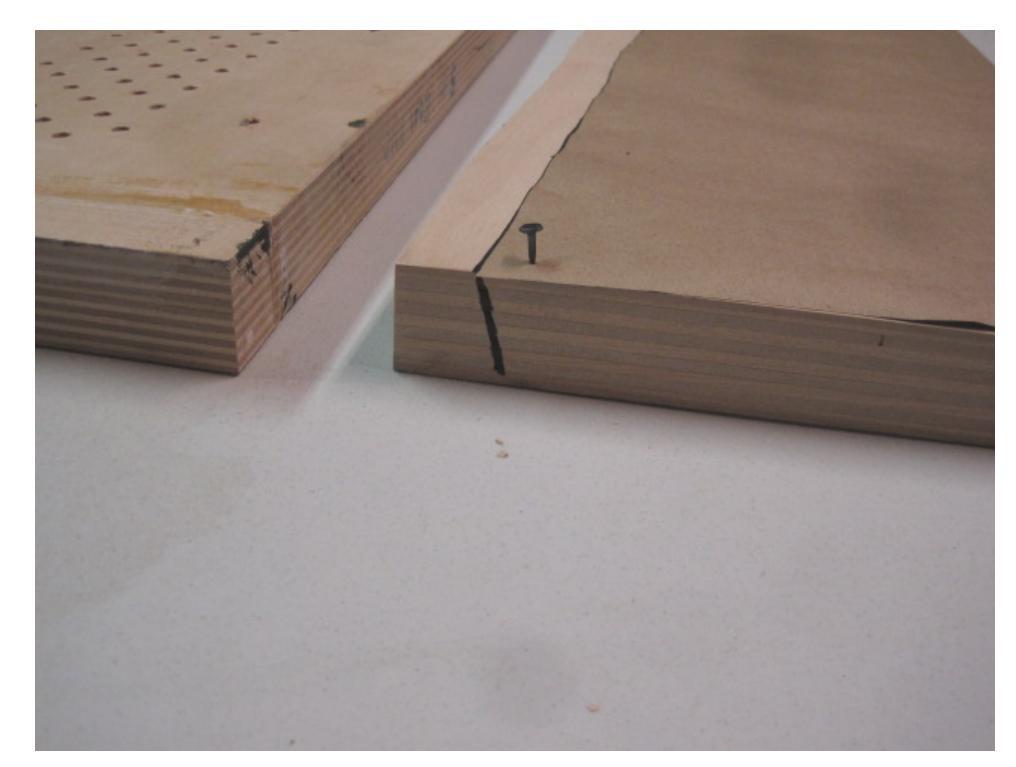
Photo 45: The bevel is clearly marked on the new pinblock material. Again, if the direction of the bevel were inadvertently reversed, the pinblock cut would be scrap wood. The new 1 ¼" thick pinblock is laminated hardrock maple. Fewer laminations mean more wood, less glue.

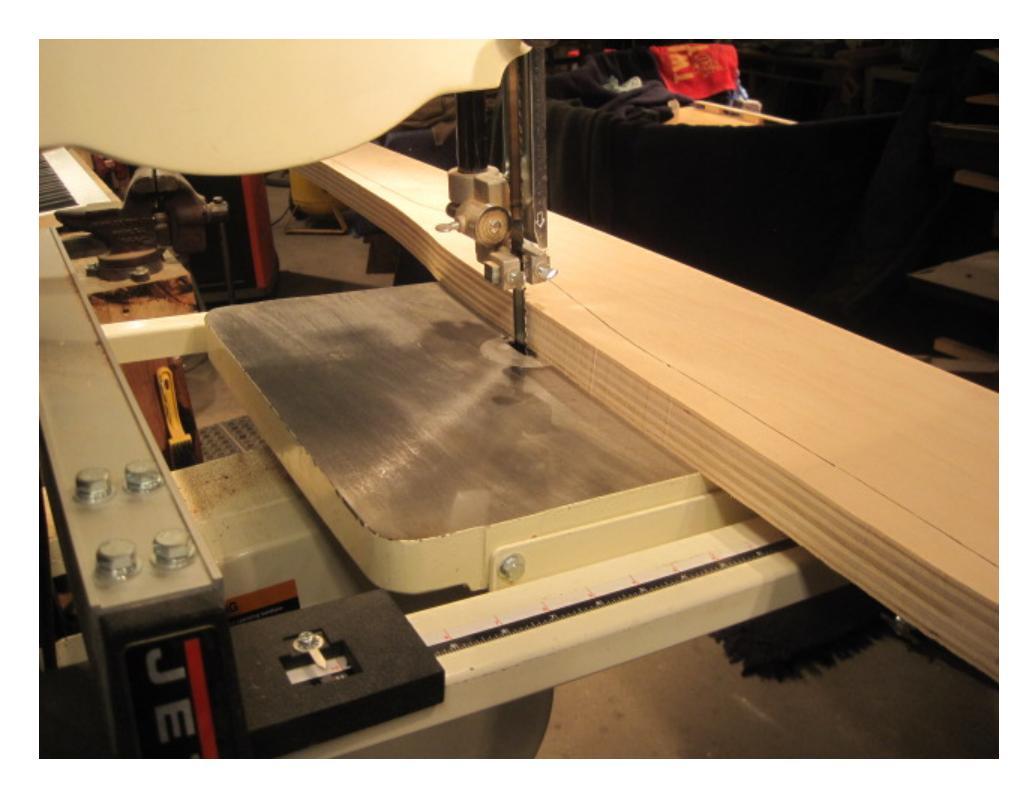
Photo 46: The pinblock is marked for cutting on the band saw.

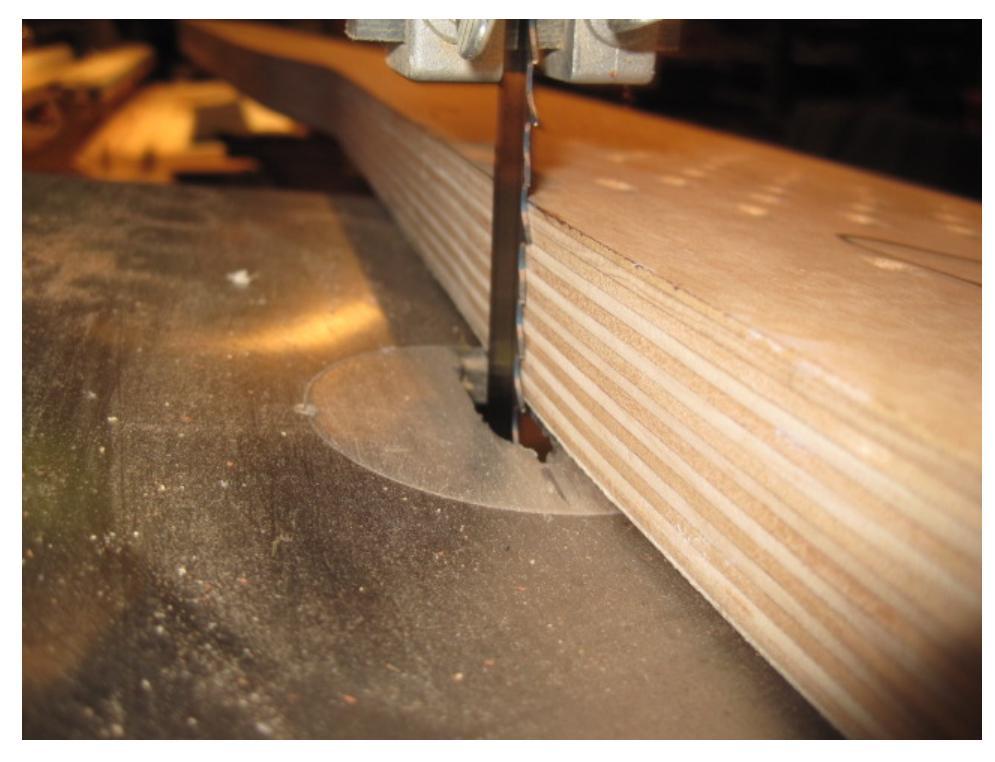
Photo 47: The saw bed is tilted so that the blade lines up with the bevel of the old pinblock.

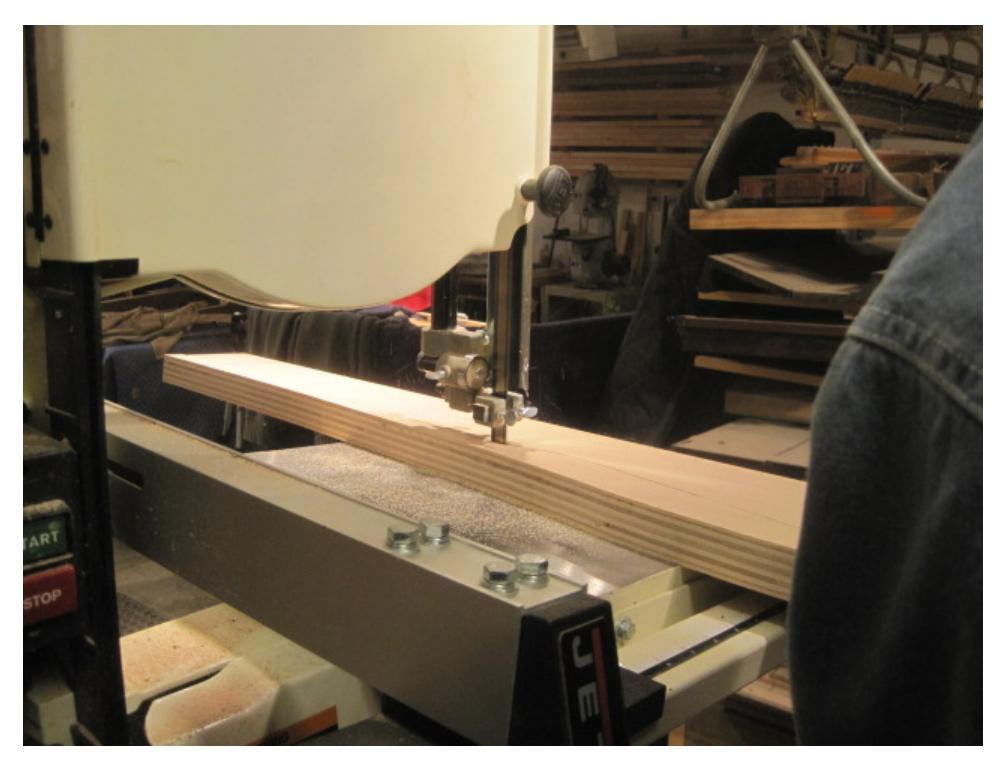
Photo 48: The cut is started. The band saw cuts through the thick hardwood like a hot knife through butter.

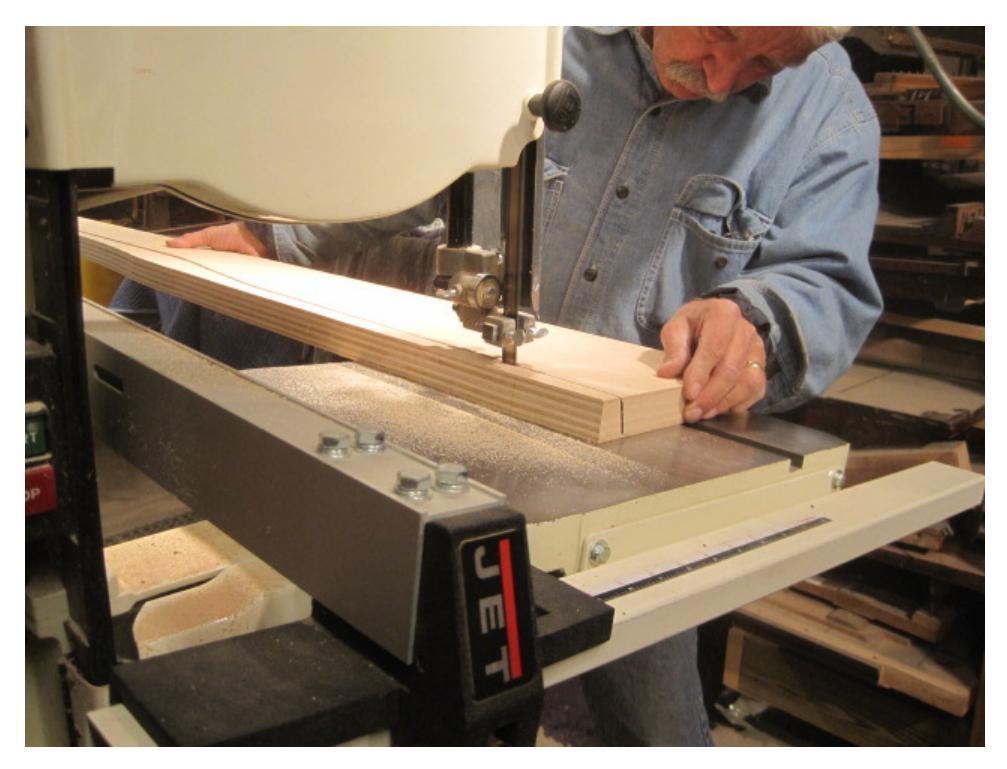
Photo 49: Changing positions to support the end of the pinblock coming off the saw, I finish the cut.
