Steinway Upright Restoration Project

Day 4

Restoration Project Photo Essay - Steinway upright

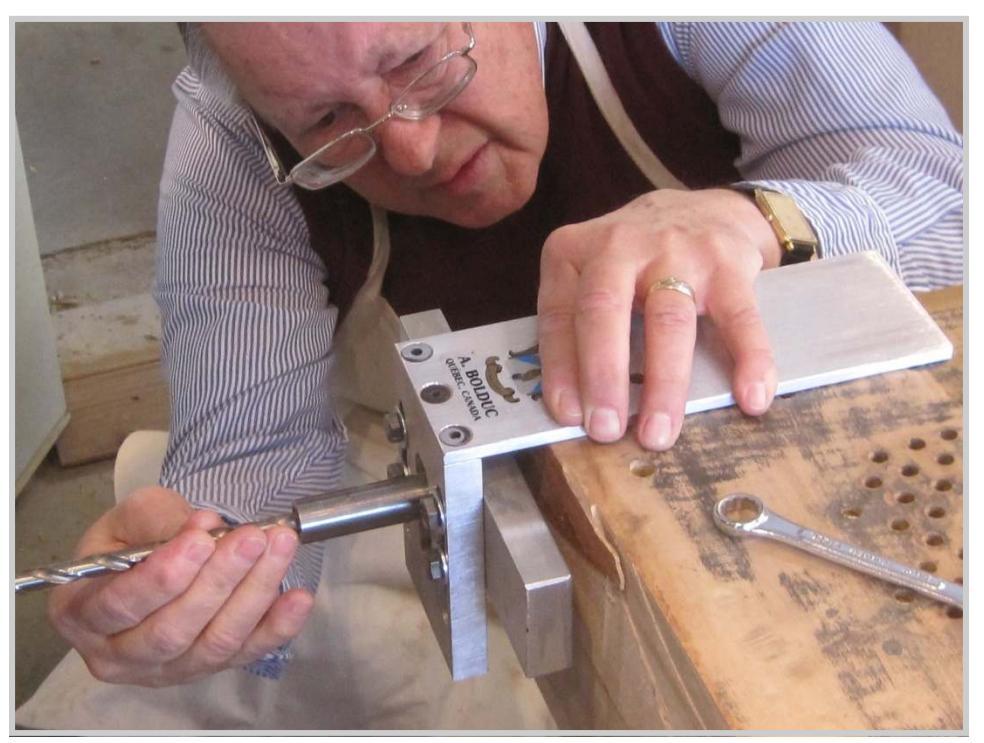
Photo 99: Neil Donald starts off the day by adjusting the jig from Bolduc Piano that will be used in undercutting the old pinblock. Here he sets the depth for the drill bit guide. The beauty of this system is that the face of the pinblock is preserved for later reference. If a router were used ,there would be nothing left of the old block to refer to.

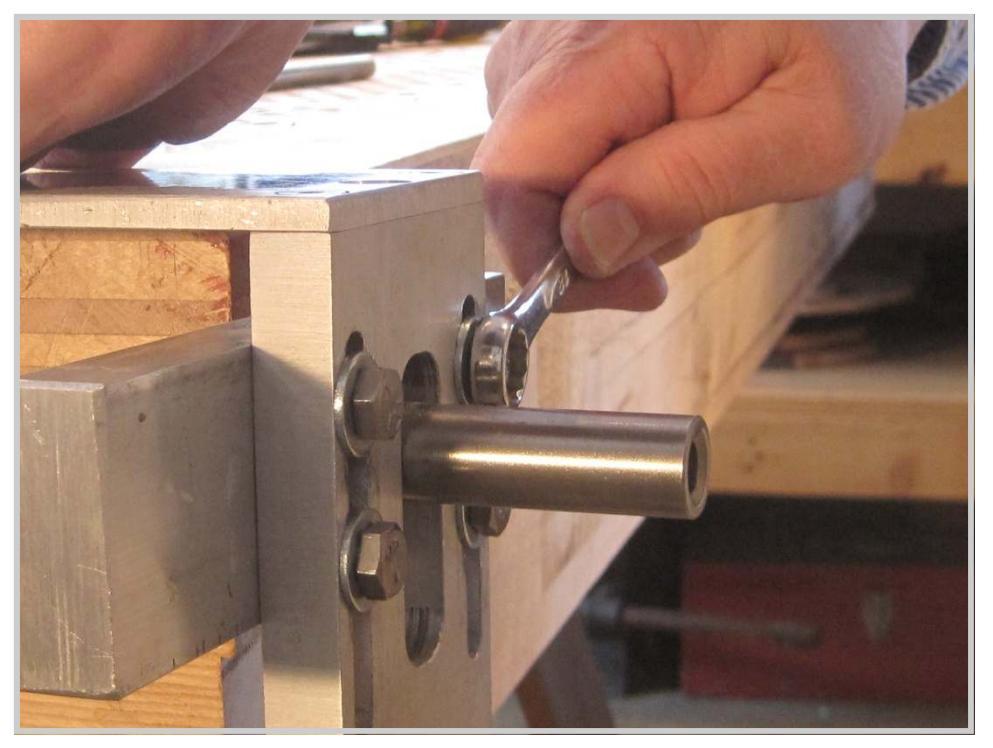
Photo 100: The adjustment for the drill bit guide is simple, effective and solid.

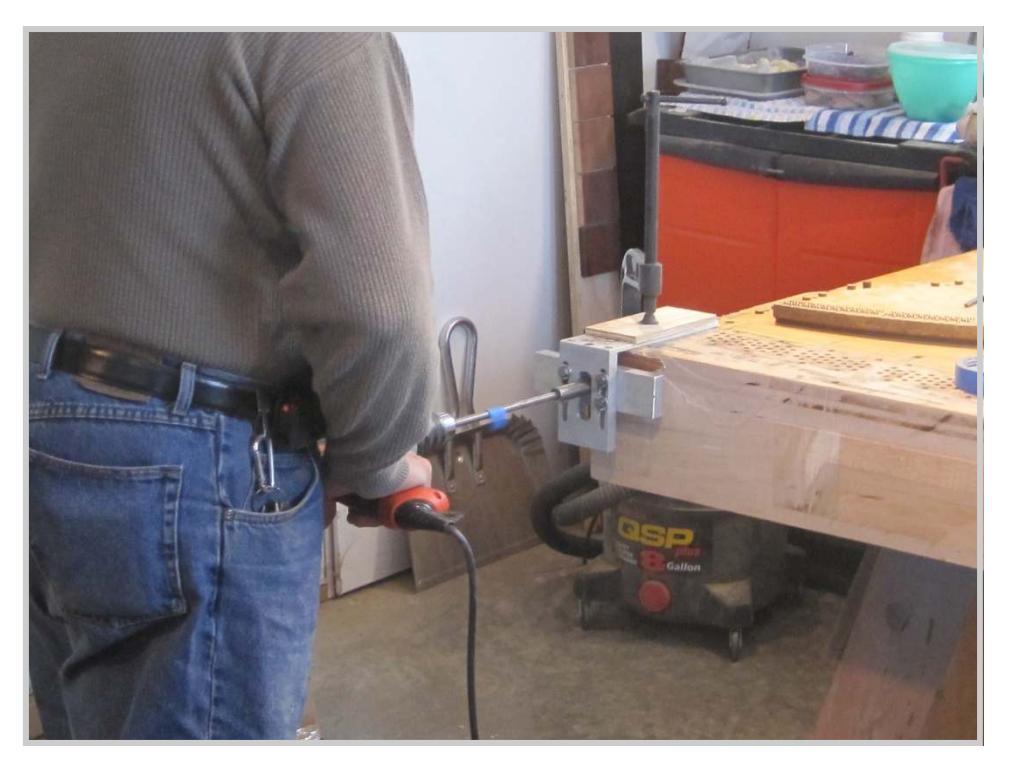
Photo 101: Chapter member Angelo Georgou tries drilling one of the first holes. Despite a new bit, drilling through the century old hard rock maple is tough going. You must firmly lean into the drill to advance the bit.

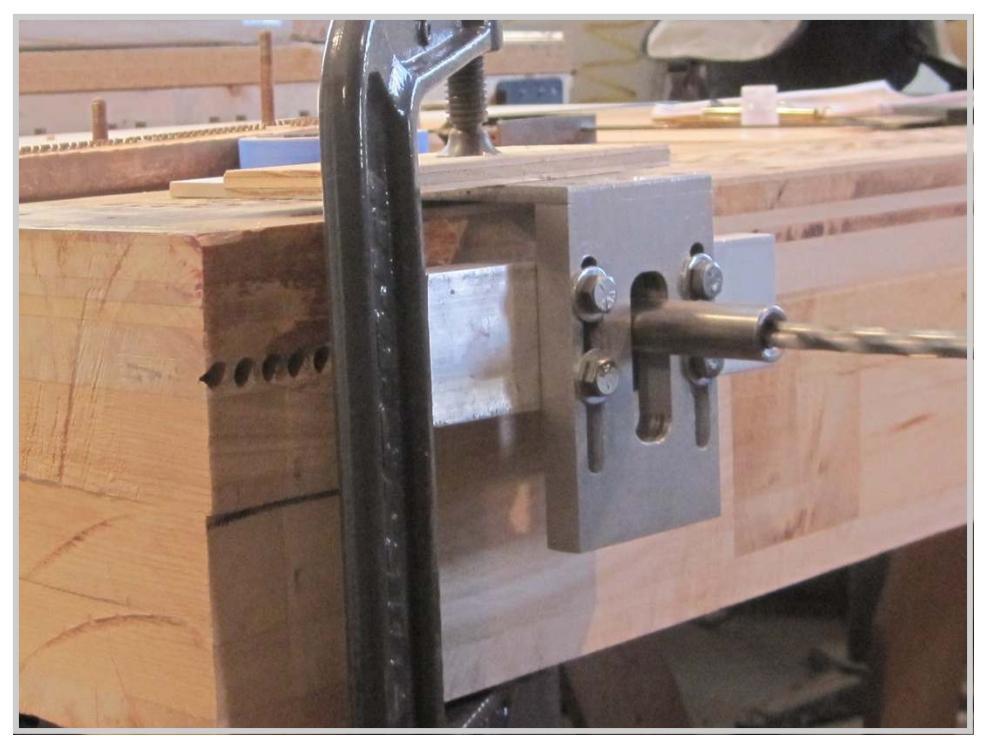
Photo 102: After each hole is drilled, the jig is moved to the right. A post on the inside of the jig fits in the previously drilled hole to lock the jig in position from side to side. The c-clamp keeps the jig set at the right level.

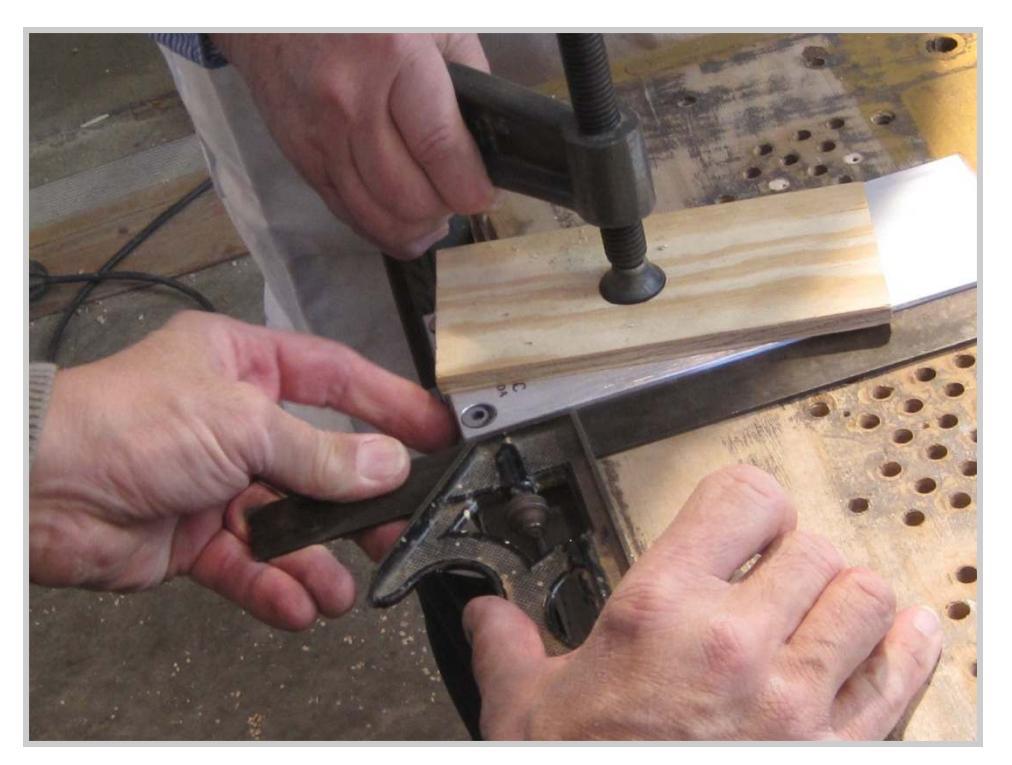
Photo 103: Advancing the jig after each hole is drilled becomes a team activity, with one person removing the clamp and the other person squaring the jig up.

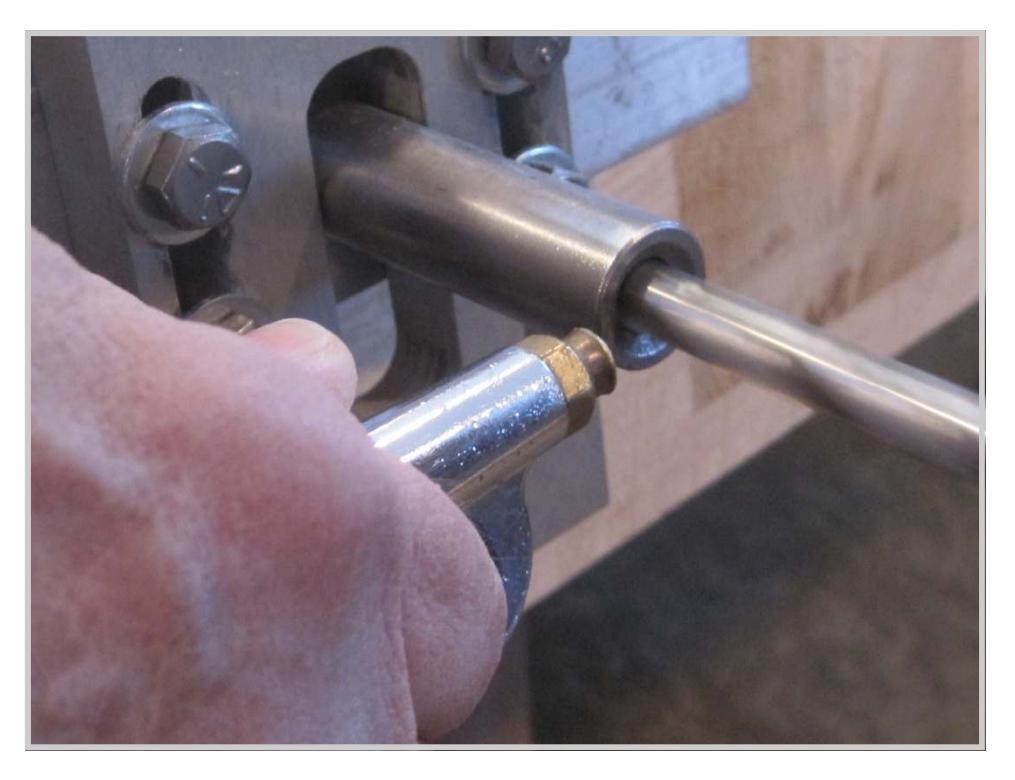
Photo 104: To keep the bit cool, a stream of compressed air was kept on the drill at the entry point to the drill bit guide. This also helps the flutes of the drill from clogging.

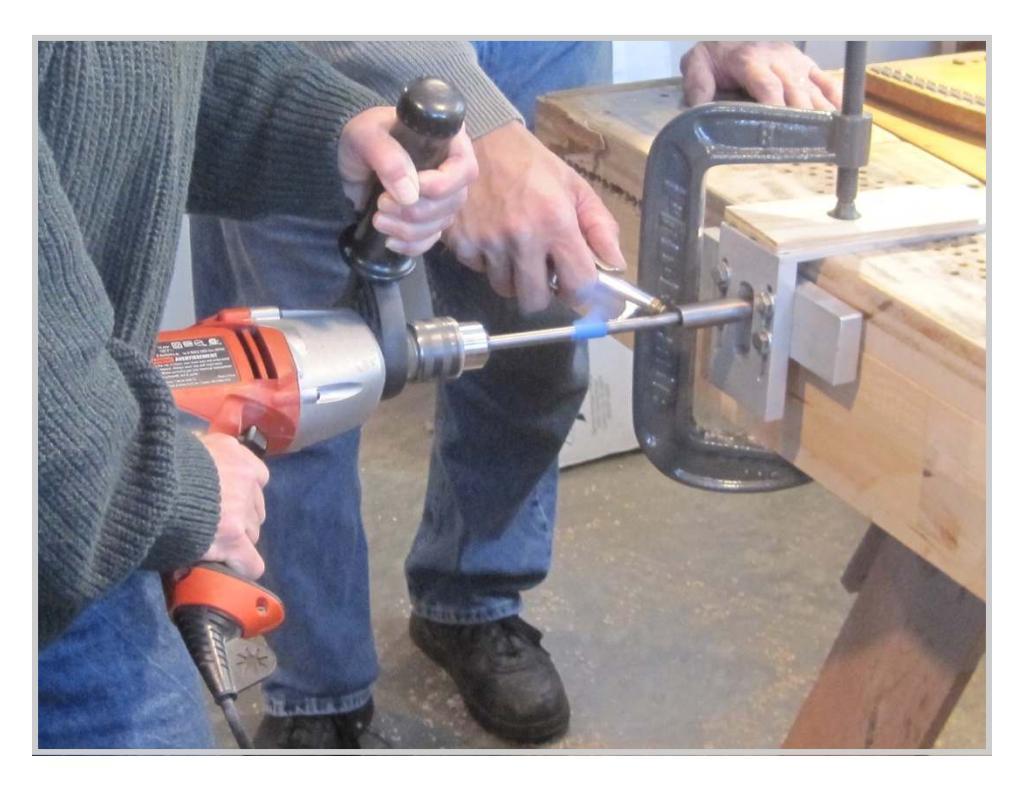
Photo 105: As the drilling progresses, chapter members switch off to give everyone a chance to try out the process. The blue tape on the bit marks the depth of the hole to be drilled.

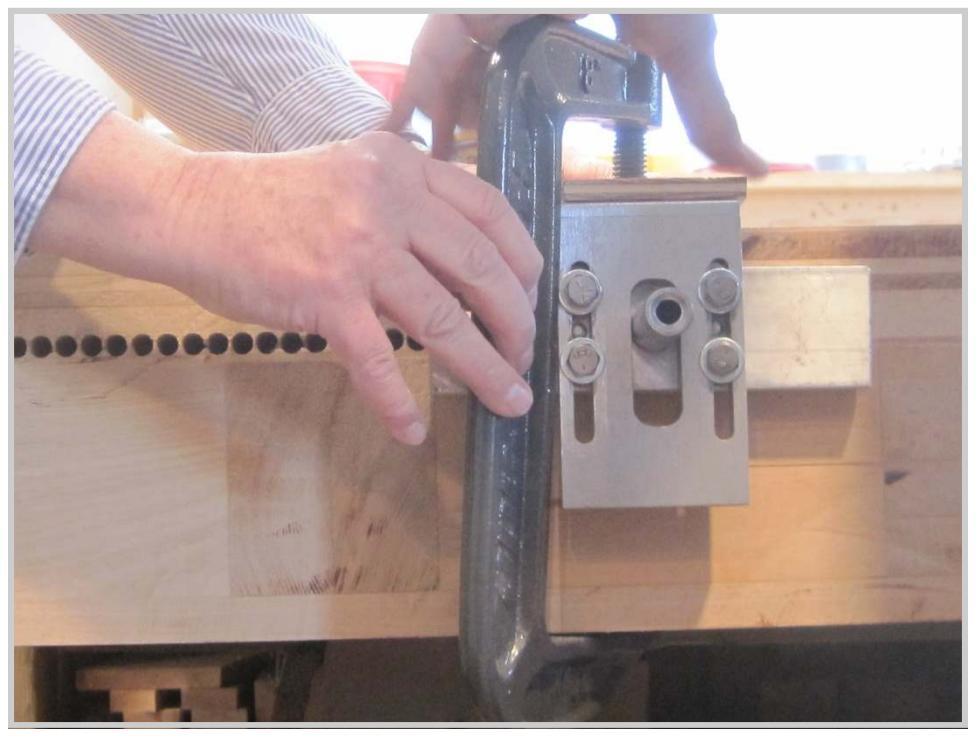
Photo 110: As the line of holes length, the process of resetting the jig becomes more efficient, with the chapter members working together like a pit crew at NASCAR changing tires.

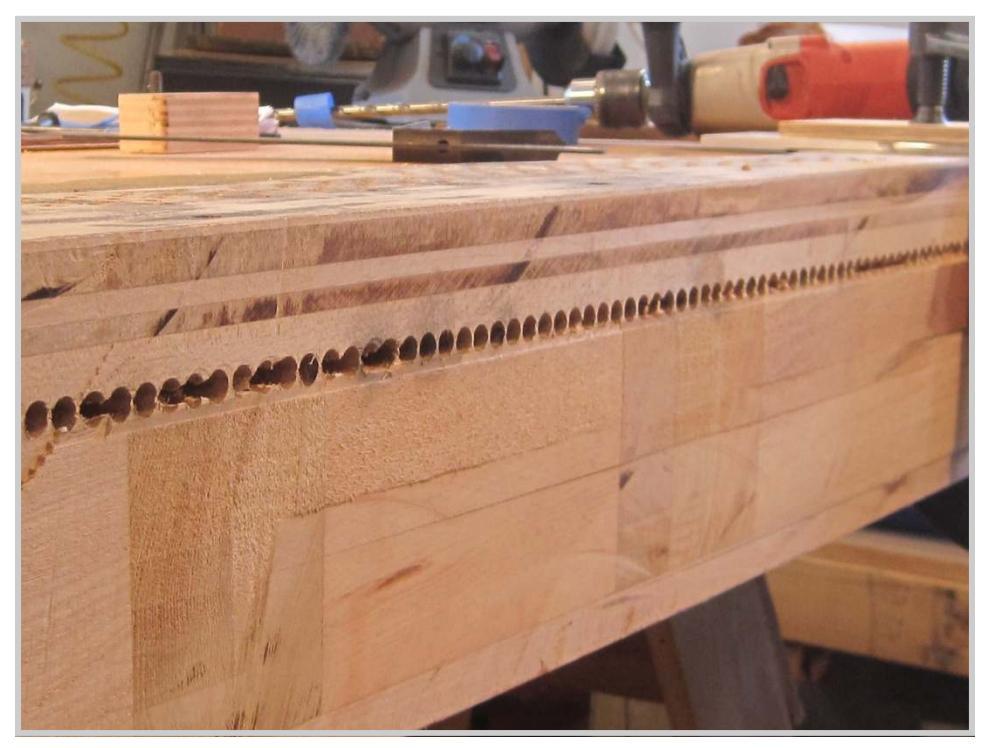
Photo 111: By mid-afternoon, the line of holes extends most of the distance to the opposite side of the pinblock. Not enough to complete the removal on this day, but close enough that an easy morning of work at the next meeting will finish the job.

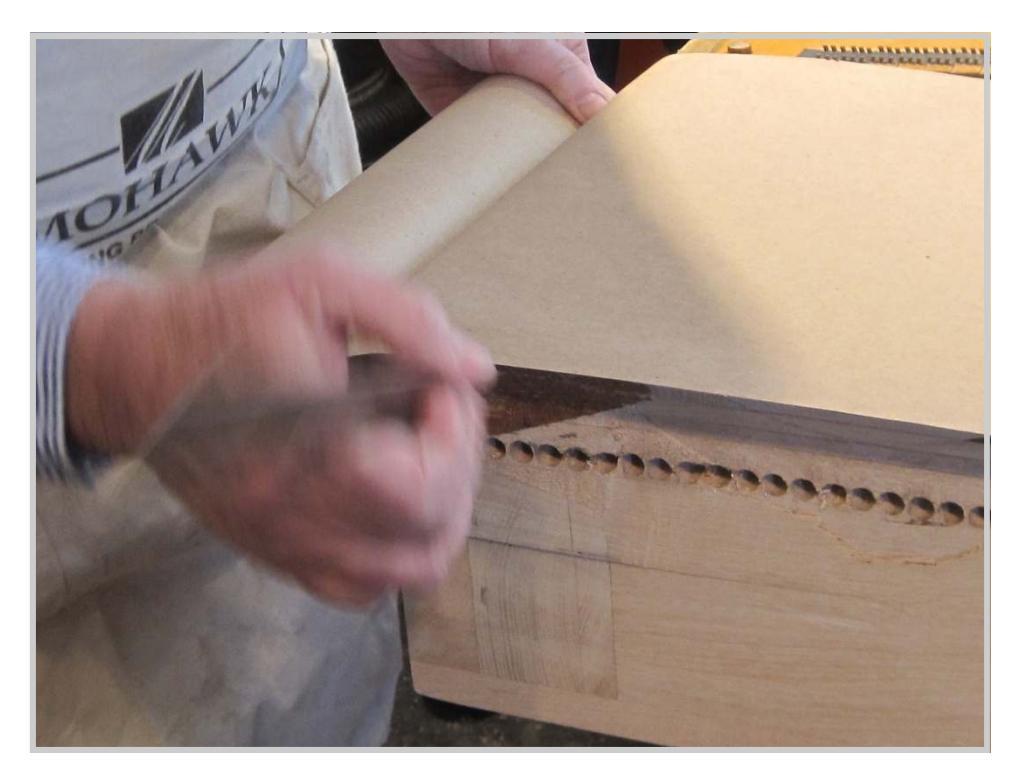
Photo 112: To round the day out, the decision is made to spend the remaining time in cutting the new pinblocks. The first step is to unroll contractor paper over the old pinblock to mark the lower edge of the pinblock. On this piano, unlike on most uprights, the pinblock is fitted to a flange on the underside of the cast iron plate.

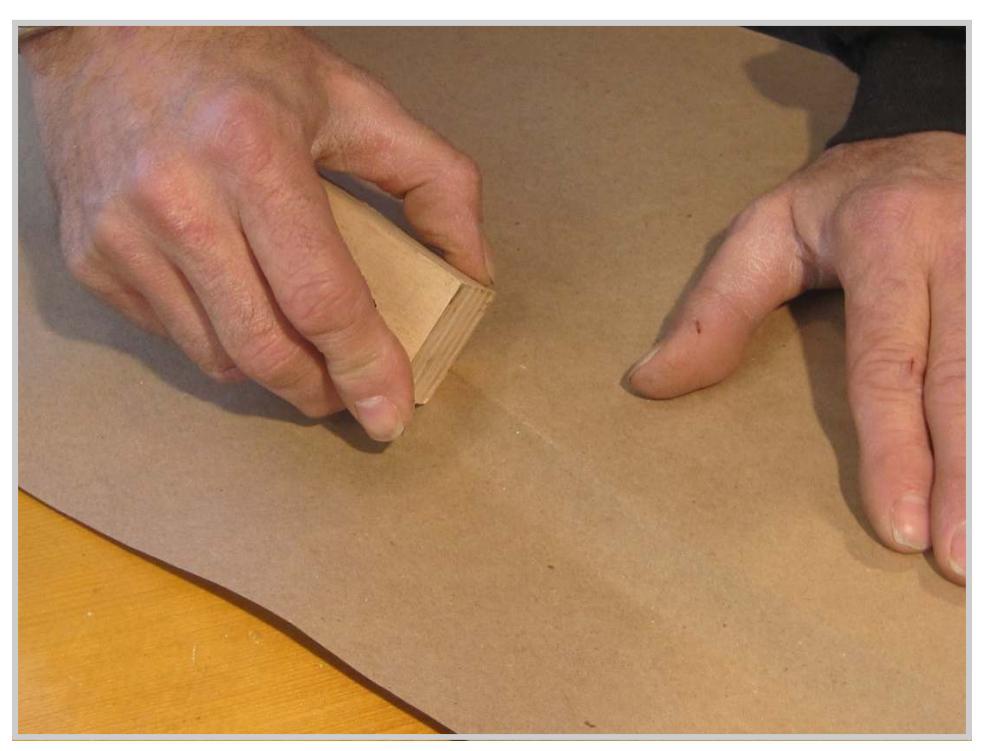
Photo 113: A scrap of pinblock material is used to make a crease in the contractor paper to mark the edge of the pinblock.

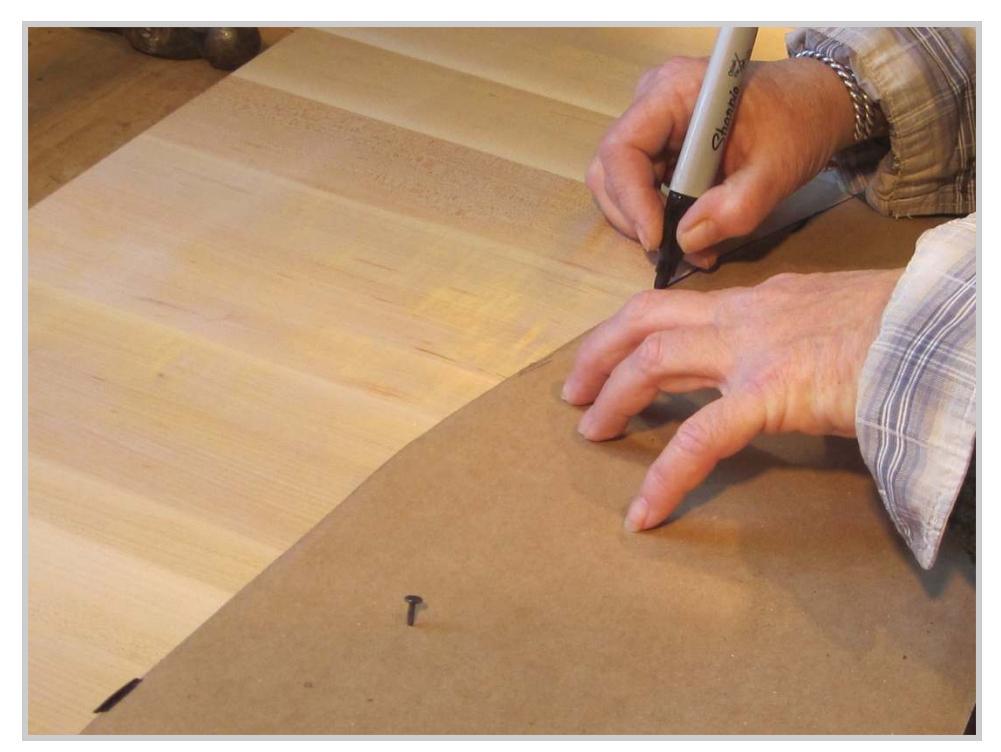
Photo 114: She then uses a marker to transfer the line produced to one of the new pinblocks.

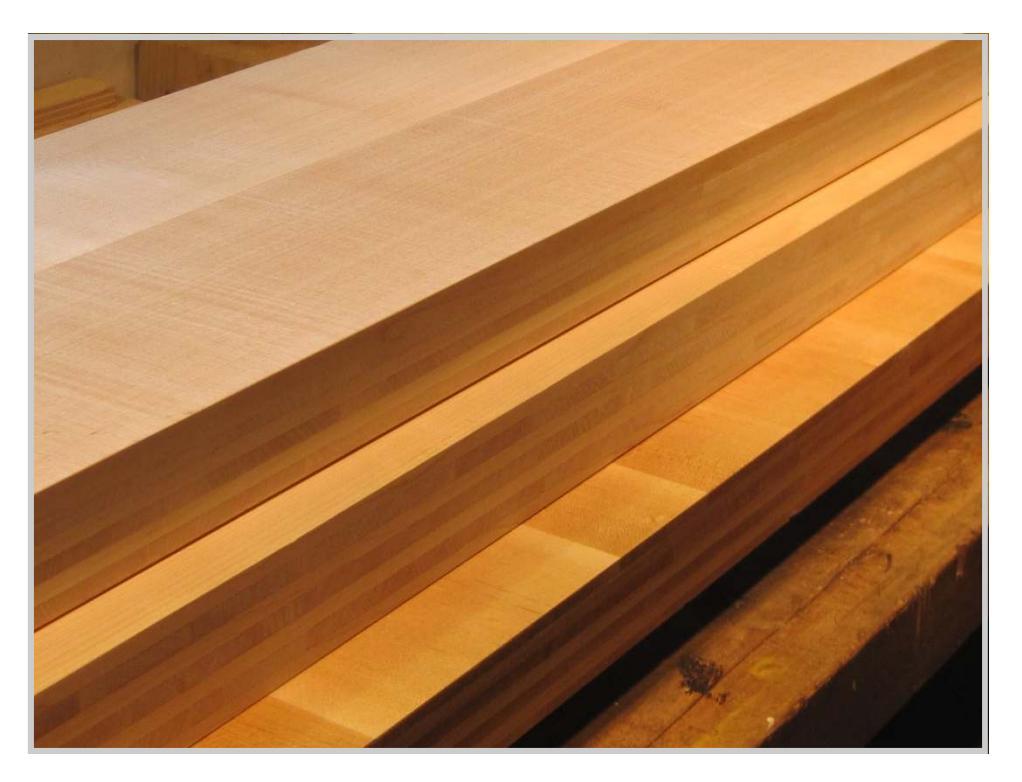
Photo 115: From top to bottom, the new pinblocks from Central Michigan Piano, Pianos André Bolduc and Wessell, Nickel and Gross. All three are great examples of premium pinblocks.

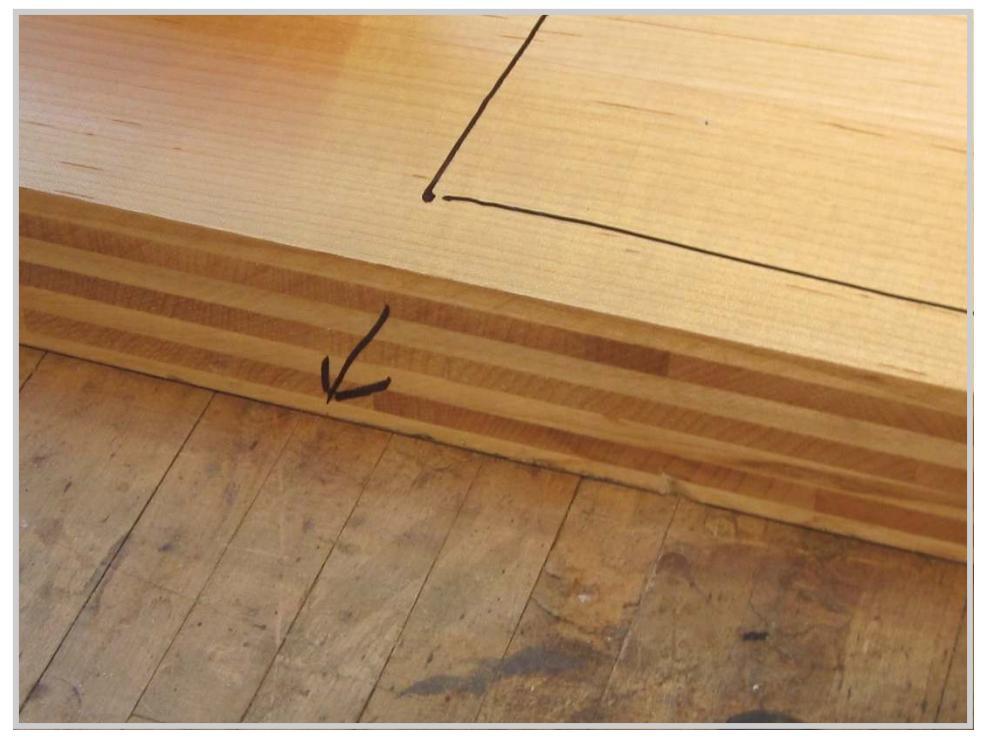
Photo 117: The slant of the cut is marked on the side of the pinblock.

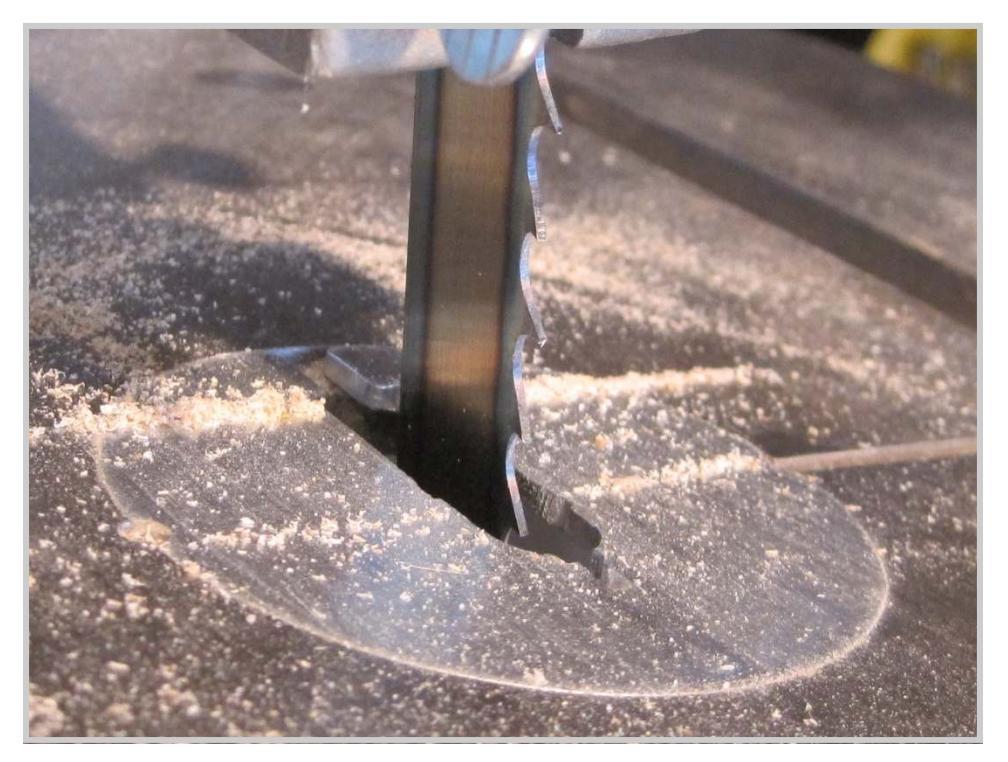
Photo 118: The 3/4" blade is set at a 3.5 degree angle to the table to match the angle of the inside of the flange on the cast iron plate. The closer the match of the cut surface of the pinblock to the flange, the less work will need to be spent in fitting the pinblock.

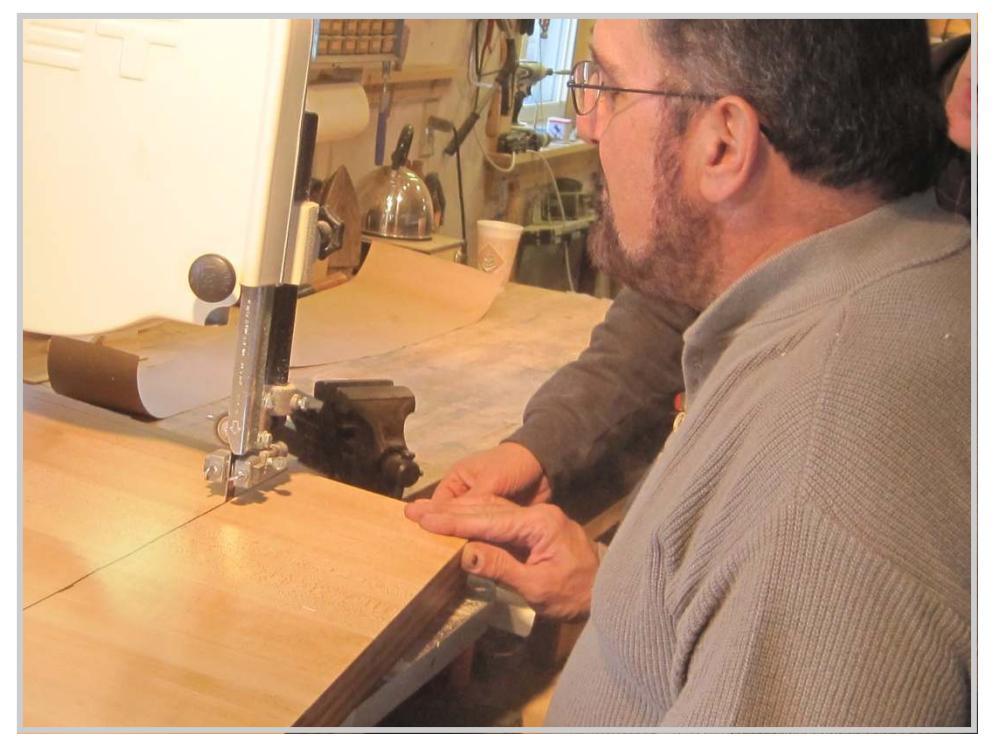
Photo 119: The WNG block is fed into the saw, with a person on either end and one in the center. The new blade cuts easily through the 2" maple, with no strain on the band saw.

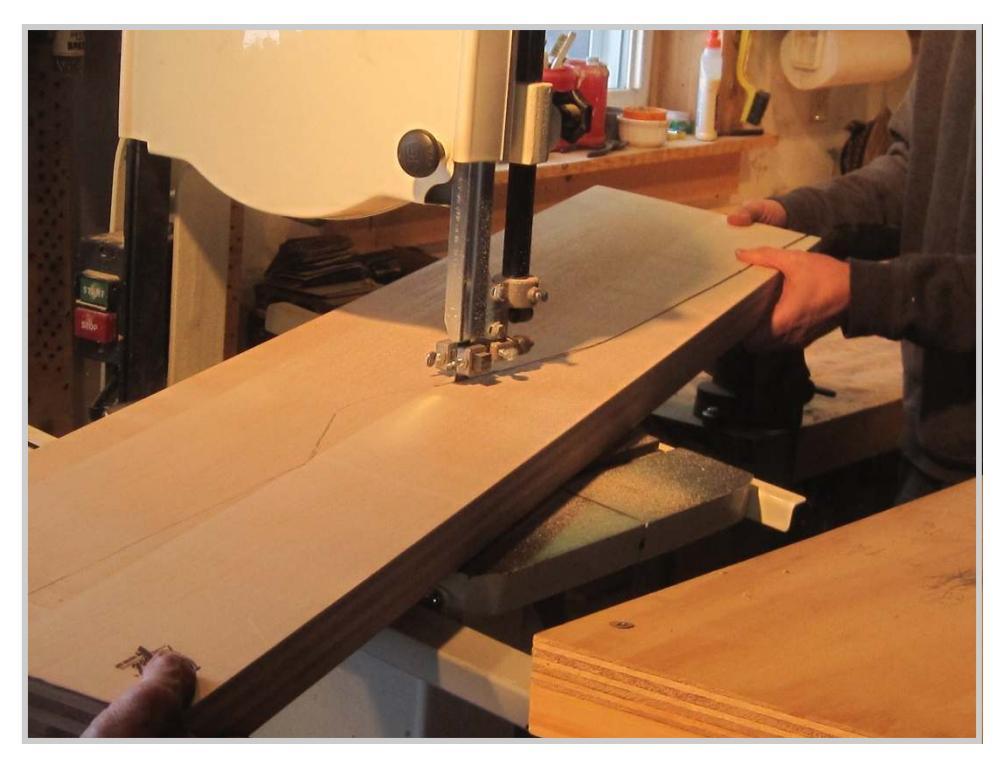
Photo 120: The Central Michigan block being cut, with the person to the left guiding the pinblock through the curves, and the person on the right stabilizing the pinblock as it comes off the table of the saw.

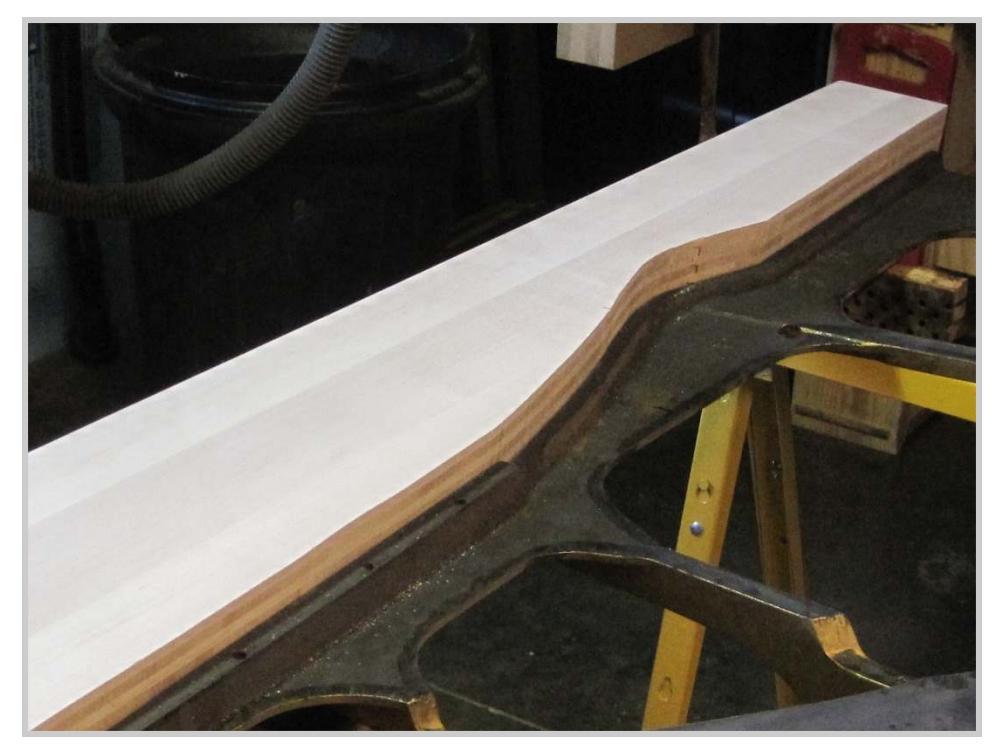
Photo 122: The fit of the Bolduc pinblock to the cast iron plate is checked out. A bit of grinding will need to be done on all three of the pinblocks to complete the fitting process.

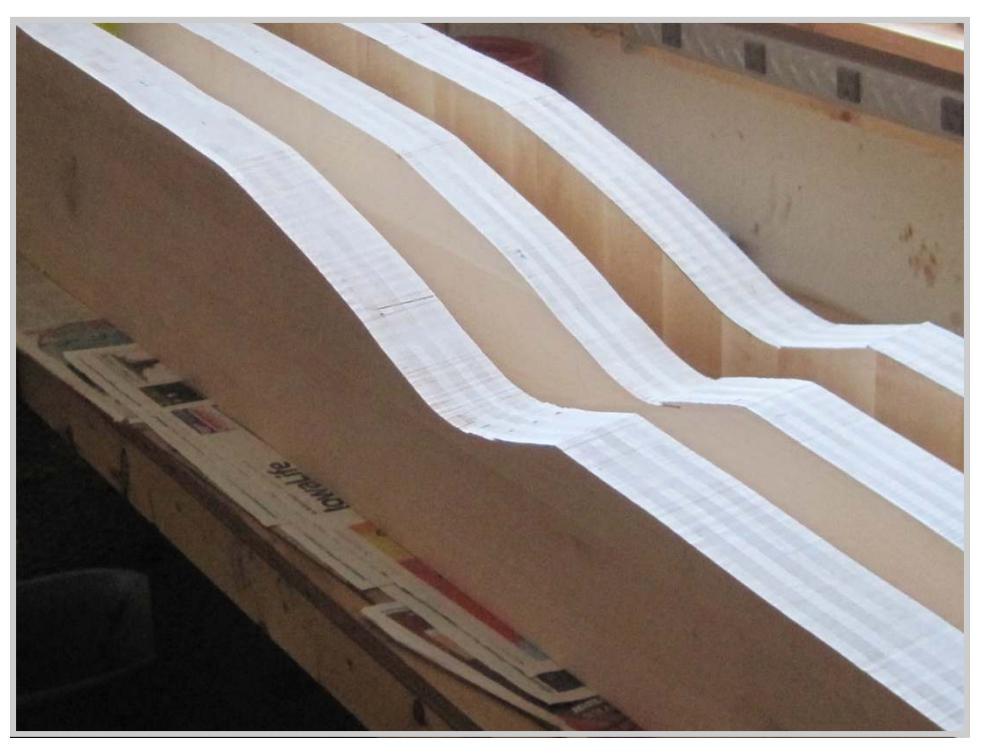
Photo 123: The three cut pinblocks side by side. By the time they are all fitted, everyone will have experience with the process involved.

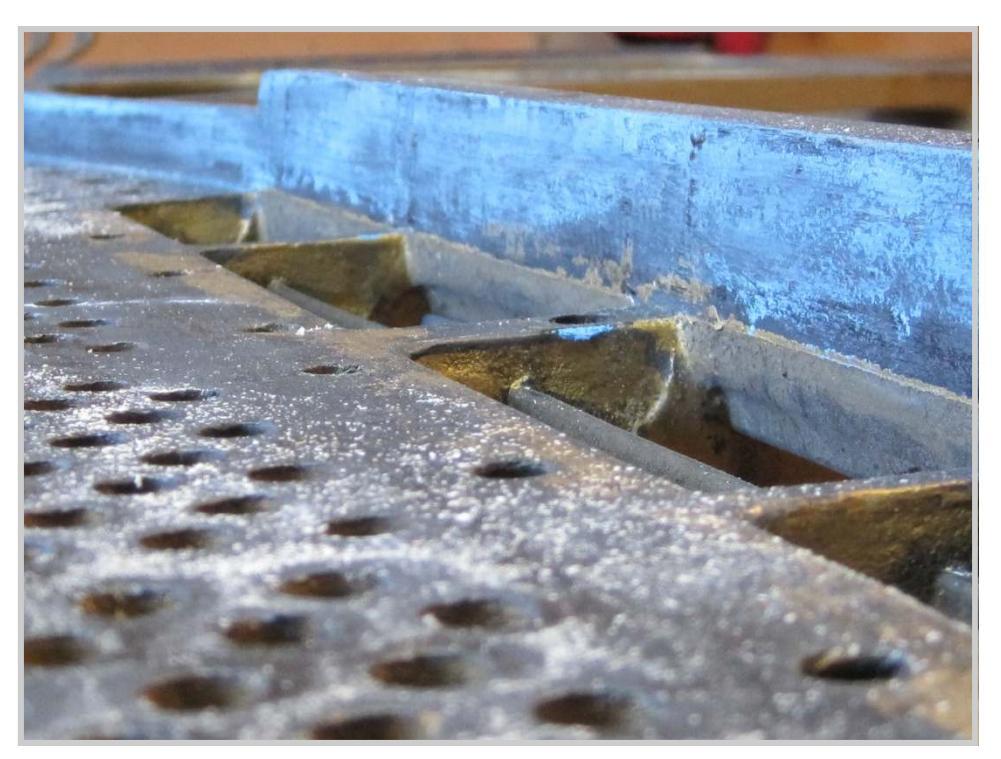
Photo 124: The flange of the cast iron plate that the pinblock will be fitted up against.
