Steinway Upright Restoration Project

Day 5

Restoration Project Photo Essay - Steinway upright

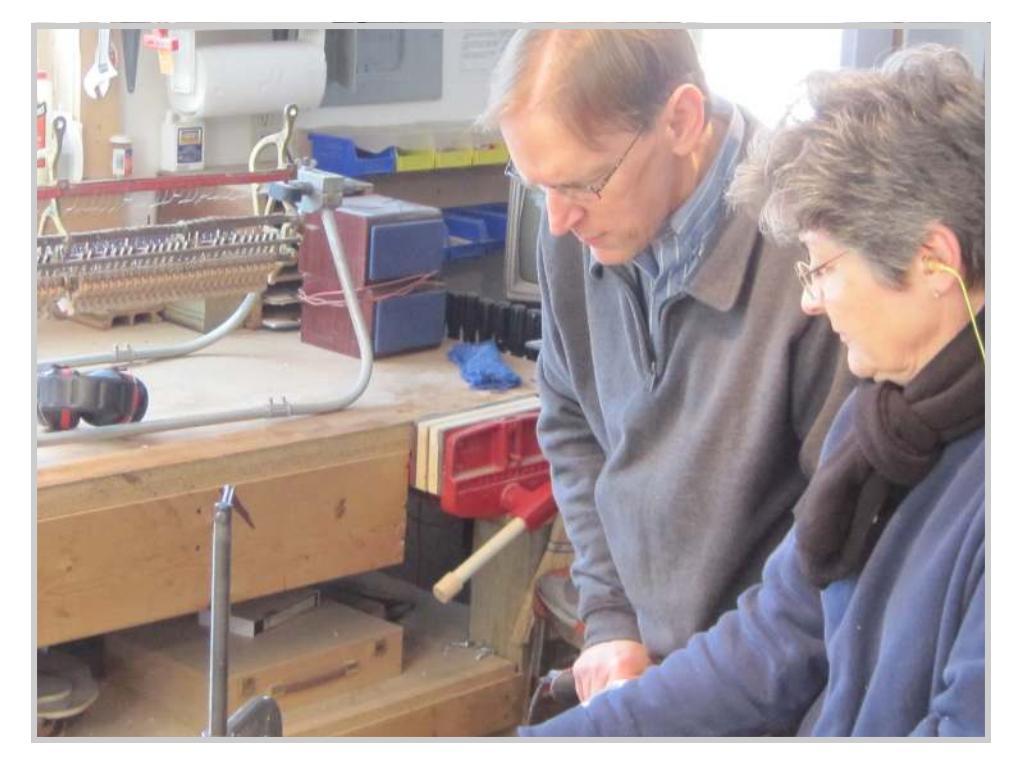
Photo 125: With a late morning start, and an 18" stretch of holes left to drill, Steve gets going on drilling the remaining holes. Bev holds the compressed air stream aimed at the bit to keep it as cool as possible. .

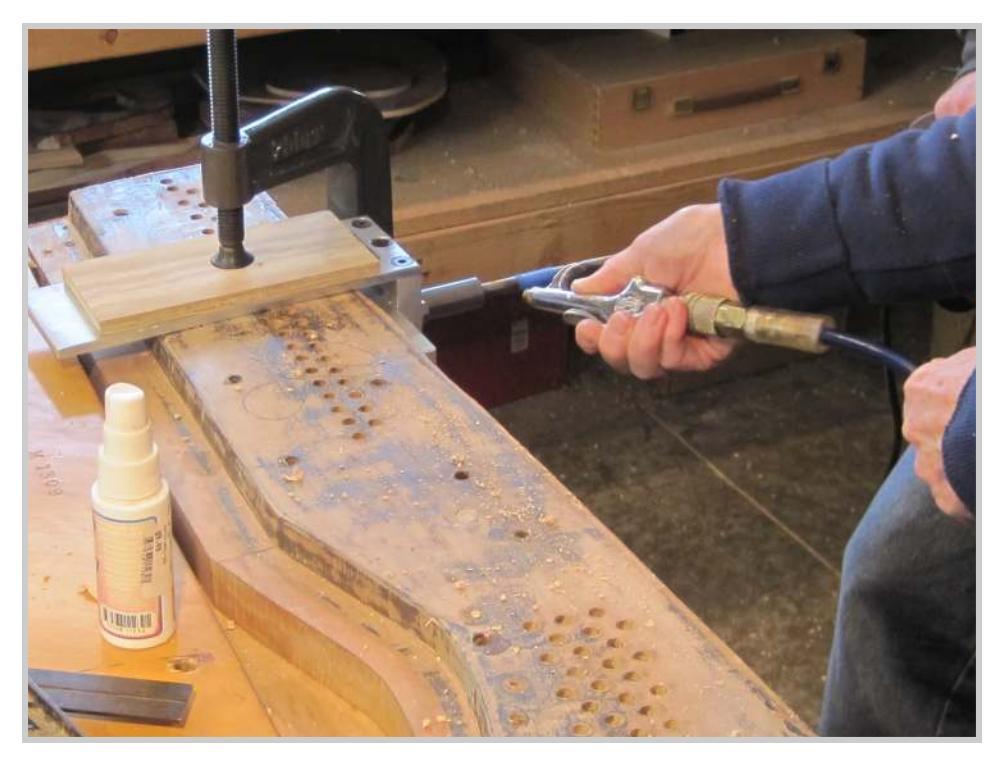
Photo 126: The jig from Bolduc is just a great tool for this job. After each hole is drilled, the clamp is loosened, the jig is moved over one place with the guide pin being inserted into the new hole, and drilling commences once again. Keeping the bit cool and sharp proved to be very important.

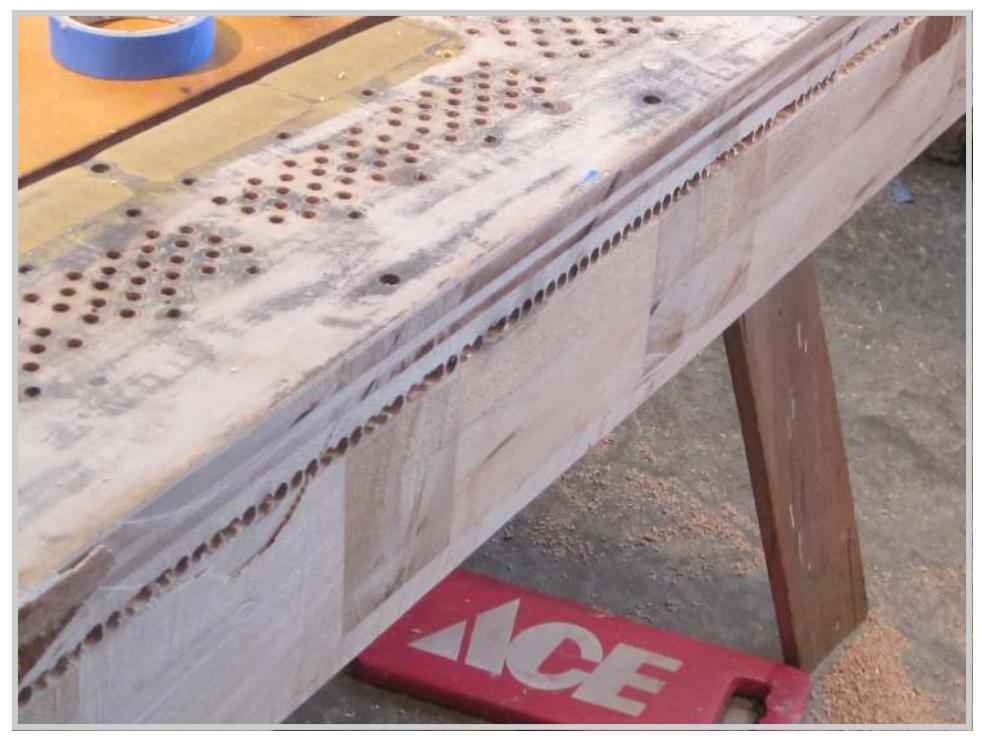
Photo 127: After lunch we get back at it, and before long the entire length of the pinblock is undercut with holes..

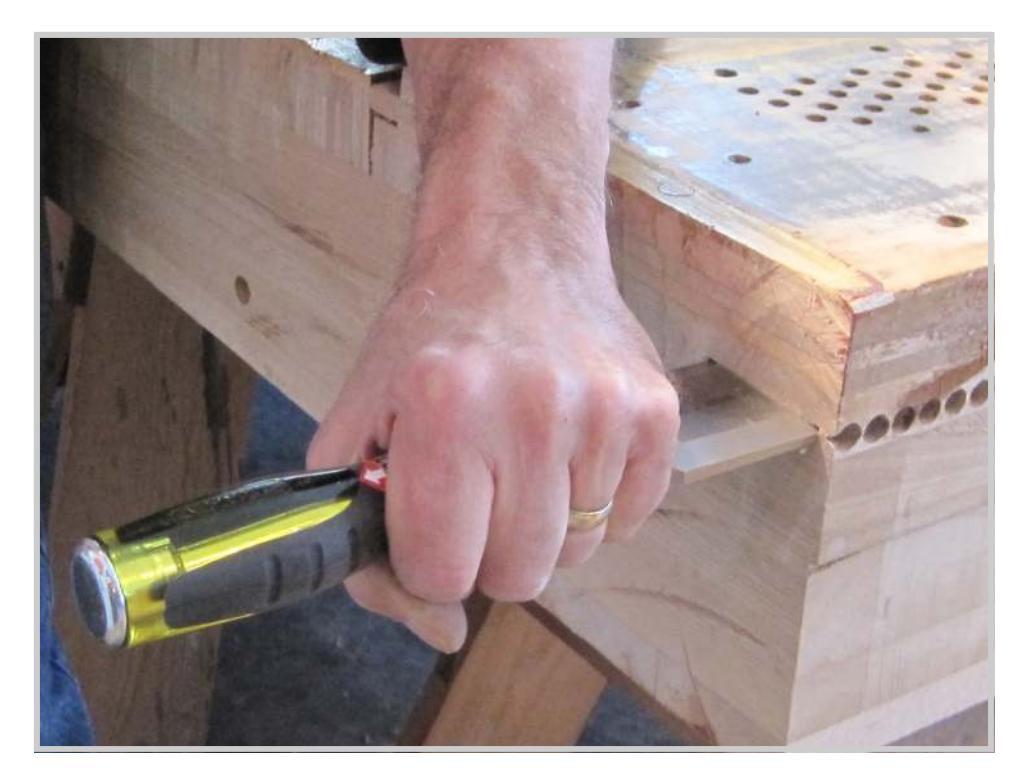
Photo 128: Using a chisel and a ball peen hammer, I take the first step in breaking apart the pinblock from its wooden backing.

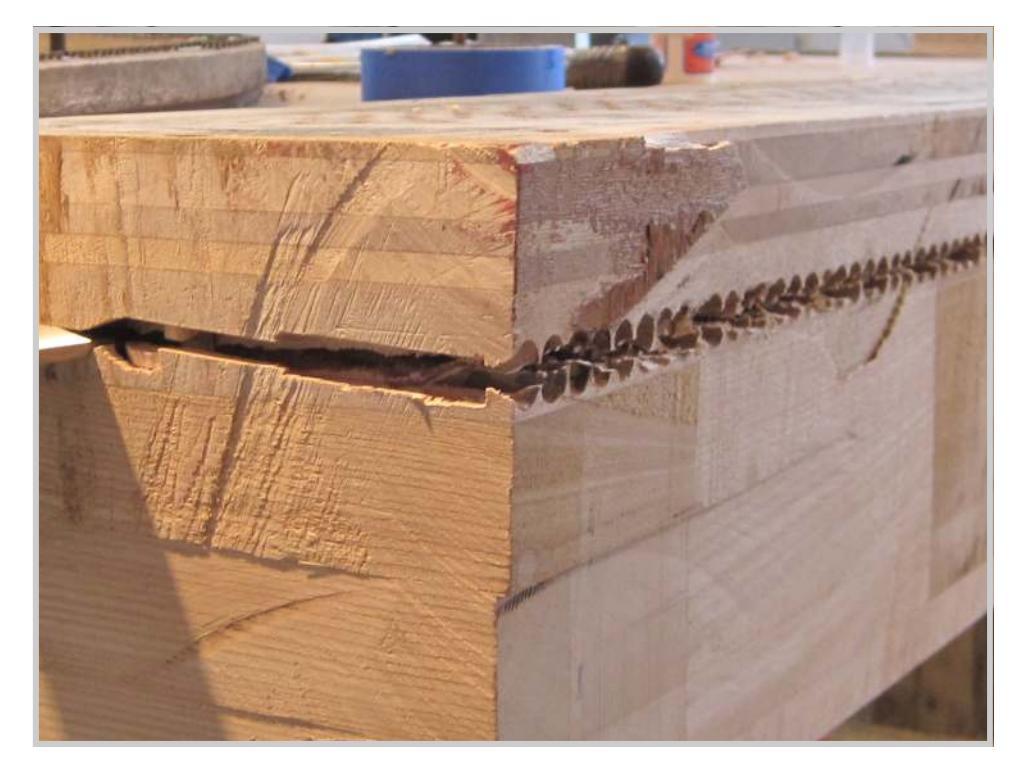
Photo 129: With a little effort on my part, the separation of the pinblock from the wooden framework of the piano begins. The line of holes are not quite touching, but are separated by a thin wall of wood. Just under the holes, the seam between the pinblock and the framework can be seen in the above photo.

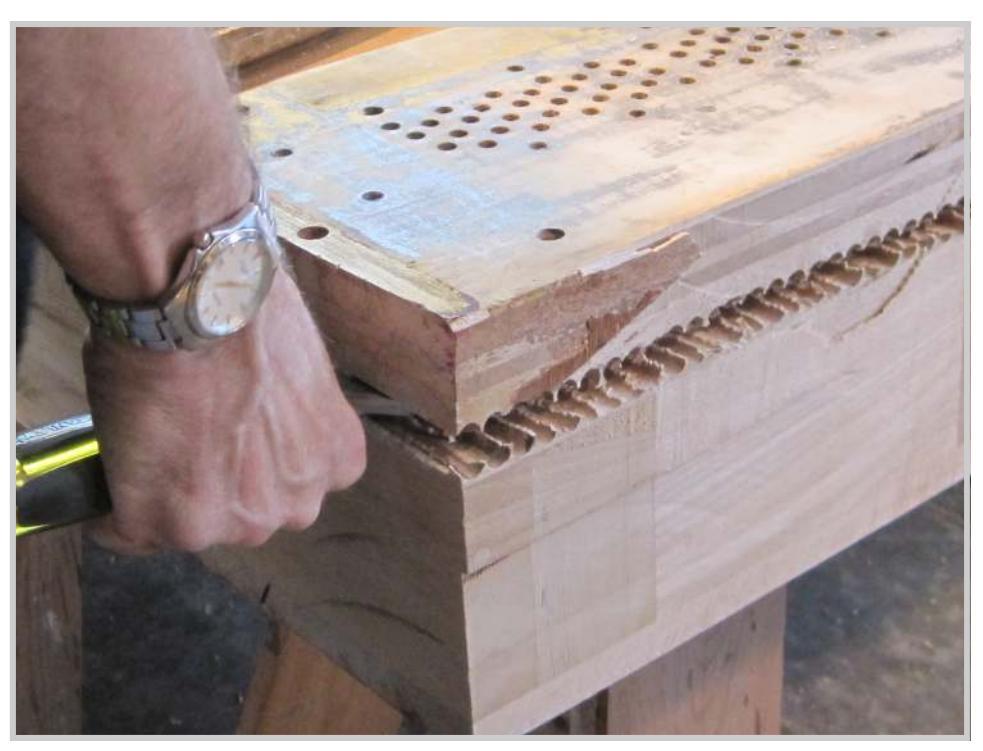
Photo 130: With the blade of the chisel driven in as far as it will go, I lift up, and a cracking sound fills the room.

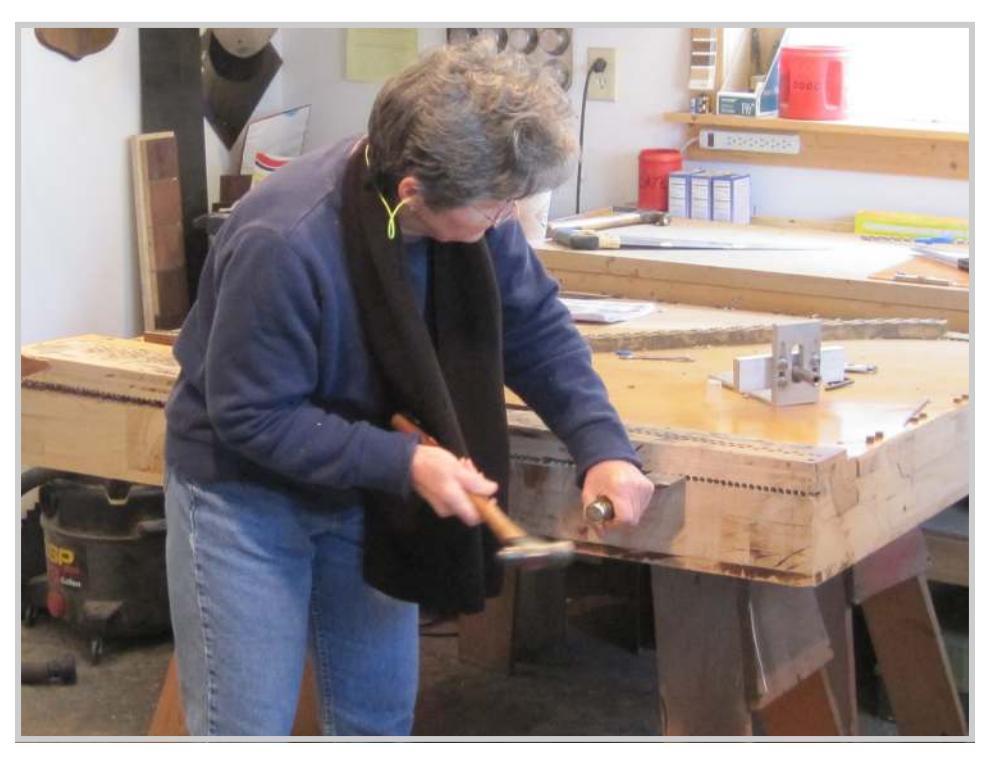
Photo 131: Bev uses the chisel and hammer to extend the split near the treble end of the pinblock.

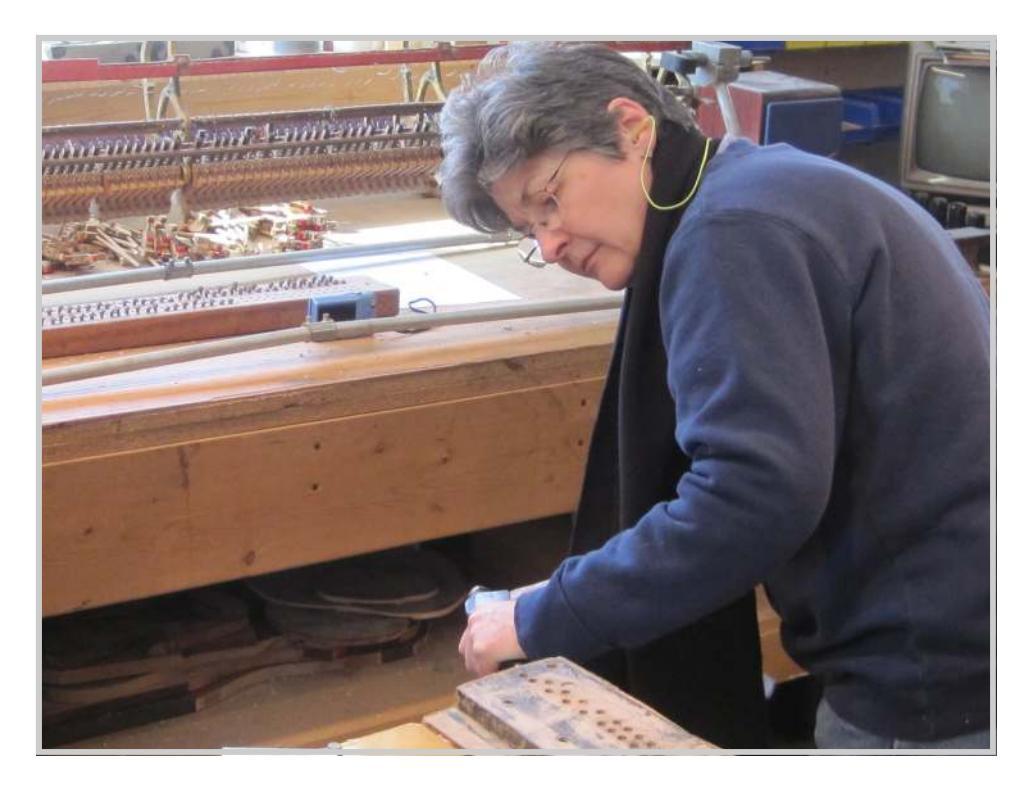
Photo 132: Bev then goes around the corner, to complete the break from the opposite end from which we started. .

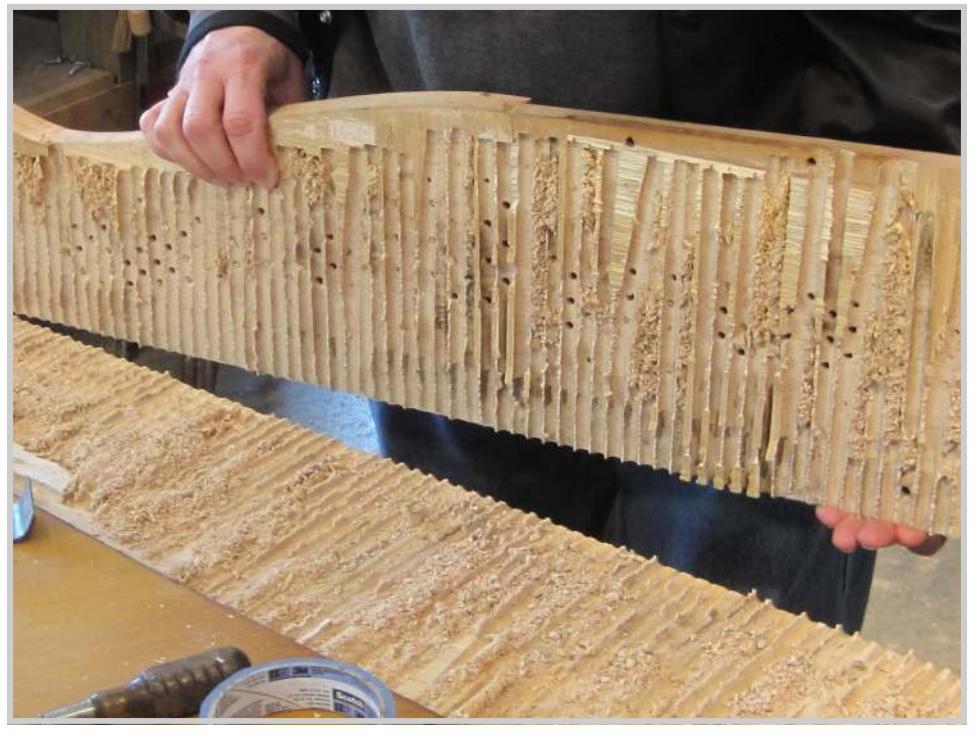
Photo 133: Voila! The pinblock comes off in one complete piece!

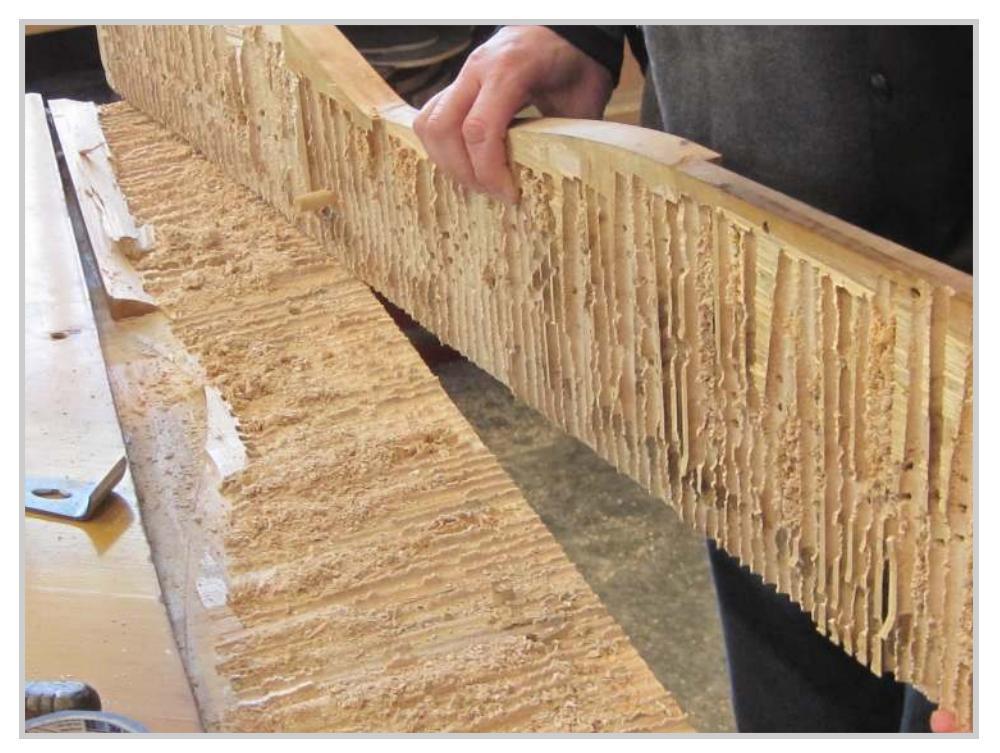
Photo 134: Using this method, probably 95% of the old pinblock is now removed from the back assembly. To finish the job, the remaining layer of old pinblock will be removed. (The split-off chunk of wood seen near the top is from a separate runner of wood that was butted up to the pinblock.)

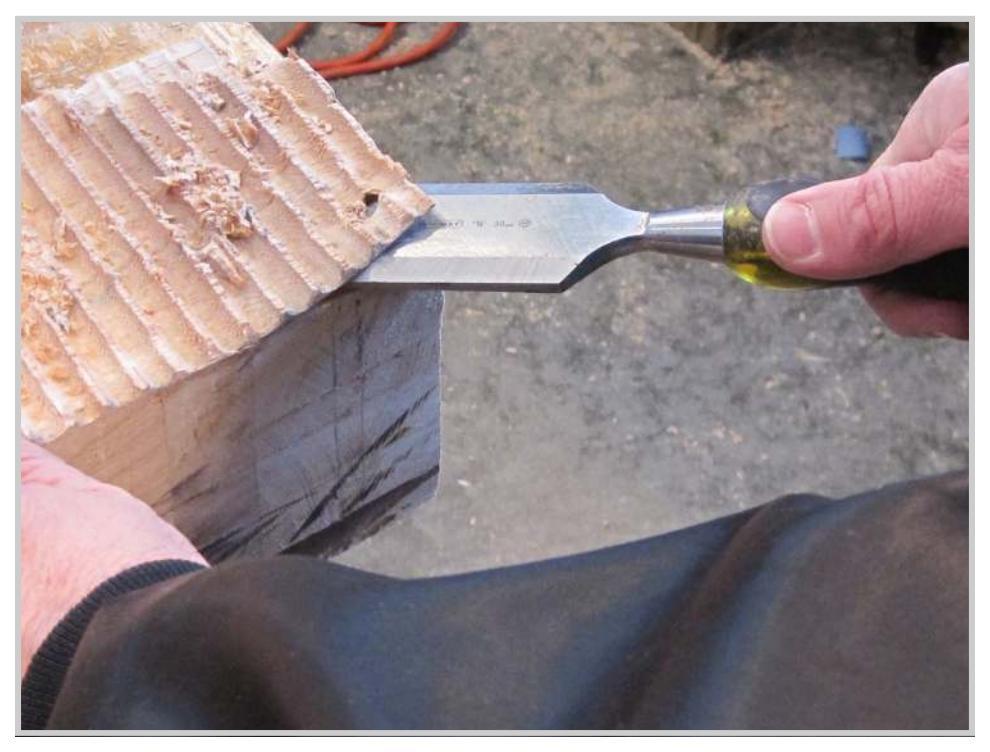
Photo 135: Steve tries removing the remnants of pinblock material with the chisel. The corner is loose, but further in the glue still holds tight.

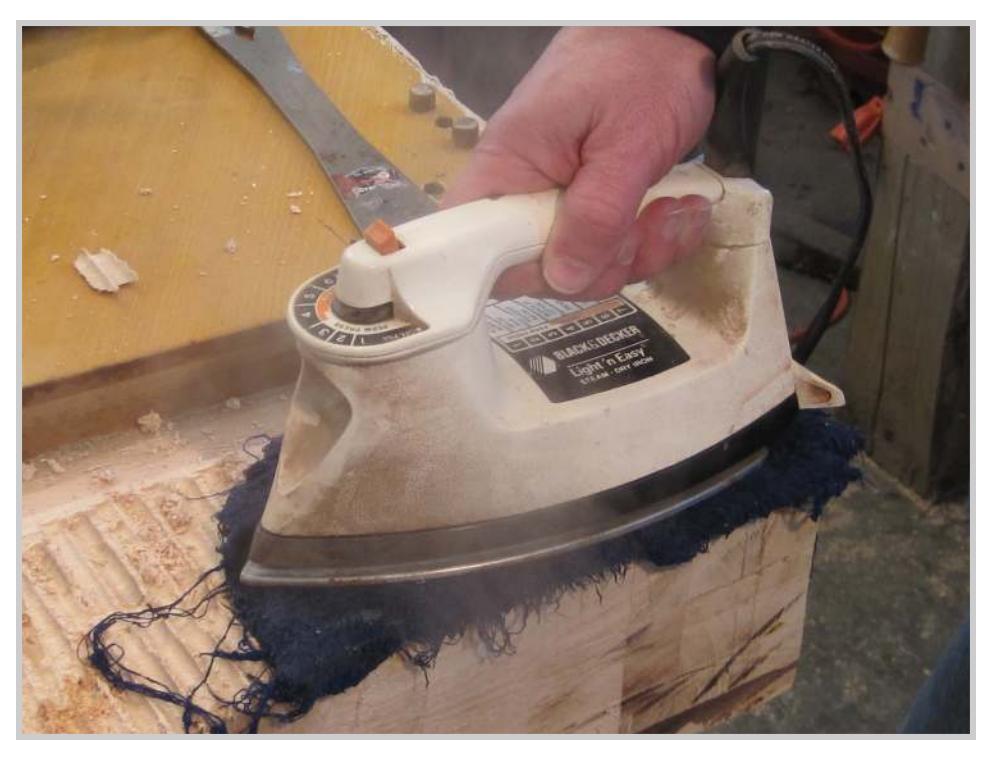
Photo 136: A damp rag and steam iron are brought into action to help soften the glue joint.

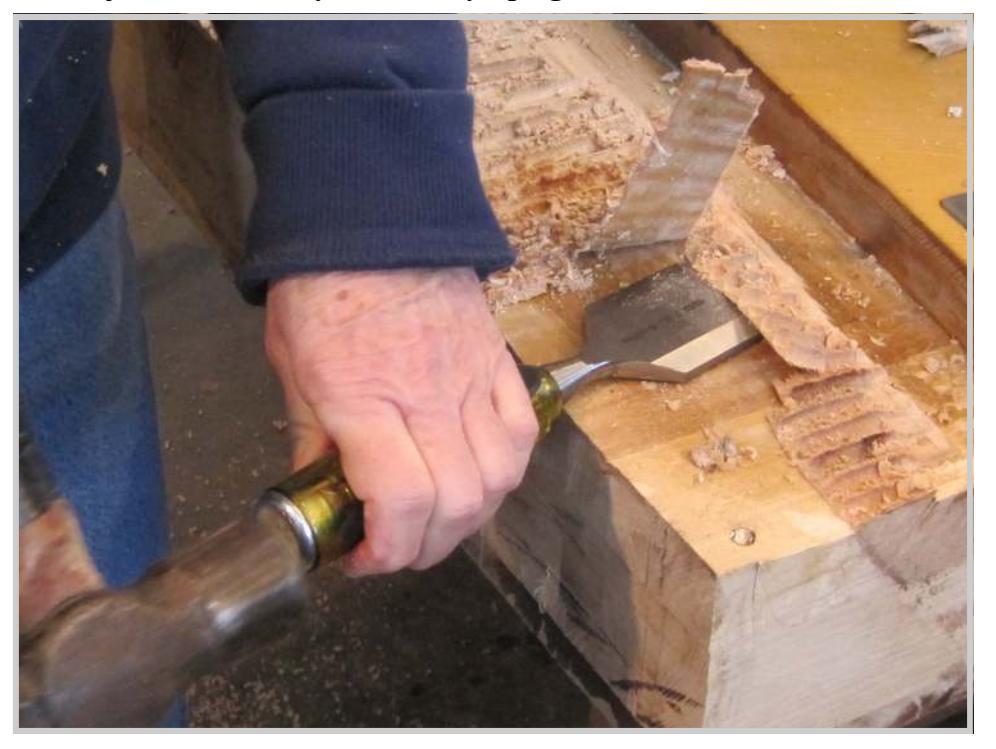
Photo 137: Bev works away at the job with the hammer and chisel. With the steam and heat, the remaining layer of pinblock material begins to come off. Although we weren't able to finish the job on this day, we made considerable headway - on our next work day we should have the surface completely prepared for the new pinblock.

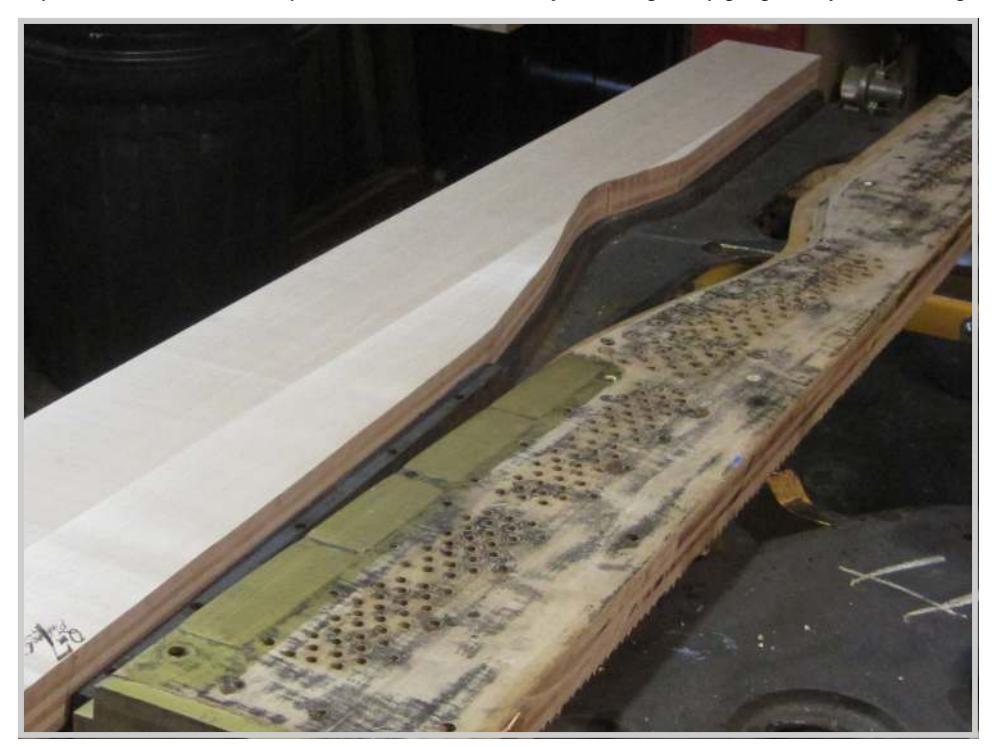
Photo 138: In another room of the shop, the cast iron plate is on sawhorses, ready to fit the new pinblocks. This will have to wait until next time as well - time is always shorter than you would like. The advantage of this method of pinbock removal is that the surface of the old pinblock is untouched, leaving it available to refer to.

Next up: Next time, hopefully, we will be able to fit the three sample pinblocks to the plate. The pinblocks will then be ready to attach to the back assembly of the piano. We will screw each block to the back, put the plate into position, and use the roll-around drill press (which I will build on my own to expedite the process) to practice drilling on 2/3's of each block. We will leave one section of each block undrilled, so that once everyone has practiced drilling, we can cut the pinblocks into thirds, and join the undrilled portion of each block into a continuous whole. We will then glue the splice pinblock into place, and drill the entire block.

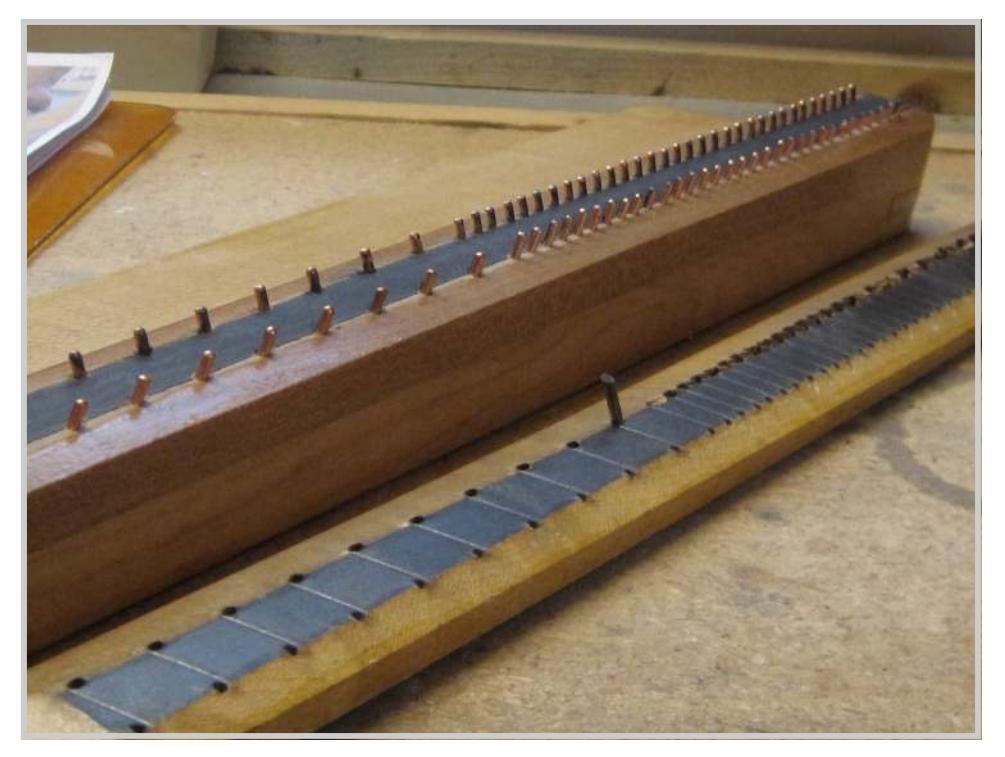
Photo 139: Thanks to Harold Marling, we now have a new bass bridge for the piano. (Refer back to . Photo set # 3, photo # 93 to see Harold removing the old bridge). Harold did a great job on the bridge! (I do have photos to share, but need to discuss captions with Harold before I include them.)
