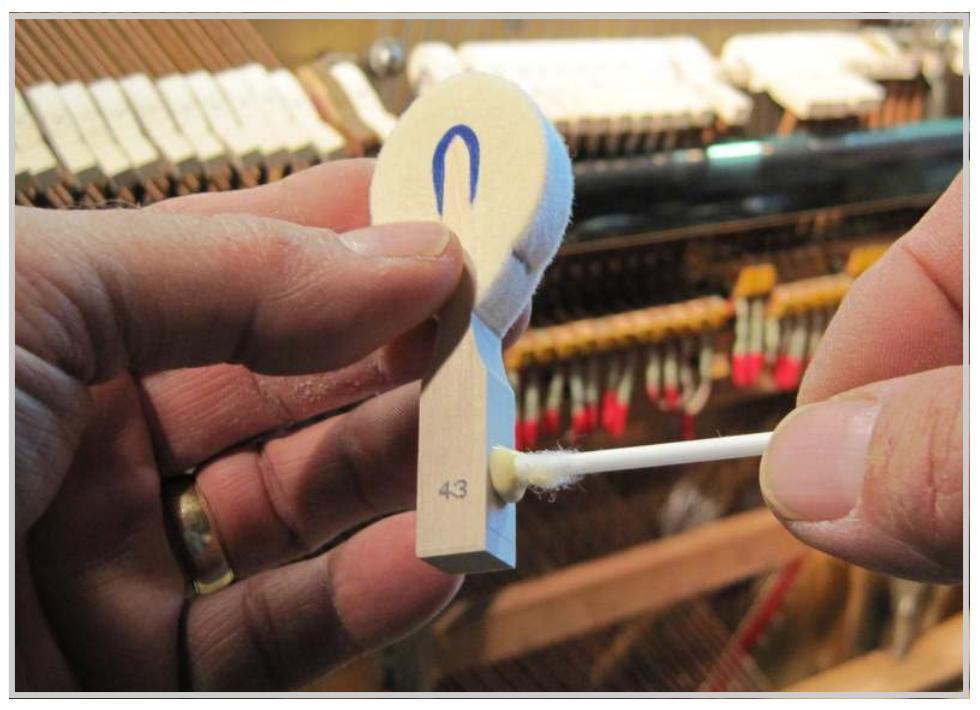
Photo 363: The piano action is now ready for its new set of Abel hammers. Titebond glue is swabbed into the predrilled hole in the molding of the hammer using a somewhat flattened Q-Tip.

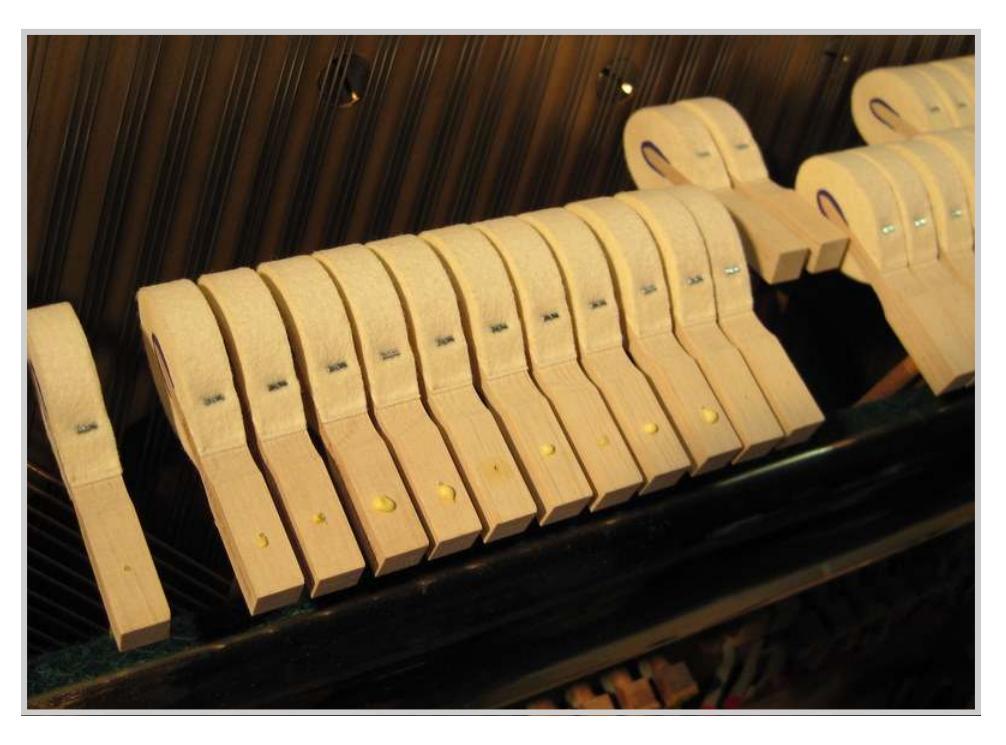
Photo 364: Each hammer has a tiny hole where the point of the drill bit penetrated. Adhesive squeezing out through this hole indicates the proper amount of glue has been applied. It will be cleaned off after the glue sets up.

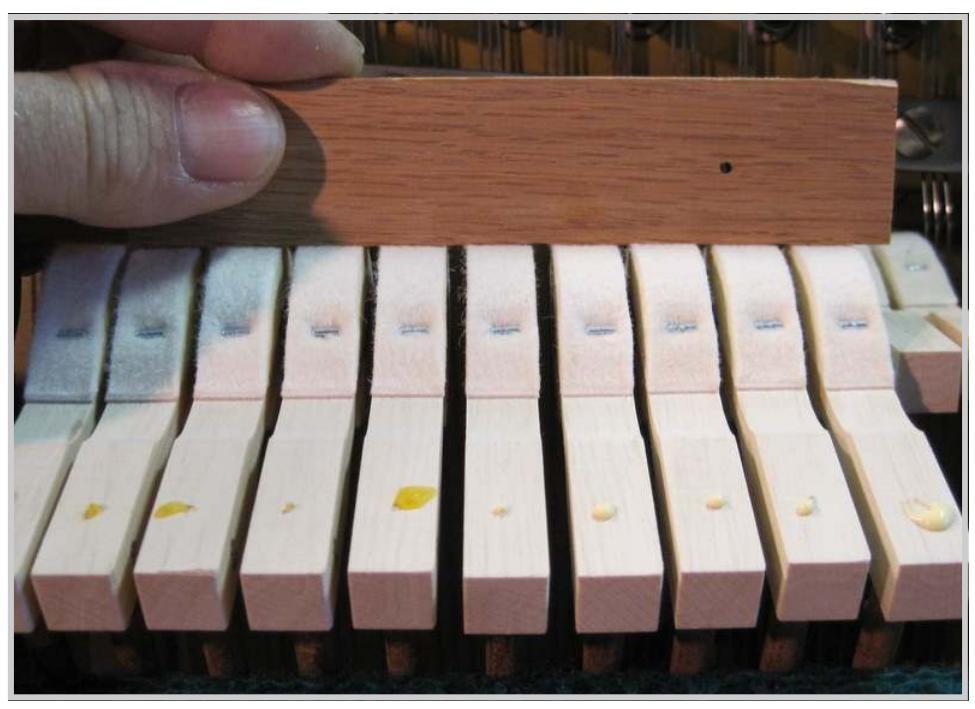
Photo 365: As hammers are glued into place, they are leveled four at a time. The glue on the hammers to the left has set. The four on the right have just been put into place. They are aligned with the strings, then leveled with the previous set.

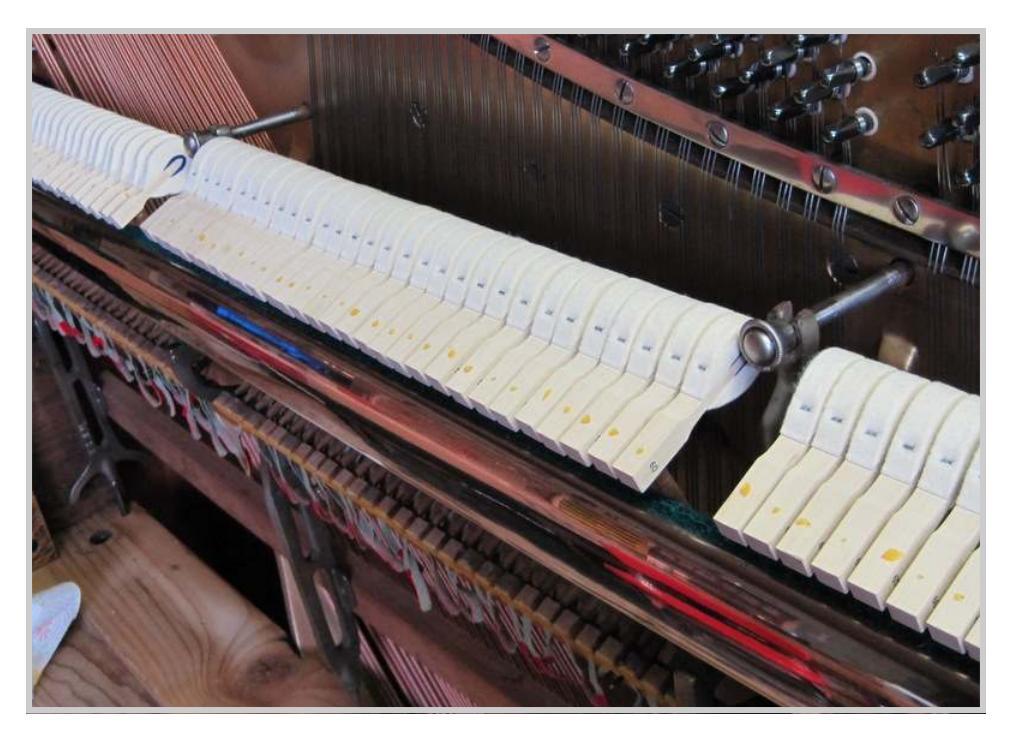
Photo 366: Except for cleaning off the dried glue, the installation of the new set of hammers is complete.

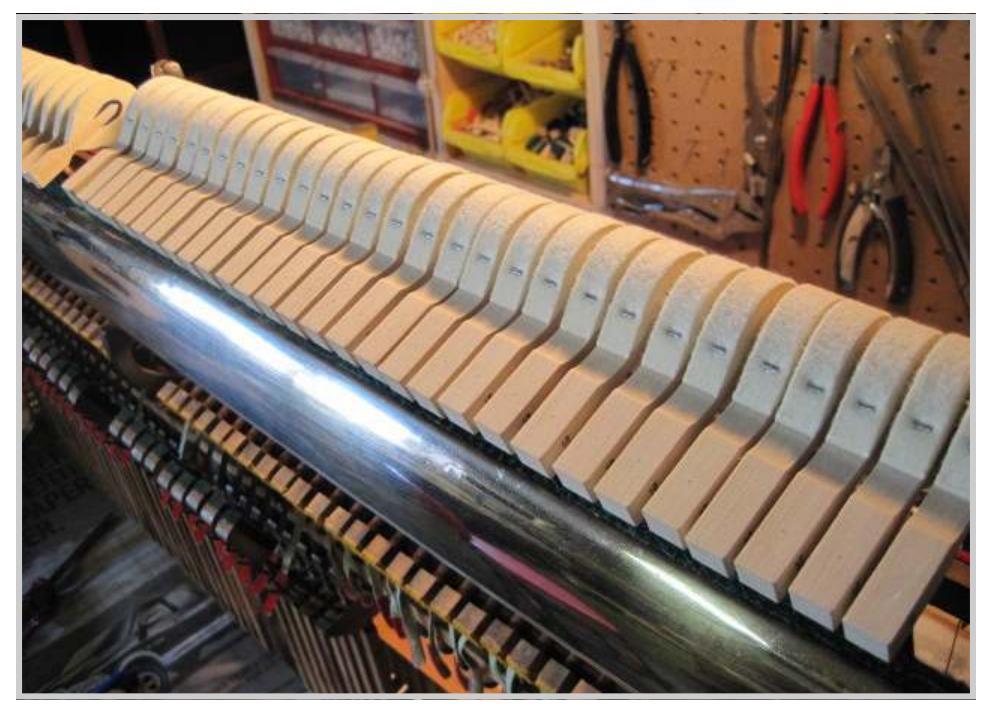
Photo 367: The finished hammer line. Refer to photo #42 of photo essay 3 to view original hammers.

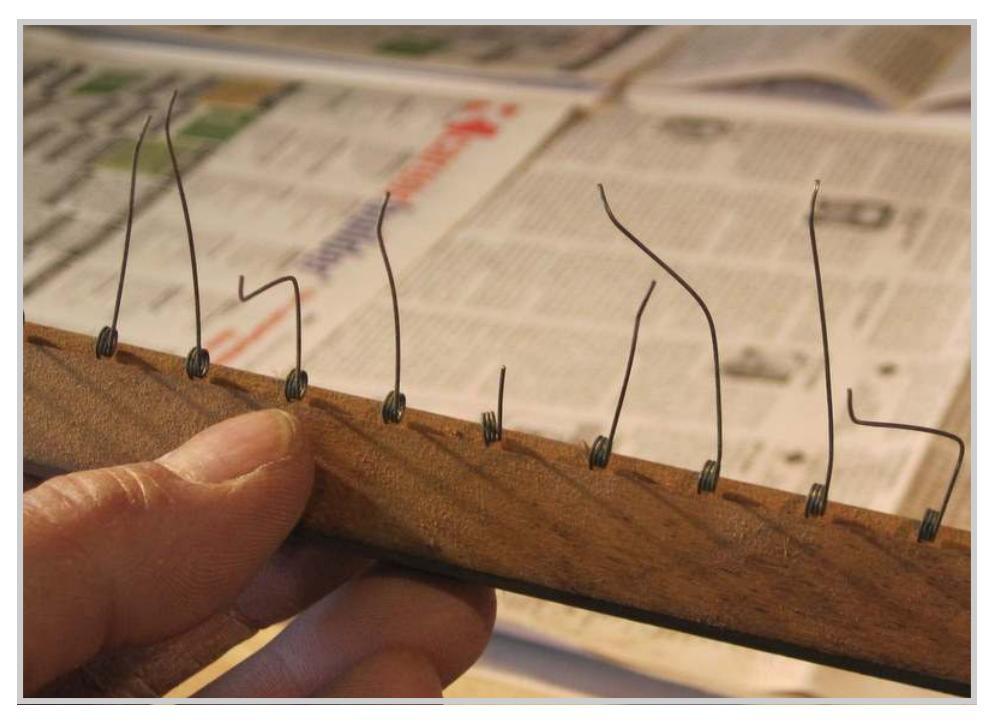
Photo 368: Another concern - the hammer spring rail. These springs are positioned in the action to assist the hammers in returning to rest position after each note is played. The original springs shown here are clearly in unusable condition. My pet theory on this is that the mice inhabiting the piano used these springs to floss after a hard day of gnawing on the keyframe. There's nothing as irritating as wood chips stuck in your teeth!

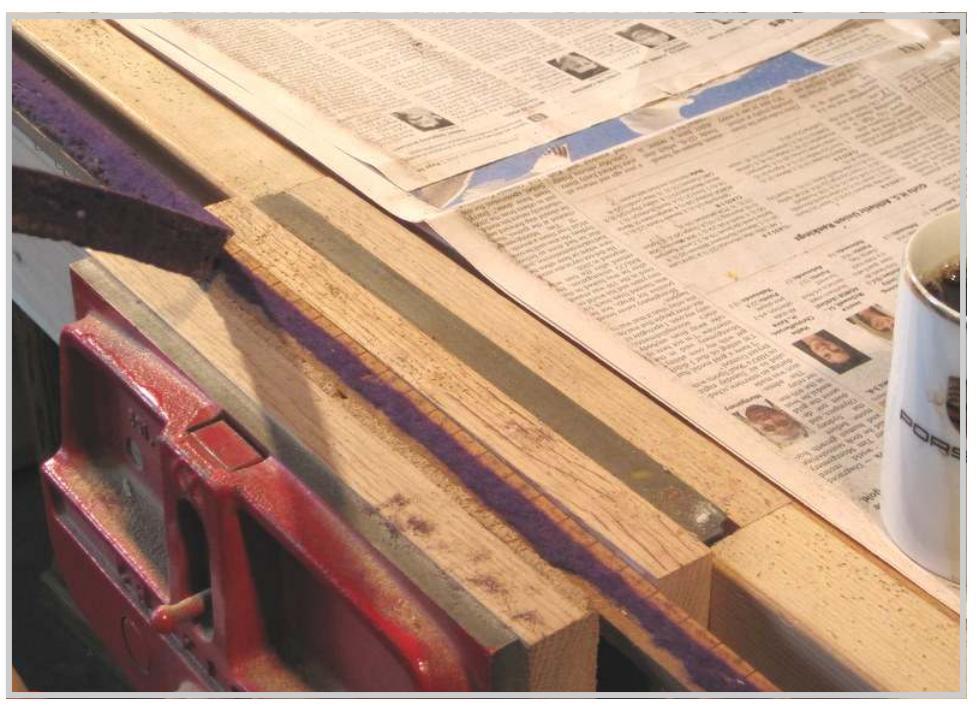
*Photo 369: The back of the hammer spring rail is felted. To replace the springs, this felt must be removed. The rail is put in the vise, and the bulk of the felt is pulled loose. The wood will be scrapped clean and lightly sanded after the old springs are removed.*

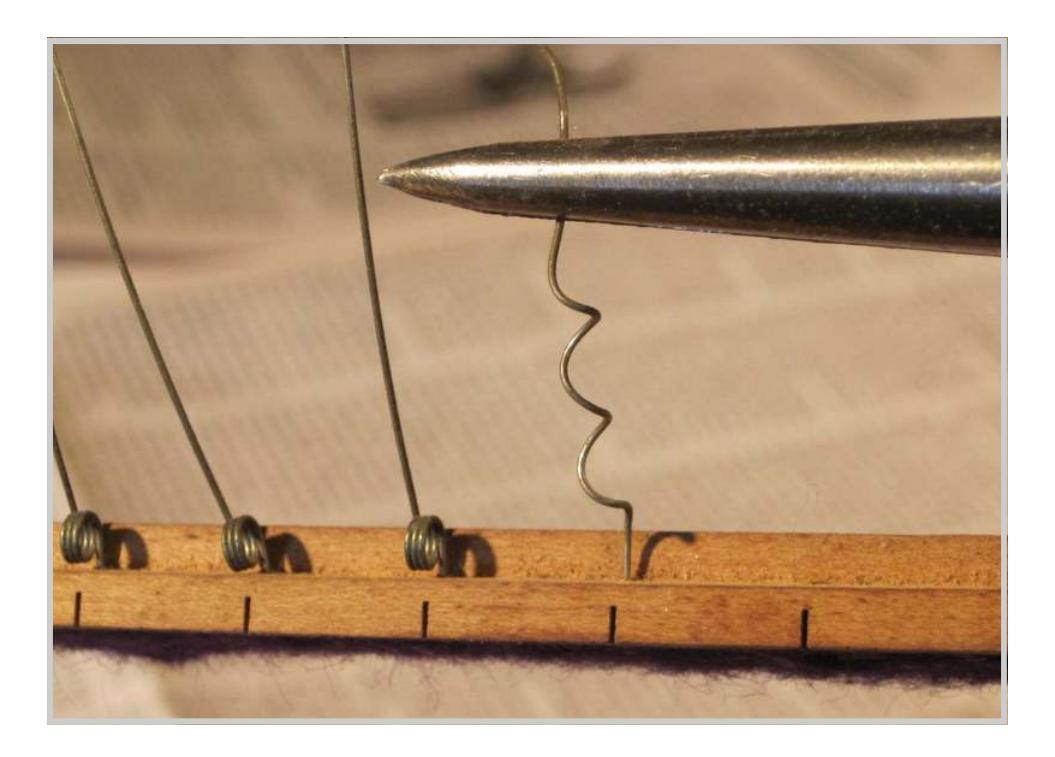
Photo 370: To remove the old springs, the coil is first stretched out.

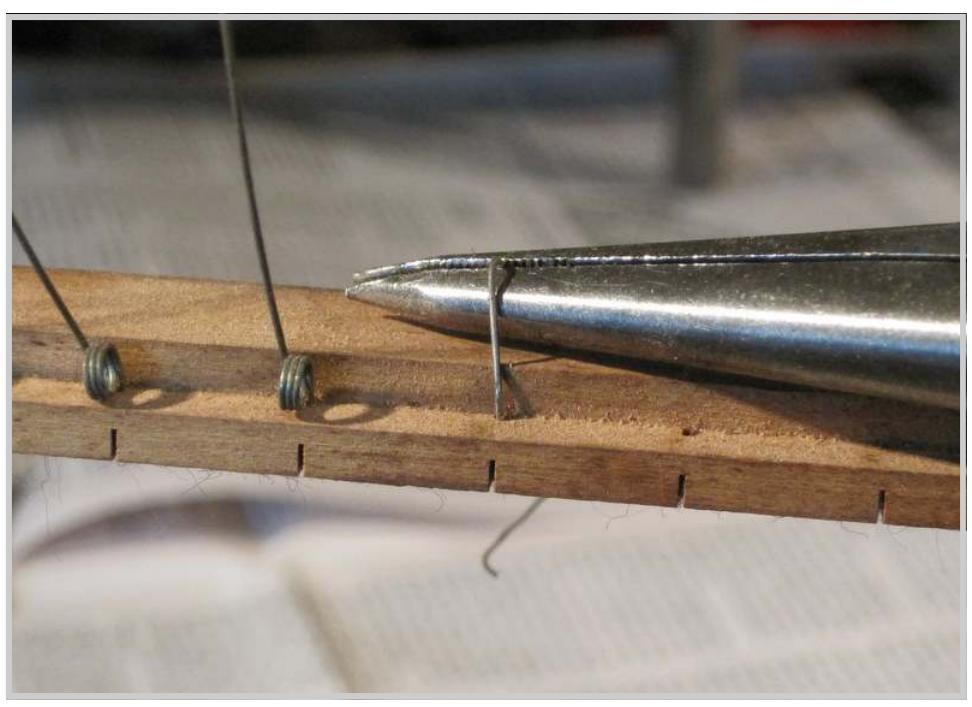
Photo 371: The spring is next firmly grasped with a pair of needle nose pliers close to the insertion point into the rail. By slowly turning the pliers clockwise and rotating them against the body of the rail, the end of the wire is pulled loose from the tiny hole in which it is held in place.

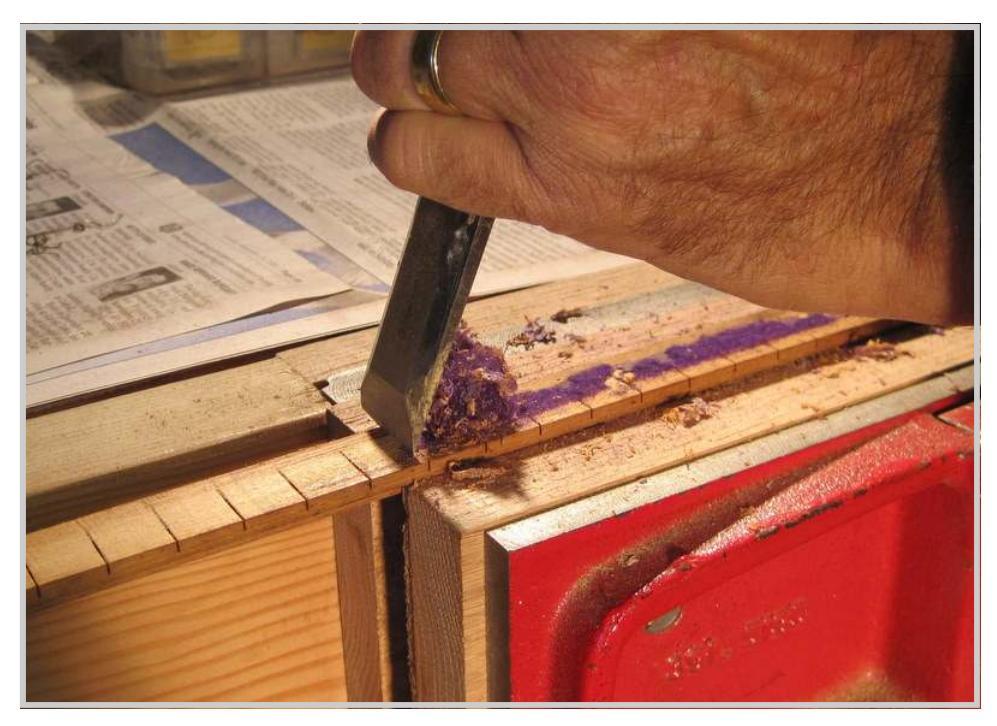
*Photo 372: With all the springs removed, the rail is returned to the vise, where the remaining felt is scraped clean. Both sides of the rail are then lightly sanded in preparation for new springs and felt.*

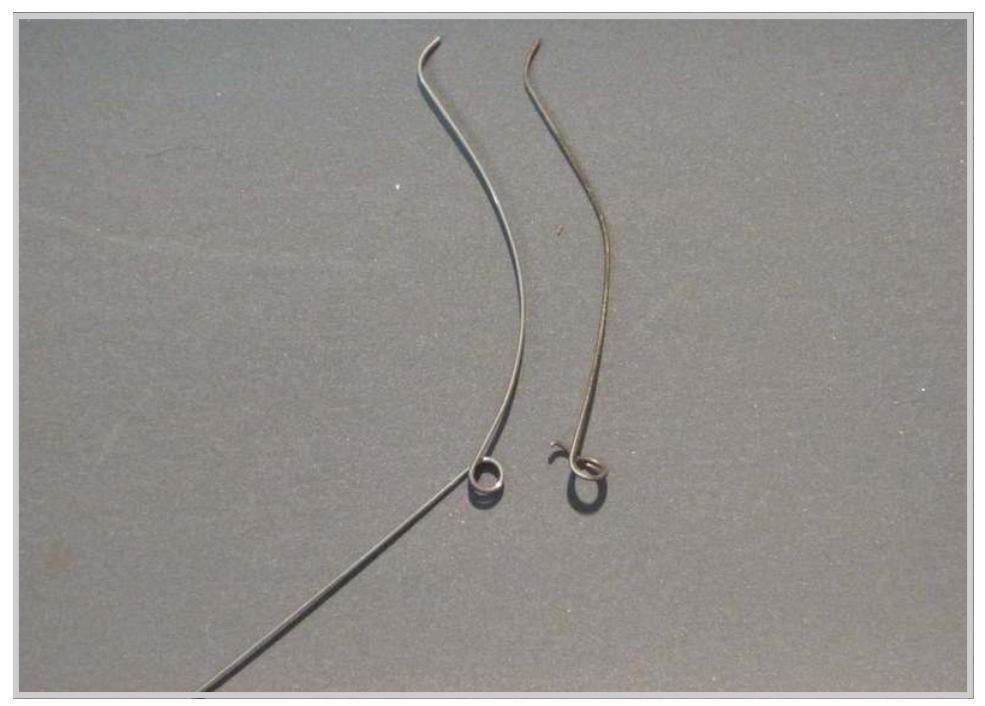
Photo 373: The correct replacement spring must be chosen from several lengths which are available. The long tail of the new spring will be inserted into the original hole in the rail, and then drawn through a newly drilled second hole to cinch it tightly into place.

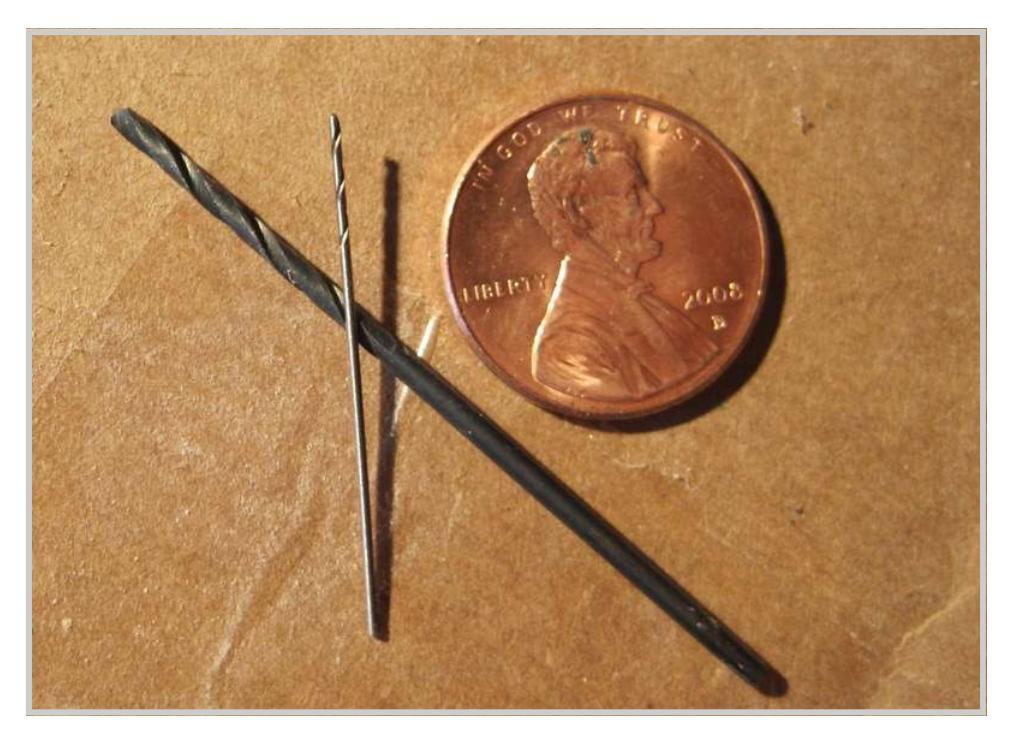
*Photo 374: The drill bit needed to drill the take-up hole for the tail of the spring. Only 25 thousands of an inch in diameter, it is dwarfed by a 1/16" drill which itself is the smallest size in most ordinary drill indexes.*

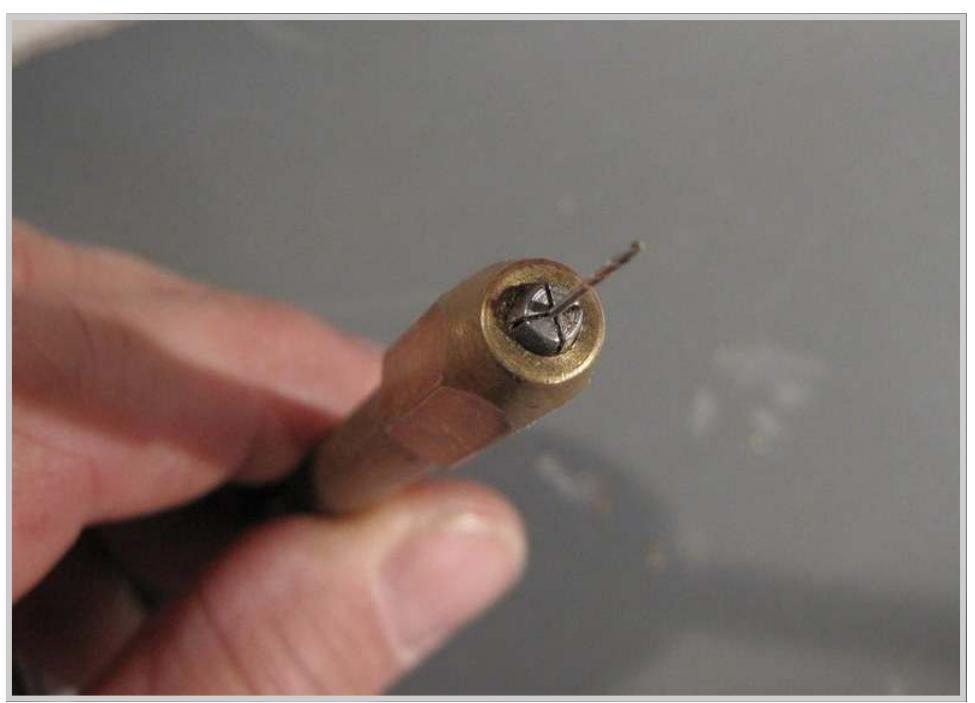
Photo 375: With this size of bit, the collet in the chuck of a normal drill won't come close to being able to hold it in place. Instead the bit is here placed in a zero clearance collet of a pin vise.

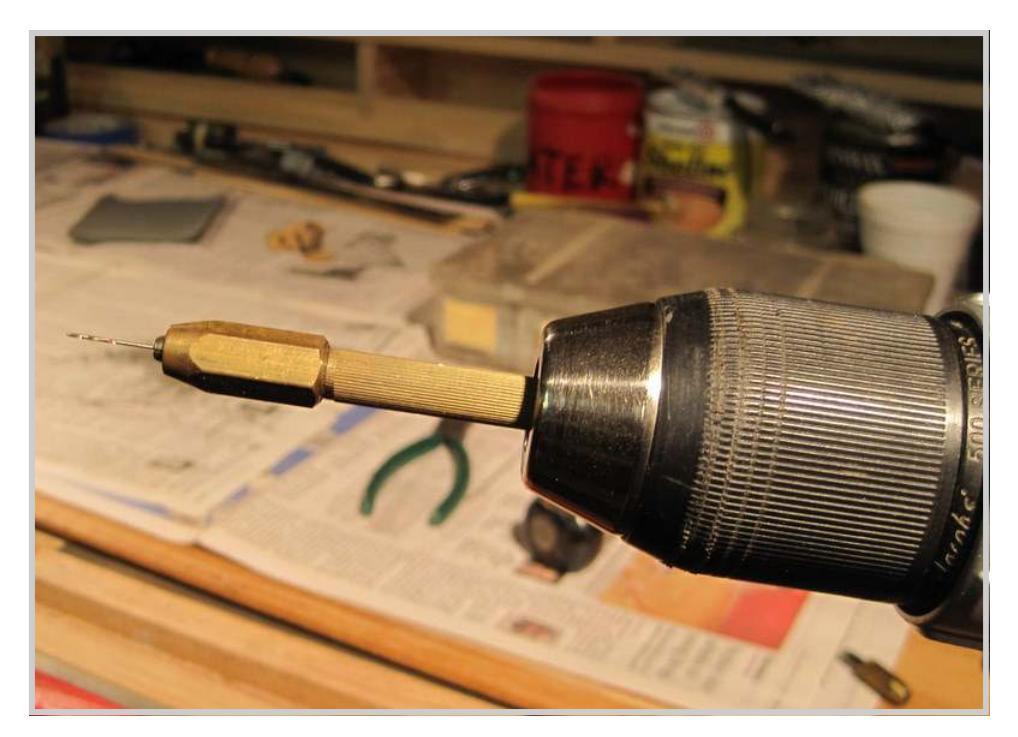
*Photo 376: Although the pin vise is ordinarily used by itself, for this application it is placed into the chuck of an electric drill.*

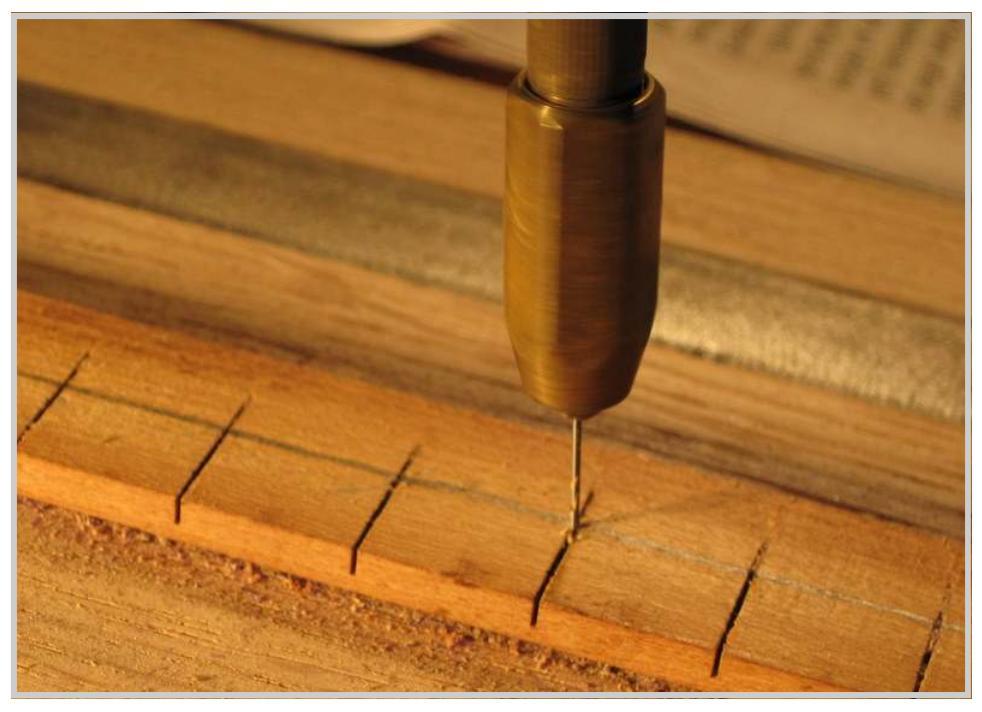
Photo 377: The new hole is drilled at the end of the slot that the tail will be drawn into.

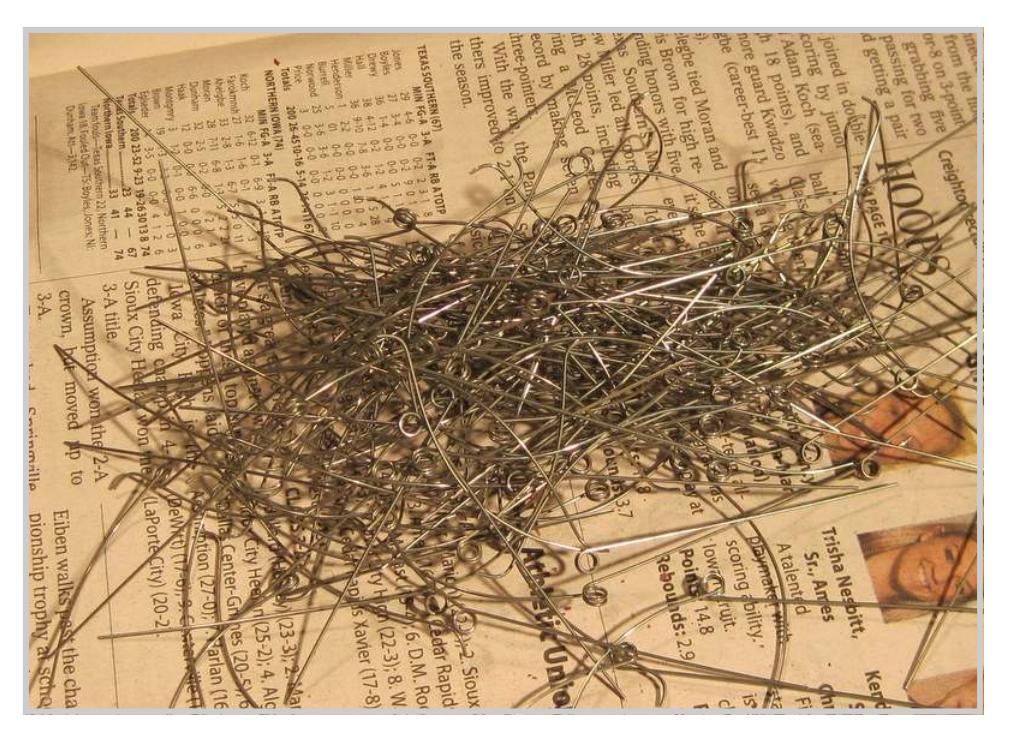
*Photo 378: The new springs right out of the sack, looking very much like a batch of Christmas ornament hooks. Creating order out of chaos is day-to-day part of the restoration process.*

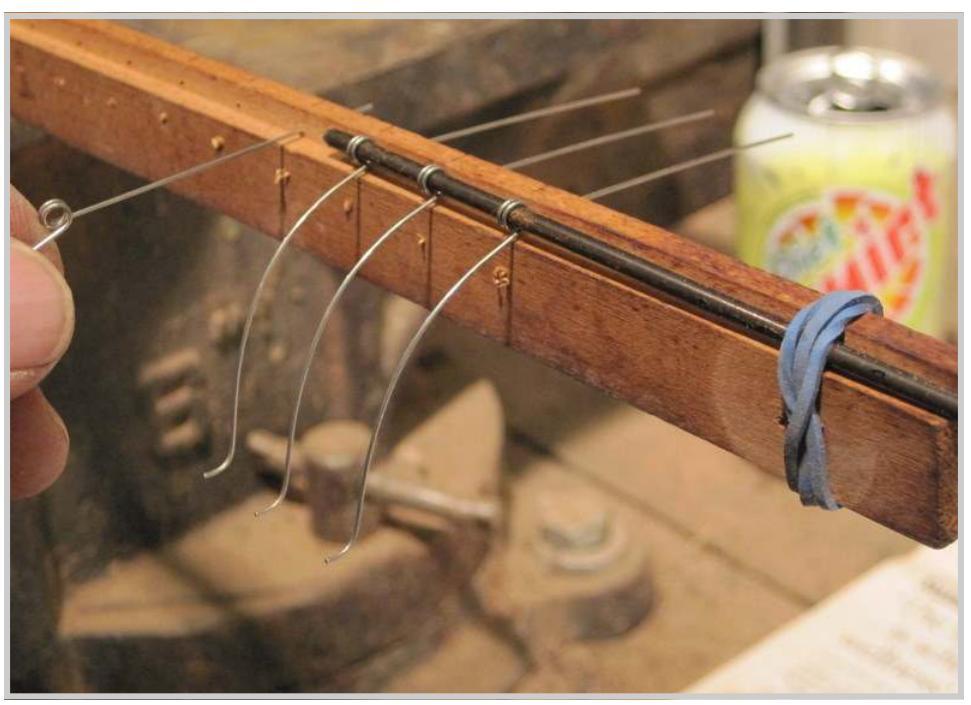
Photo 379: With the rail held firmly in place in a vise, the new hooks are inserted through the original spring holes. The black wire in the slot being held in place by the rubber band is actually just a piece of coat hanger wire, which is temporarily used to hold the coils of the springs in position. The hole underneath each spring is the takeup hole through which the tails of the springs will be drawn.

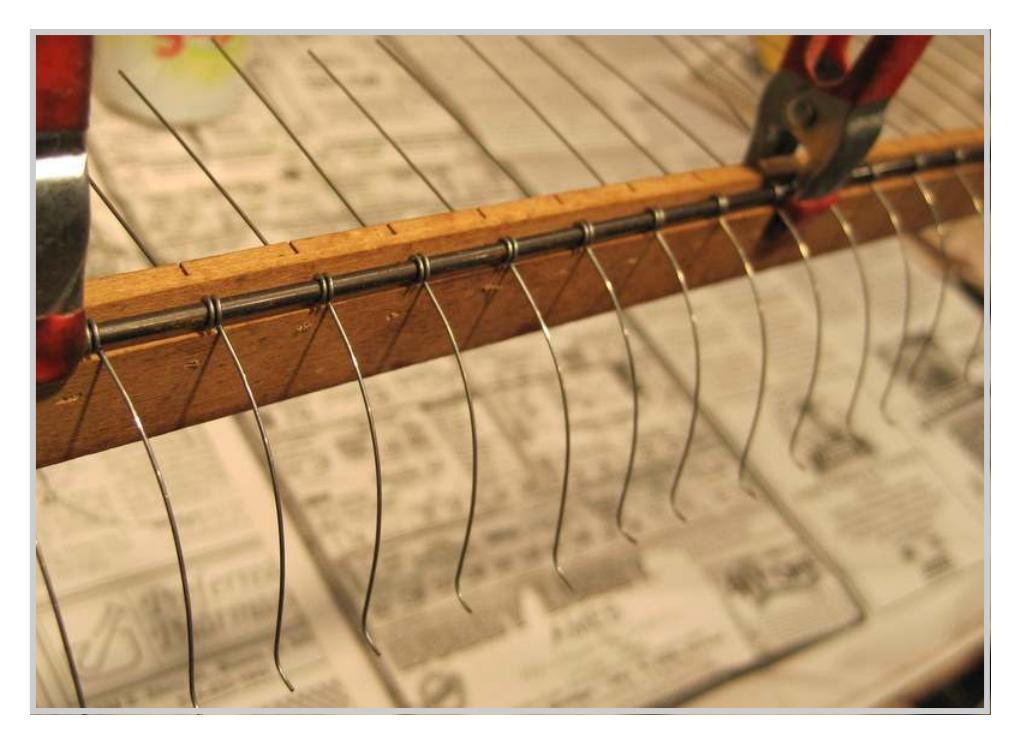
Photo 380: Once a section of springs have been positioned, clamps are used to hold the coat hanger wire in place.

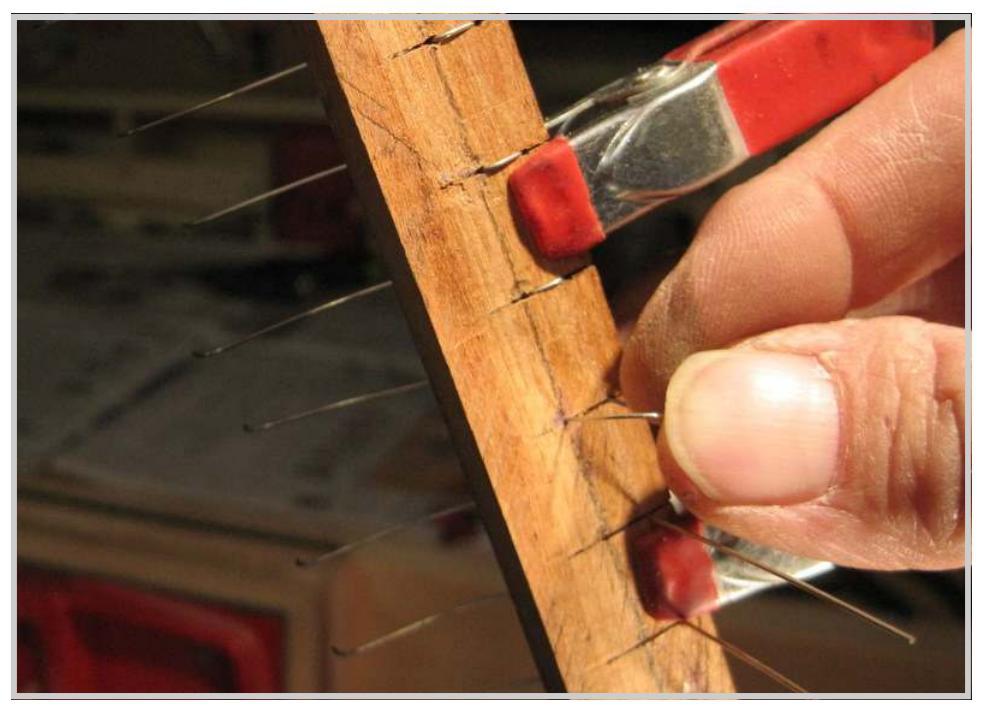
*Photo 381: The rail is then removed from the vise, and turned around. Each tail is bent in a U shaped loop, so that the end of the tail may be pushed through the newly drilled take-up hole.*

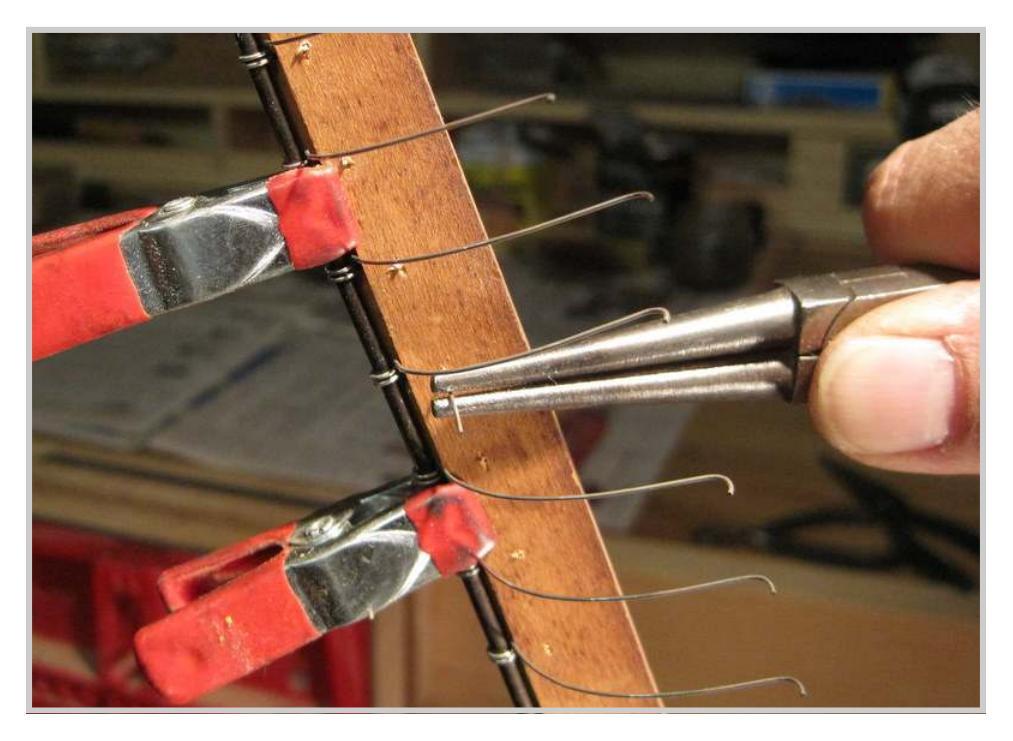
Photo 382: Back to the front side of the rail, the tail is drawn up tight by grasping the end of the tail with a pair of round nose pliers and using them as a lever against the edge of the rail to pull the slack out of the loop on the back of the rail.

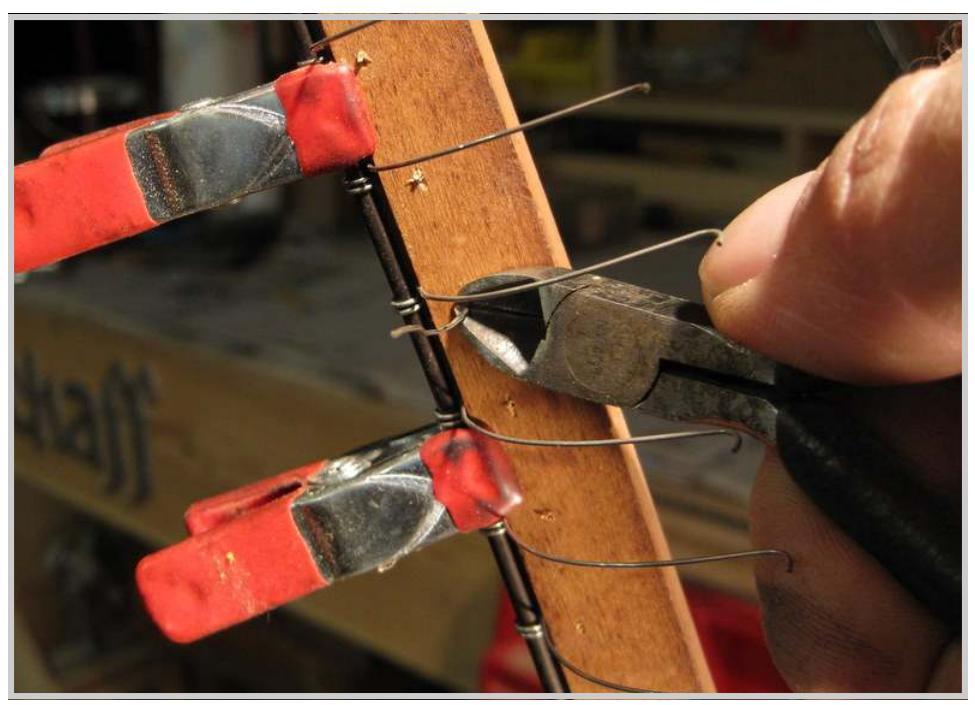
Photo 383: The excess is snipped with a pair of wire nippers.

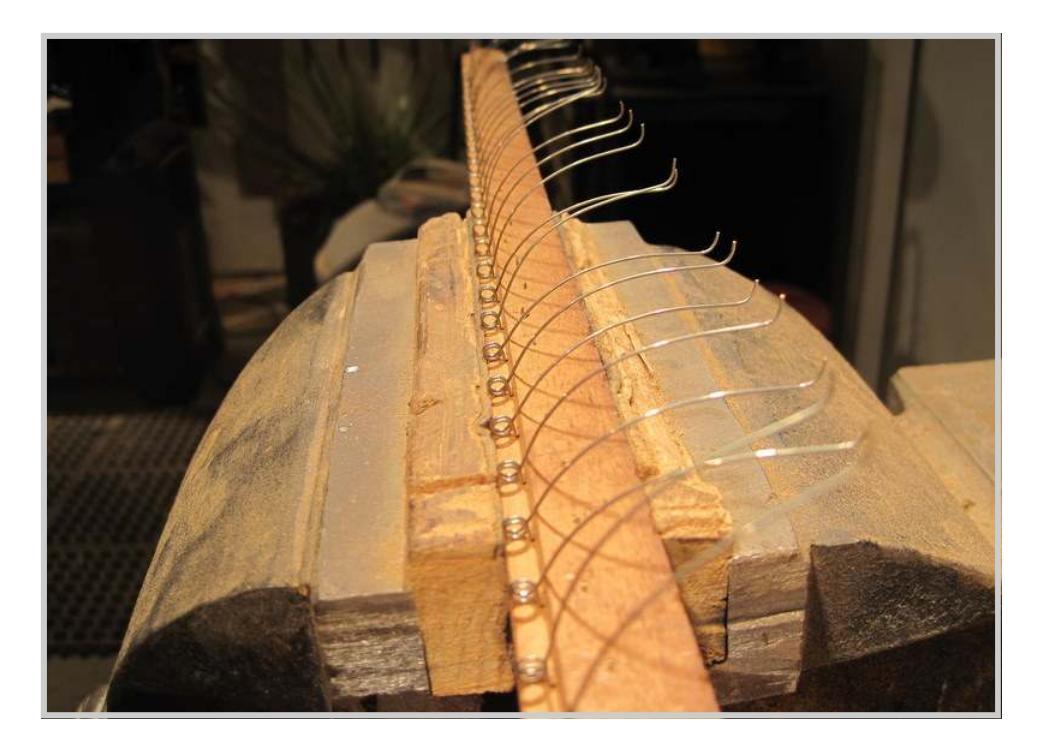
*Photo 384: With the new springs installed, the rail is again placed in a vise. Notice the helter-skelter nature of the springs at this point. Very unruly looking.*

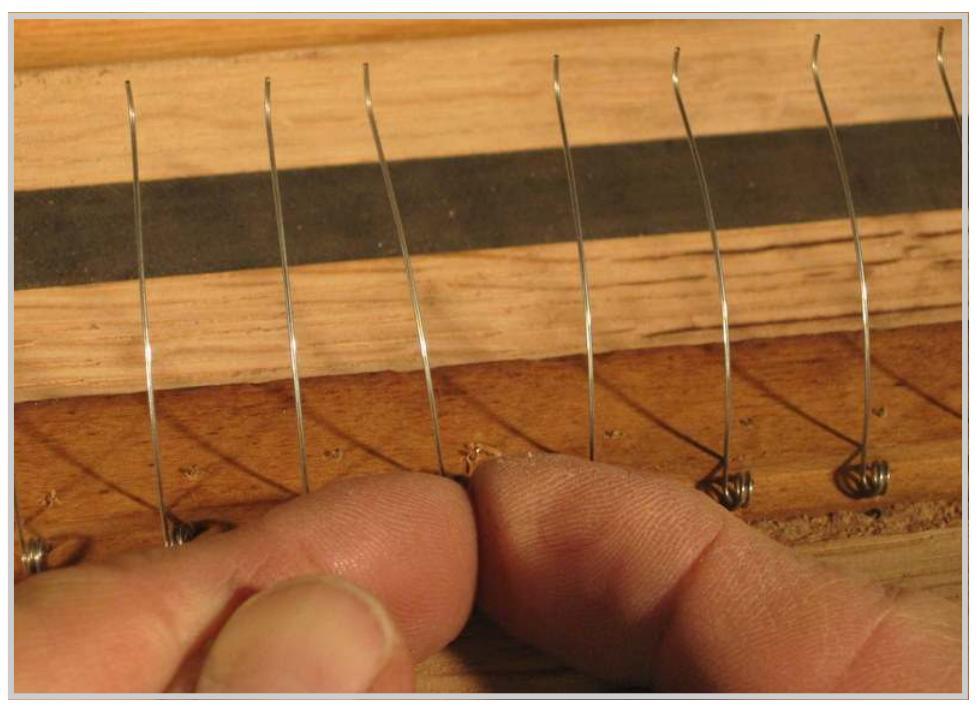
Photo 385: Minor adjustments are made along the line of springs to bring them into harmony with one another. Side to side deviations are corrected by using the forefinger on either hand to gently pinch the coil of the spring and to "persuade" it to tilt in the desired direction.

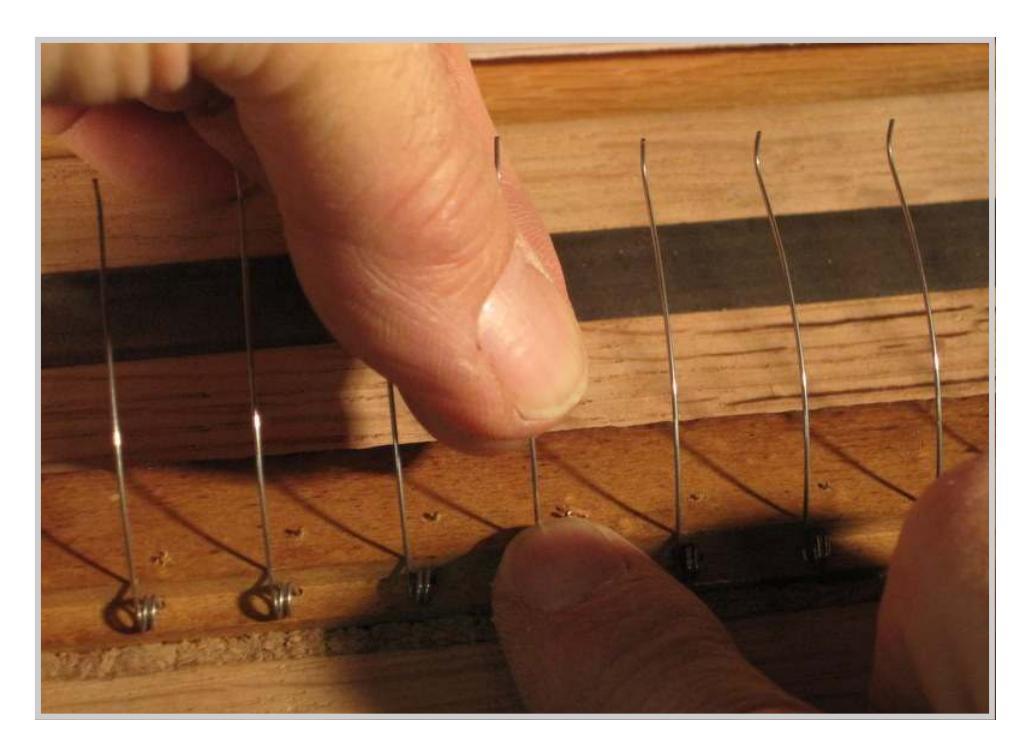
Photo 386: Springs with too much or too little arc are "massaged" between the thumb and forefinger of the left hand, while the coil is held in place by a finger of the right hand.

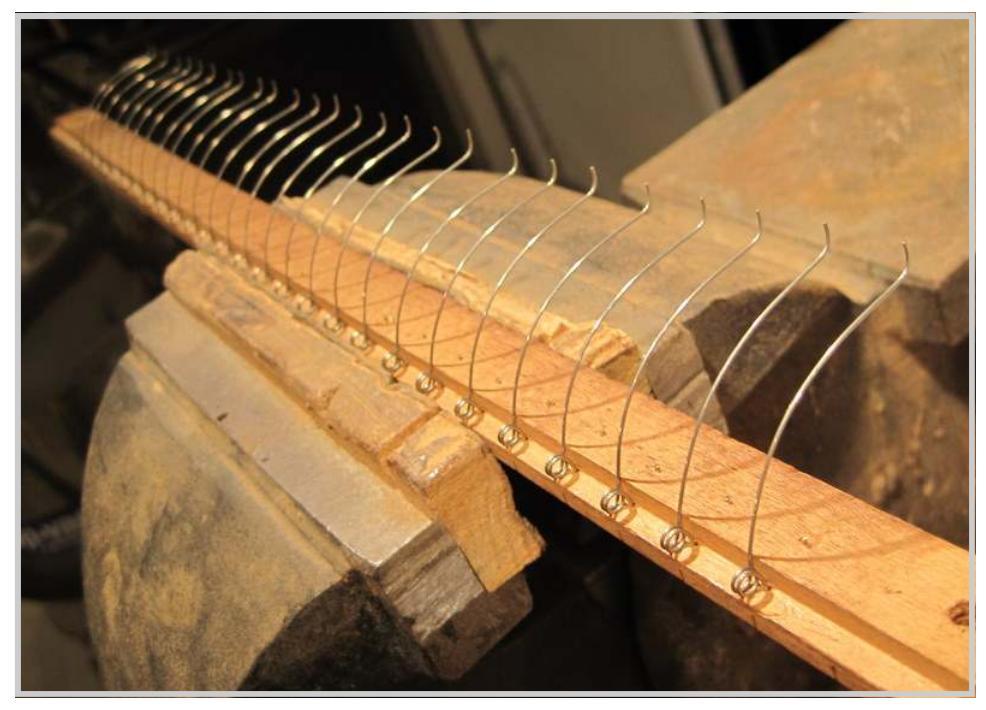
Photo 387: The spring line after adjusments are made, looking for all the world like the chorus line of the Rockettes kicking up their legs. Much more in unison than before.

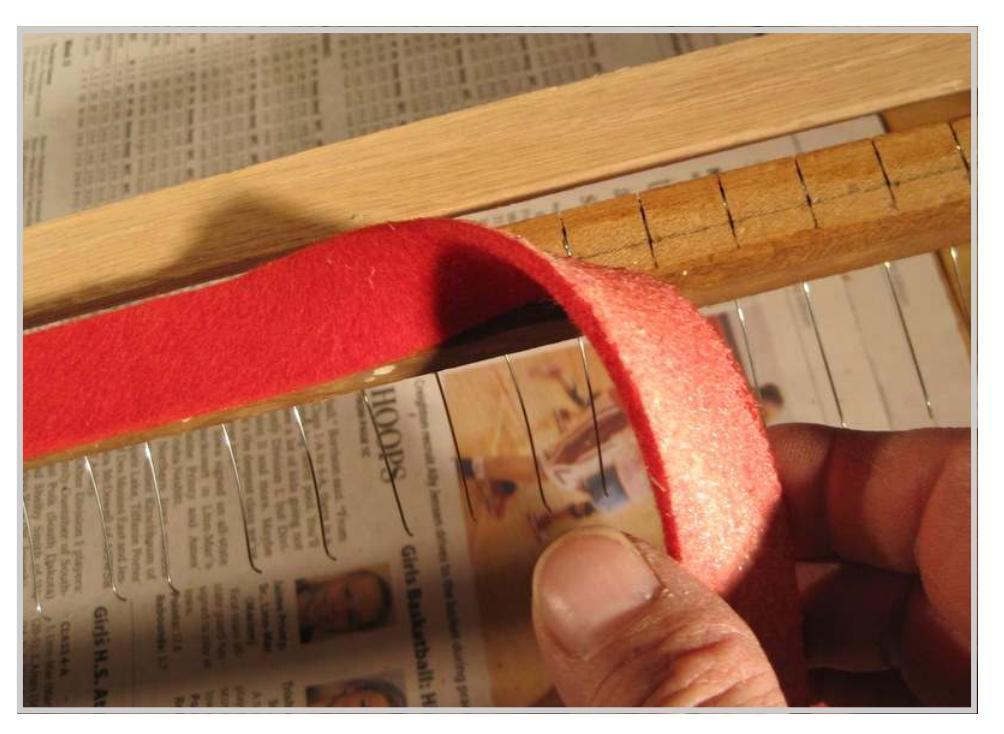
*Photo 388: The spring rail cloth is now ready to glue in place on the back side of the rail. Titebond is my choice of glue for this particular application.*

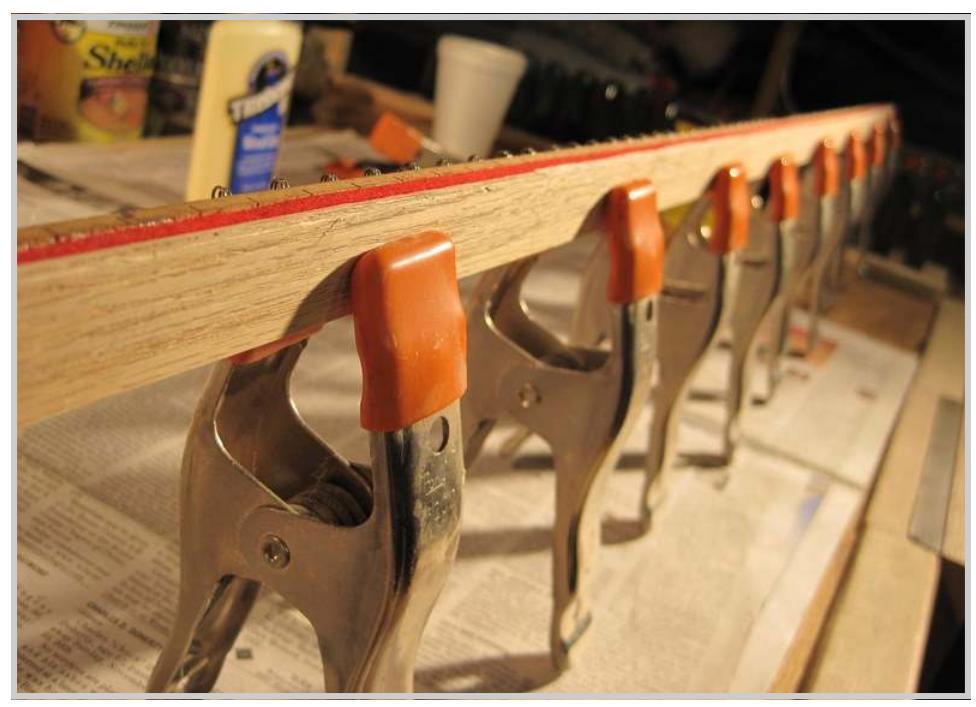
*Photo 389: The felt is clamped in place to dry using a specially cut strip of oak to spread out the pressure of the clamps evenly.*

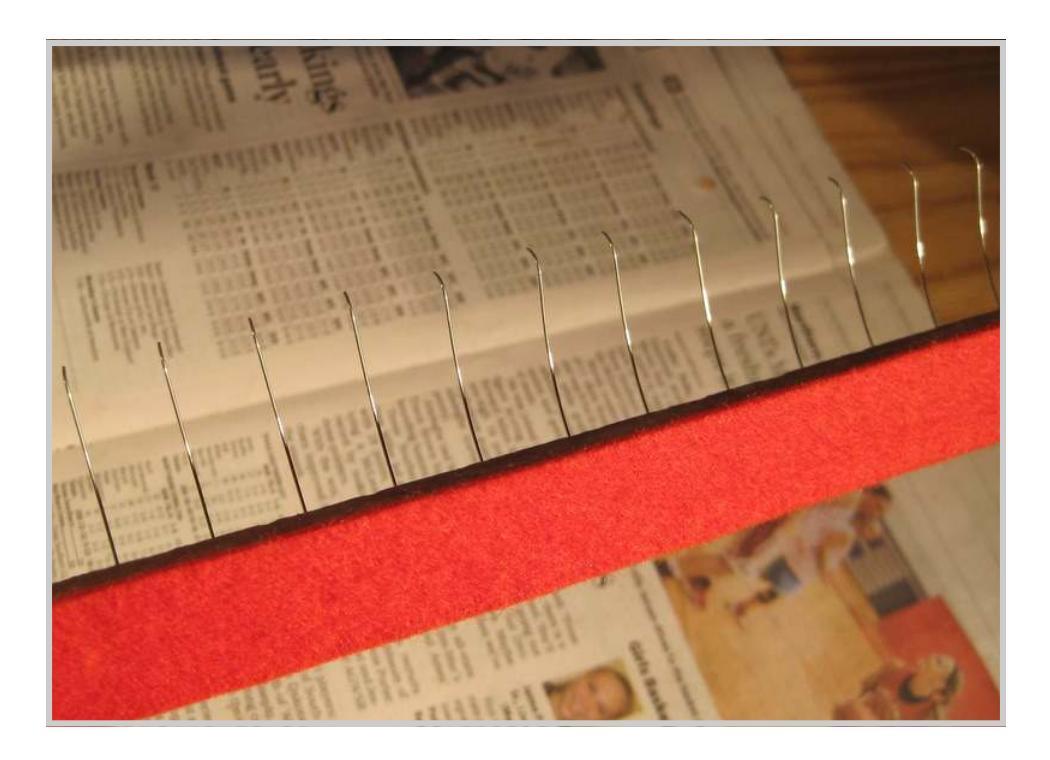
Photo 390: The new felt once the clamps are removed the next morning.

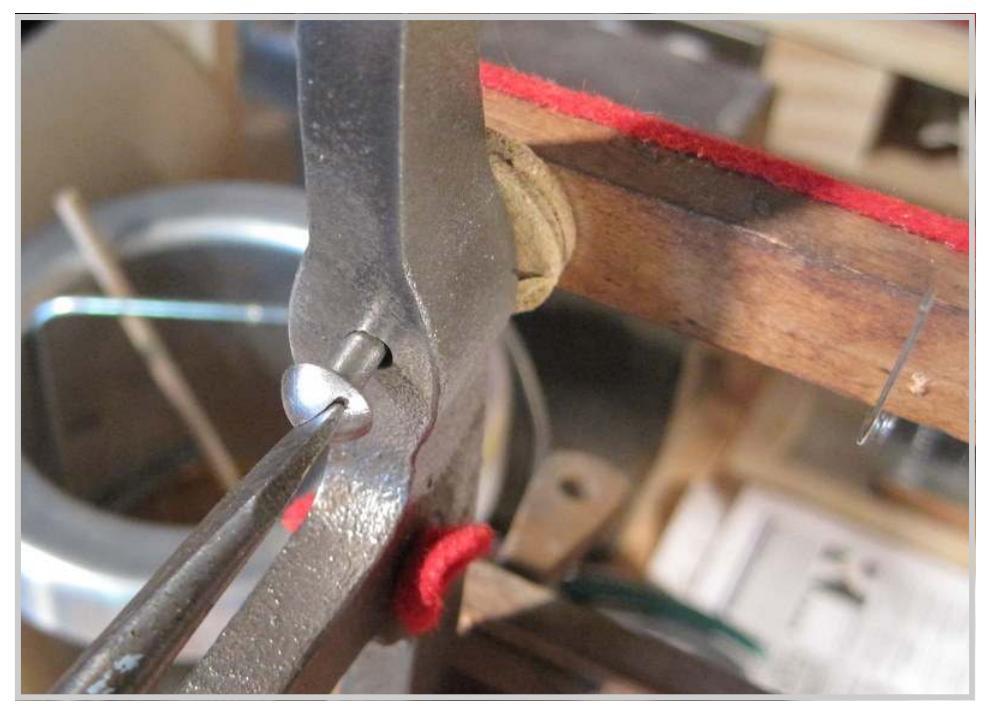
*Photo 391: The spring rail is returned to its position in the action. It is screwed to the action brackets. The original spacers are used in between the bracket and the front side of the rail.*

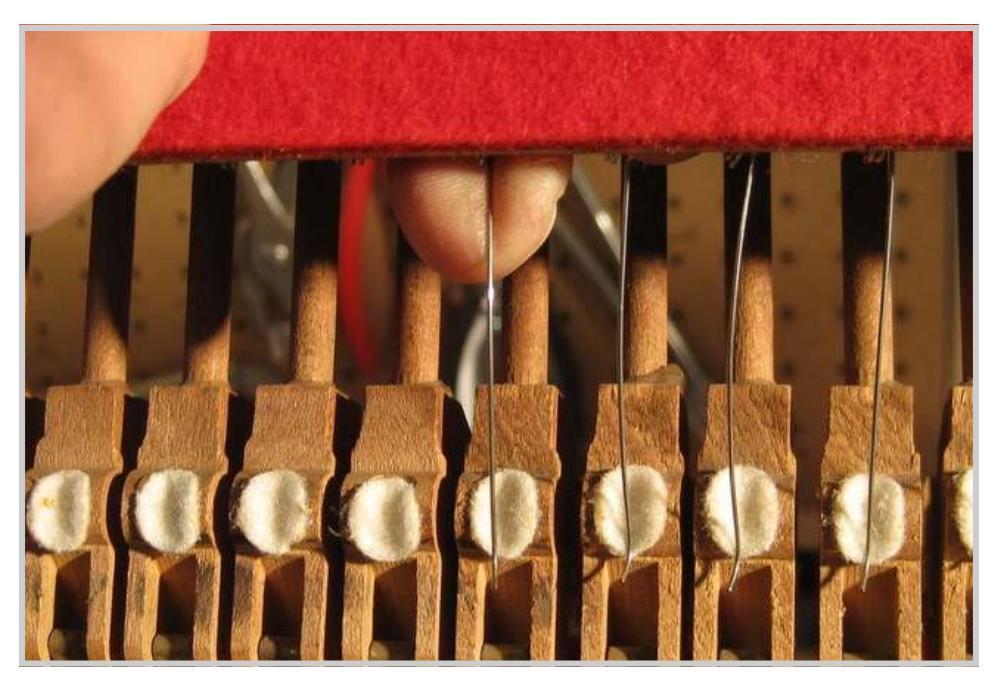
Photo 392: The springs are placed into position. Final adjustments need to be made before the job is finished.
