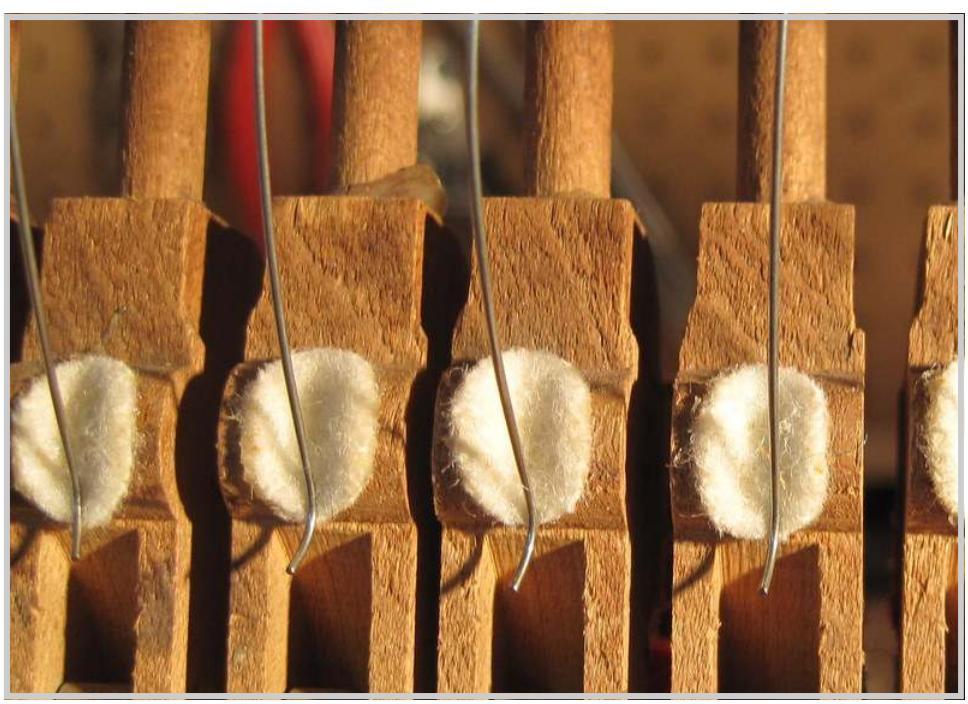
Photo 393: The springs installed are slightly too long. The bend on the end of the string should fall with the boundaries of the felt punching. Also, some of the springs are not sitting straight, but are tending to veer to one side or the other, now that they are seated and at tension.

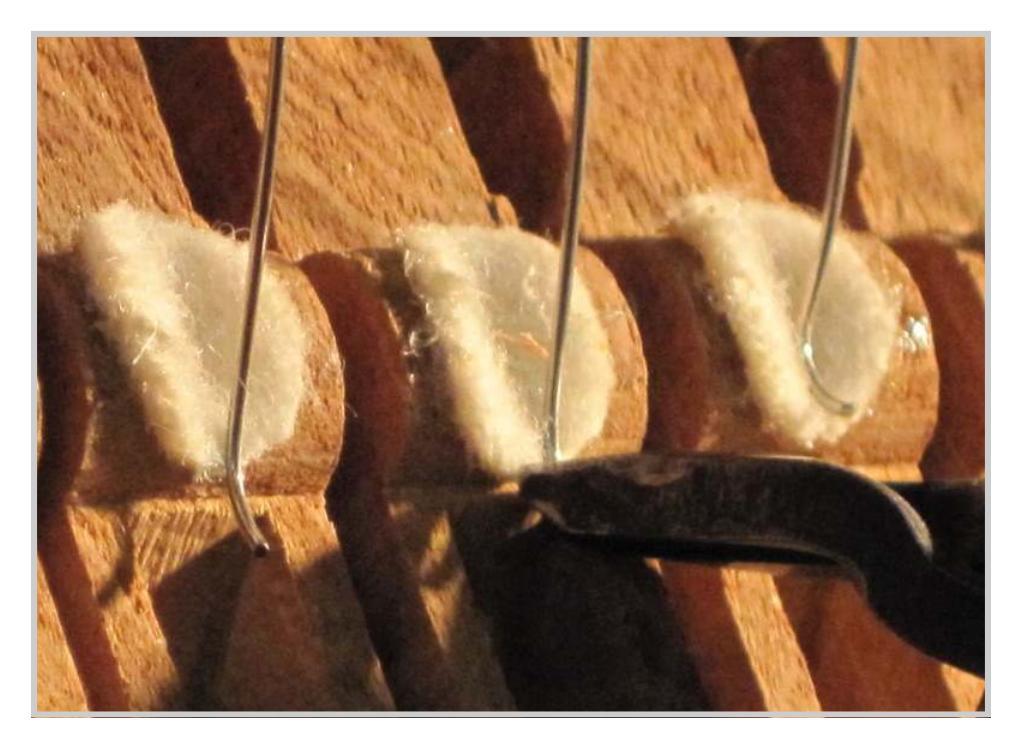
*Photo 394: The issue of length is first attended to. Using the wire nippers, the very end of the spring is cut off flush with the bottom of the felt punching. The spring on the left is still its original length, while the spring on the right has been nipped and its lower bend reformed.*

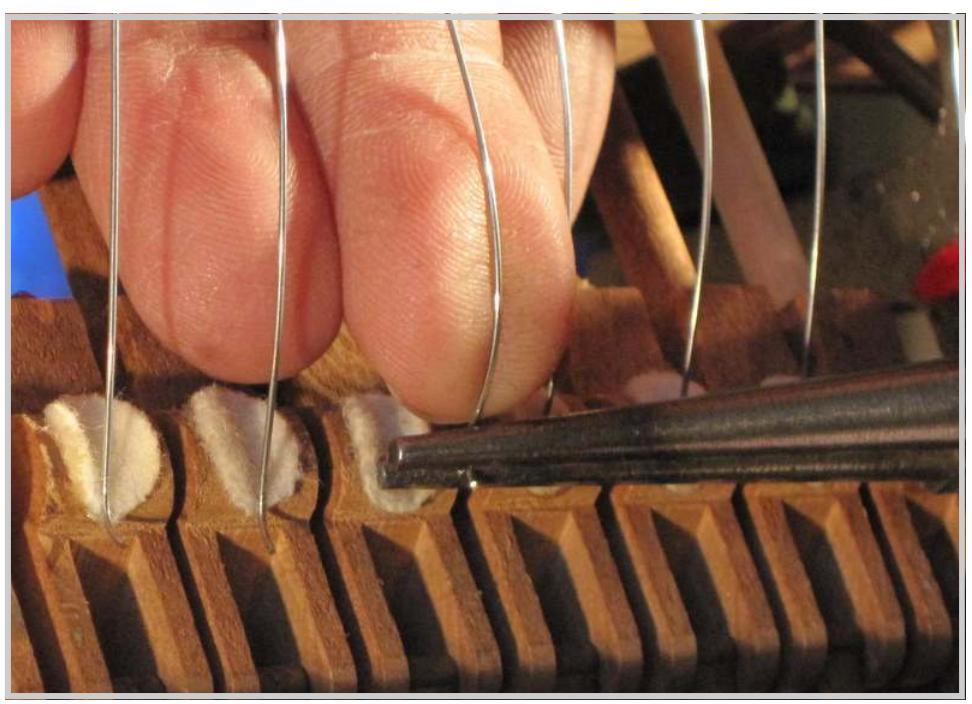
Photo 395: Reforming the bend is done by grasping the end of the spring with a medium pair of round nose pliers held in one hand, while at the same time pushing with the middle finger of the other hand outward against the arc of the spring. The pliers are then rotated slightly in a clockwise direction to complete the procedure.

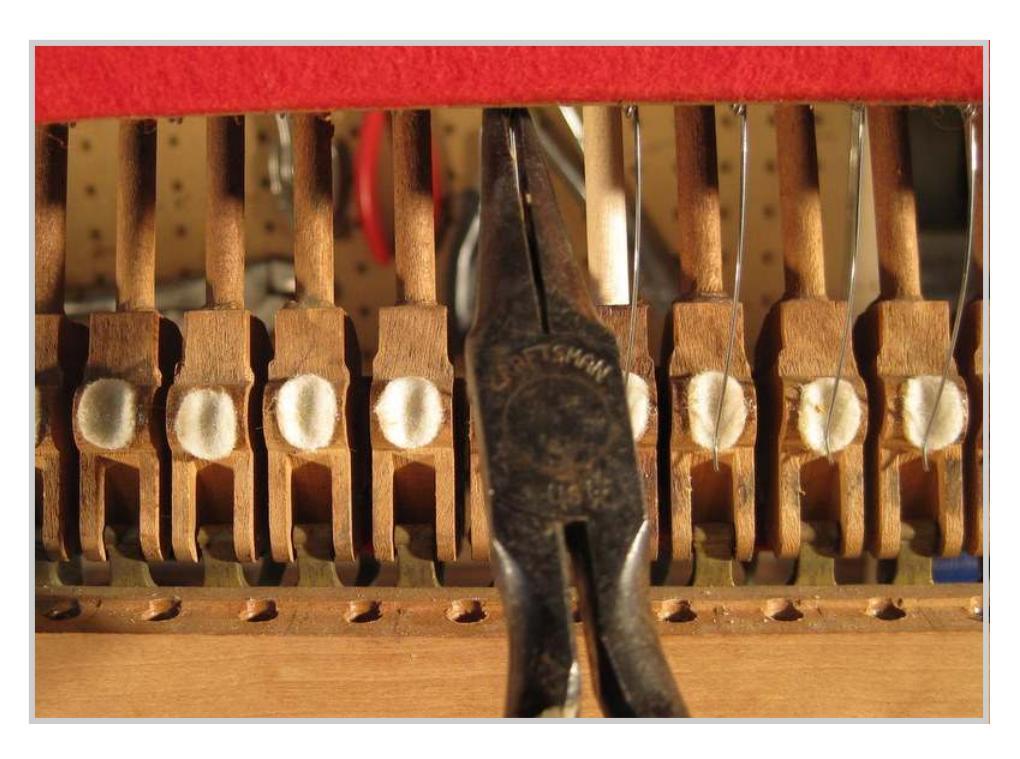
*Photo 396: Any sideways cant is corrected by grasping the coil with a pair of needle nose pliers, and gently turning the coil in the correct direction*
